### STAFF RECOMMENDATION 400 Broadway July 20, 2016

**Application:** New construction—addition; Alterations  
**District:** Broadway Historic Preservation Zoning Overlay  
**Council District:** 19  
**Map and Parcel Number:** 09306308200  
**Applicant:** Joshua Hughes, Tuck Hinton  
**Project Lead:** Melissa Baldock, melissa.baldock@nashville.gov

**Description of Project:** Application is to construct a rear and rooftop addition, to alter historic and non-historic windows, to alter window openings on the rear façade, and to alter the storefronts.

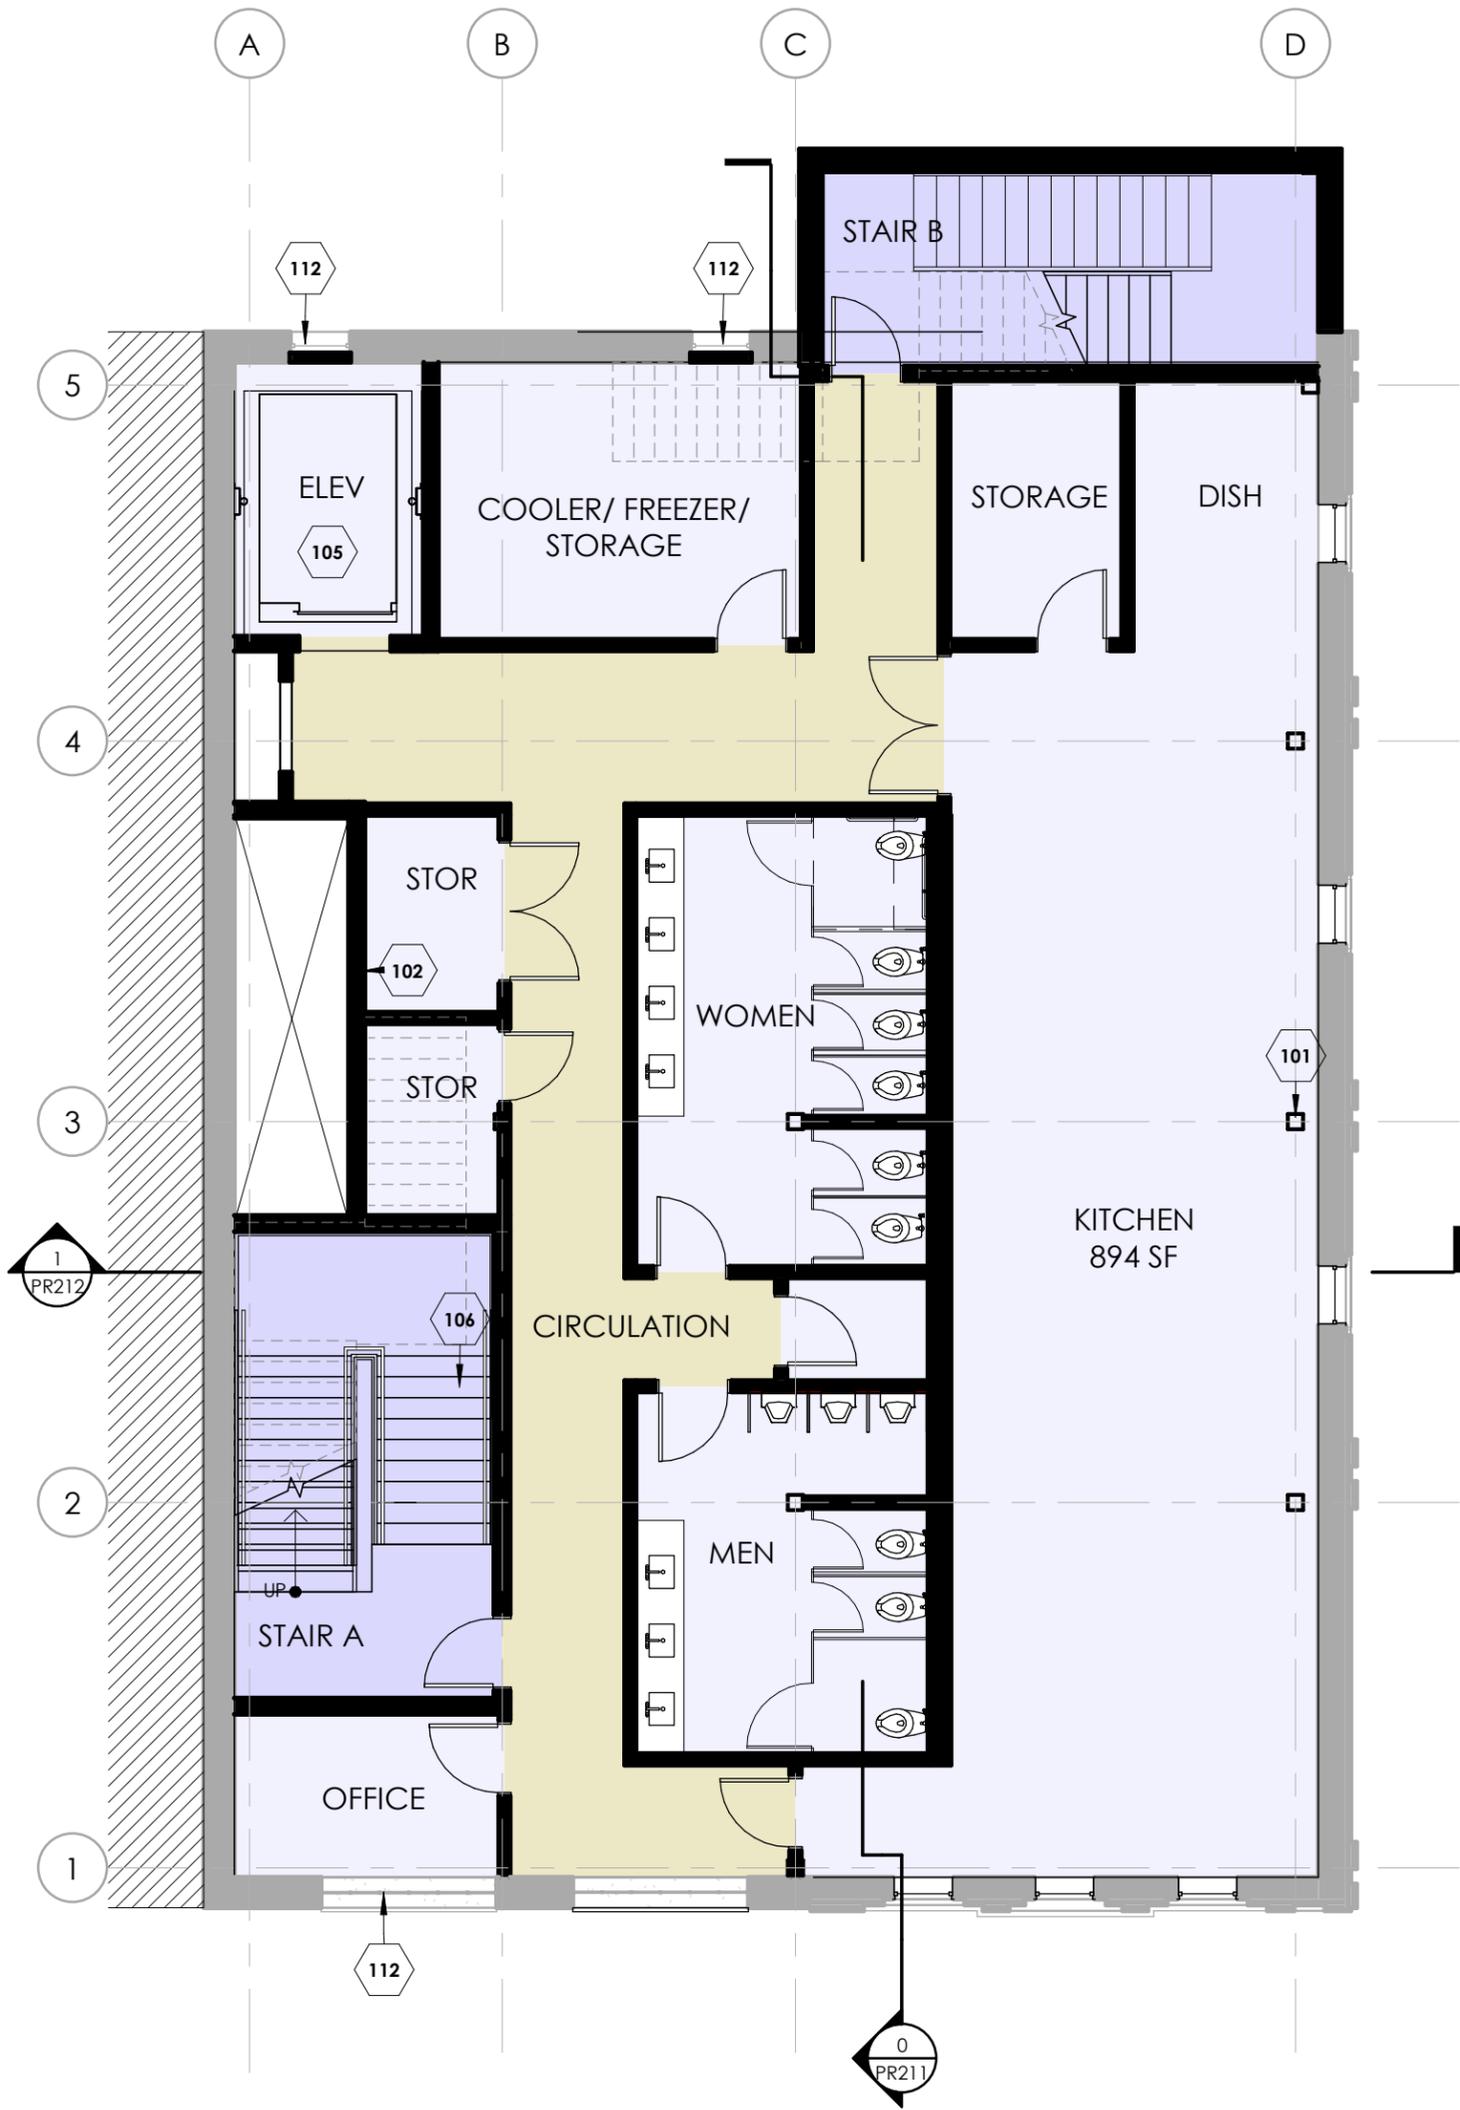
LEVEL 3 PLAN

- 101 1 HOUR PROTECTED STEEL COLUMNS, TYP.
- 102 2 HOUR RATED WALL ENCLOSURE
- 105 FREIGHT | PASSENGER ELEVATOR
- 106 CONCRETE FILLED METAL PAN STAIR
- 112 EXISTING WINDOWS TO REMAIN, TYP.

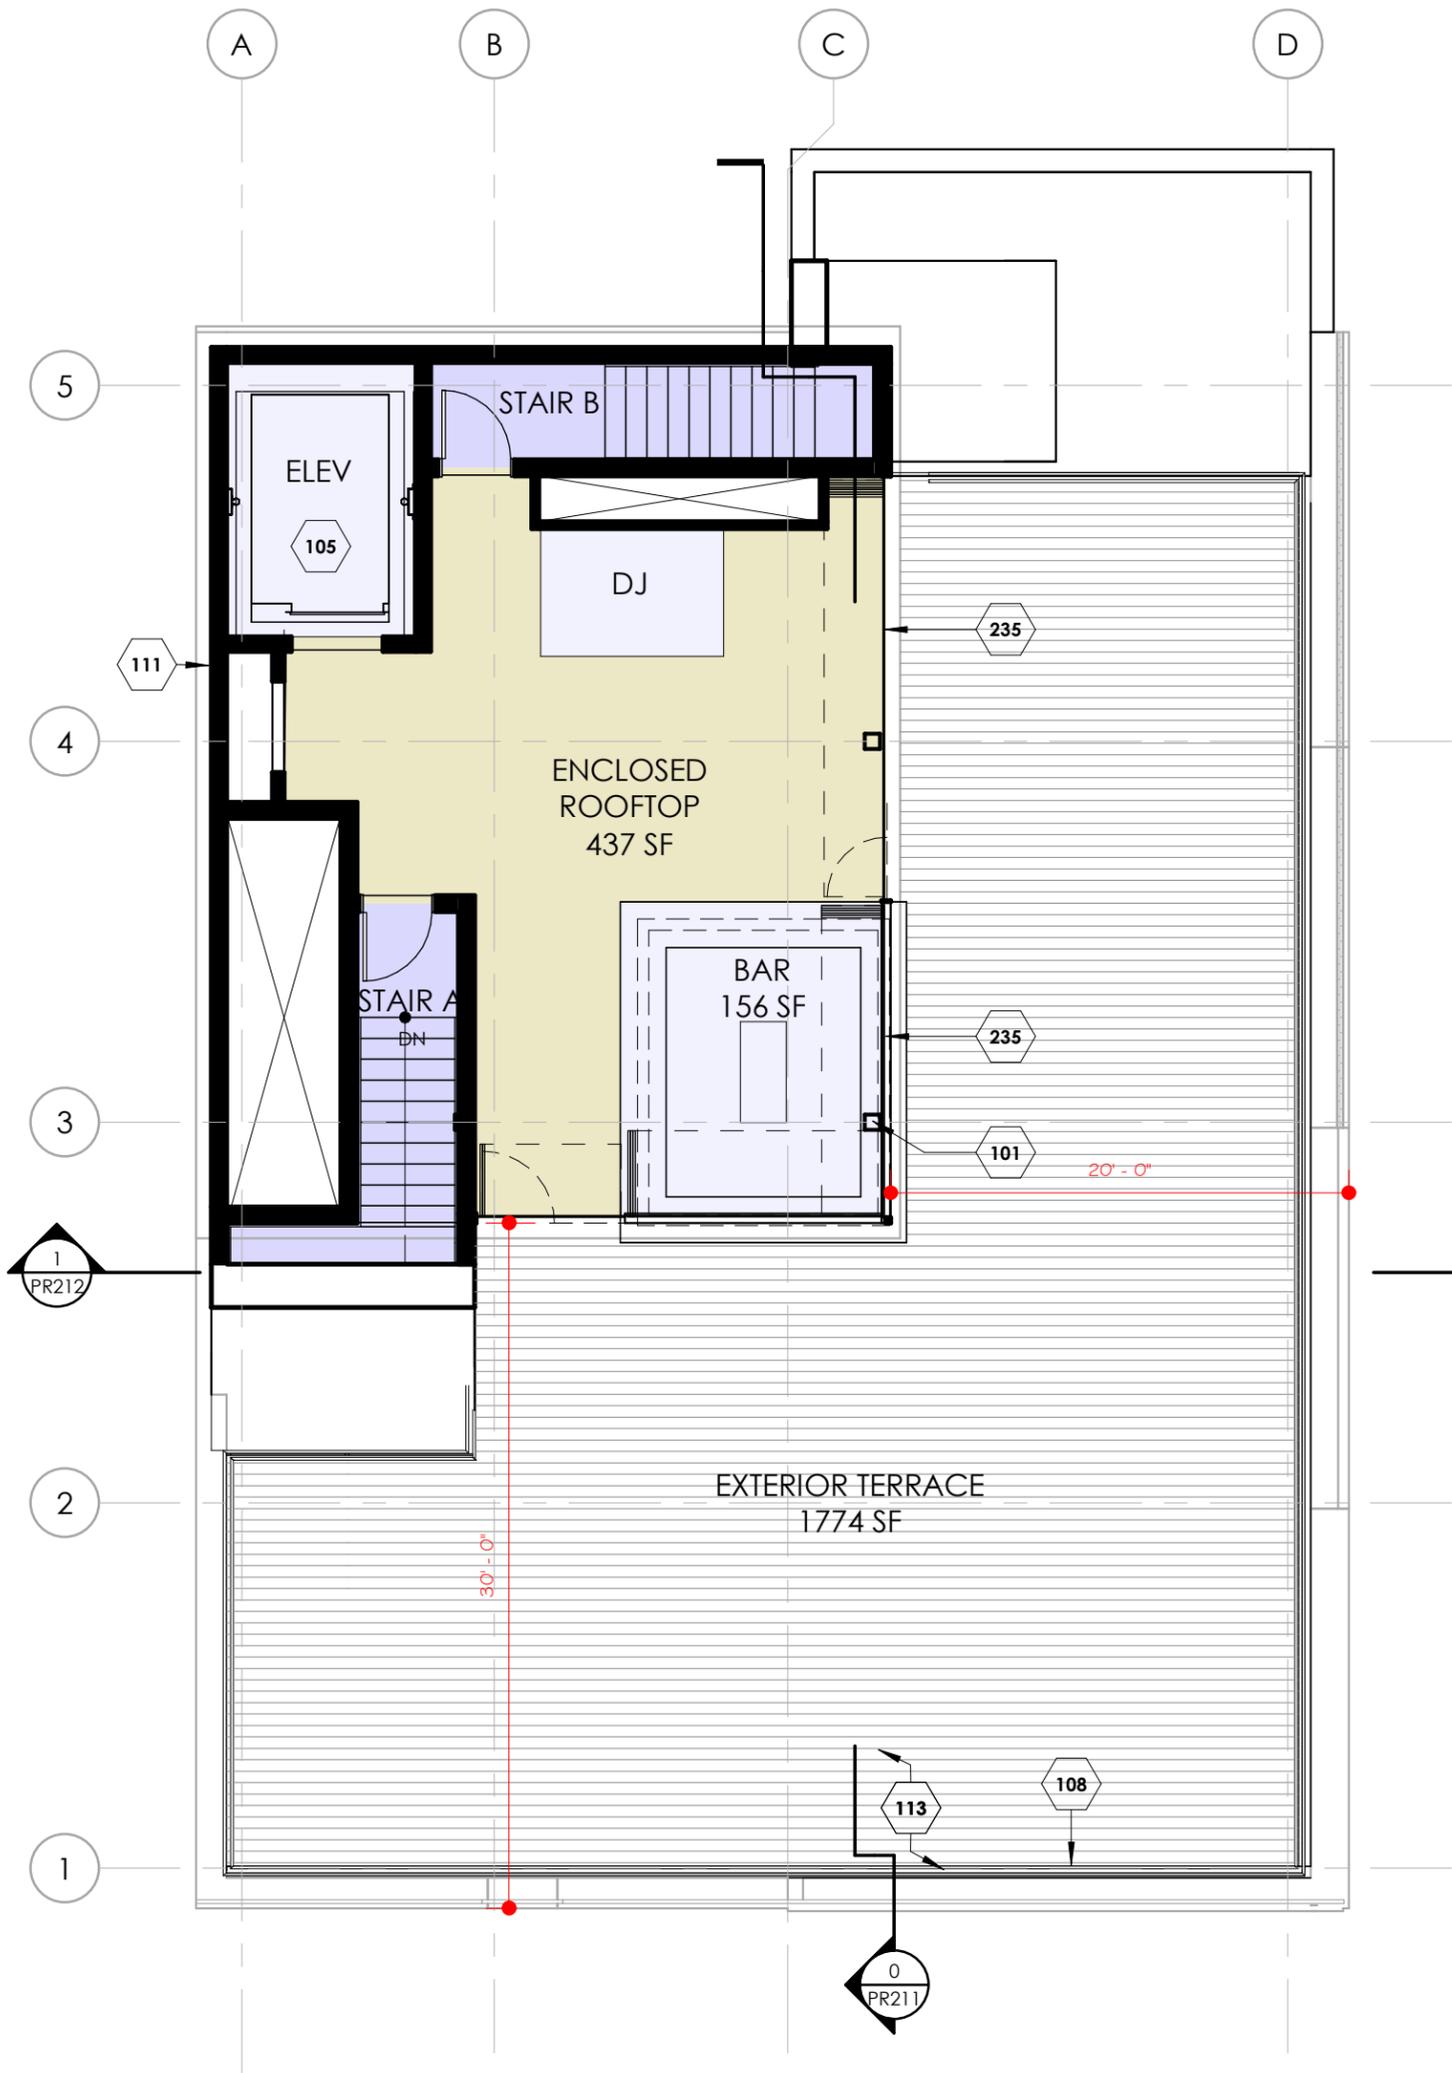
LEVEL 4 ROOF PLAN

- 101 1 HOUR PROTECTED STEEL COLUMNS, TYP.
- 105 FREIGHT | PASSENGER ELEVATOR
- 108 DECORATIVE STEEL HANDRAIL
- 111 COMPOSITE METAL PANEL
- 113 MEMBRANE ROOFING
- 235 FULLY OPERABLE FOLDING GLASS WALL SYSTEM

Rooftop Addition: The applicant is proposing a rooftop addition. The bulk of the addition is setback from the Broadway façade by the required thirty feet (30'). However a portion of the stair bulkhead encroaches on the thirty-foot (30') setback by approximately eight (8') feet. This stair bulkhead is no taller than five (5') and is slanted so that the tallest portion of the bulkhead is further back. The bulkhead will likely be at most minimally visible, and staff therefore finds that its encroachment to the required setback is appropriate. Similarly, the bulk of the addition is setback twenty feet (20') from the Fourth Avenue North façade, as is required. However, a stairwell bulkhead will extend approximately seven feet (7') into this setback. Staff finds this encroachment to be appropriate because the bulkhead has a maximum height of three feet (3') above the parapet and is designed so that its tallest portion is furthest from the parapet wall.

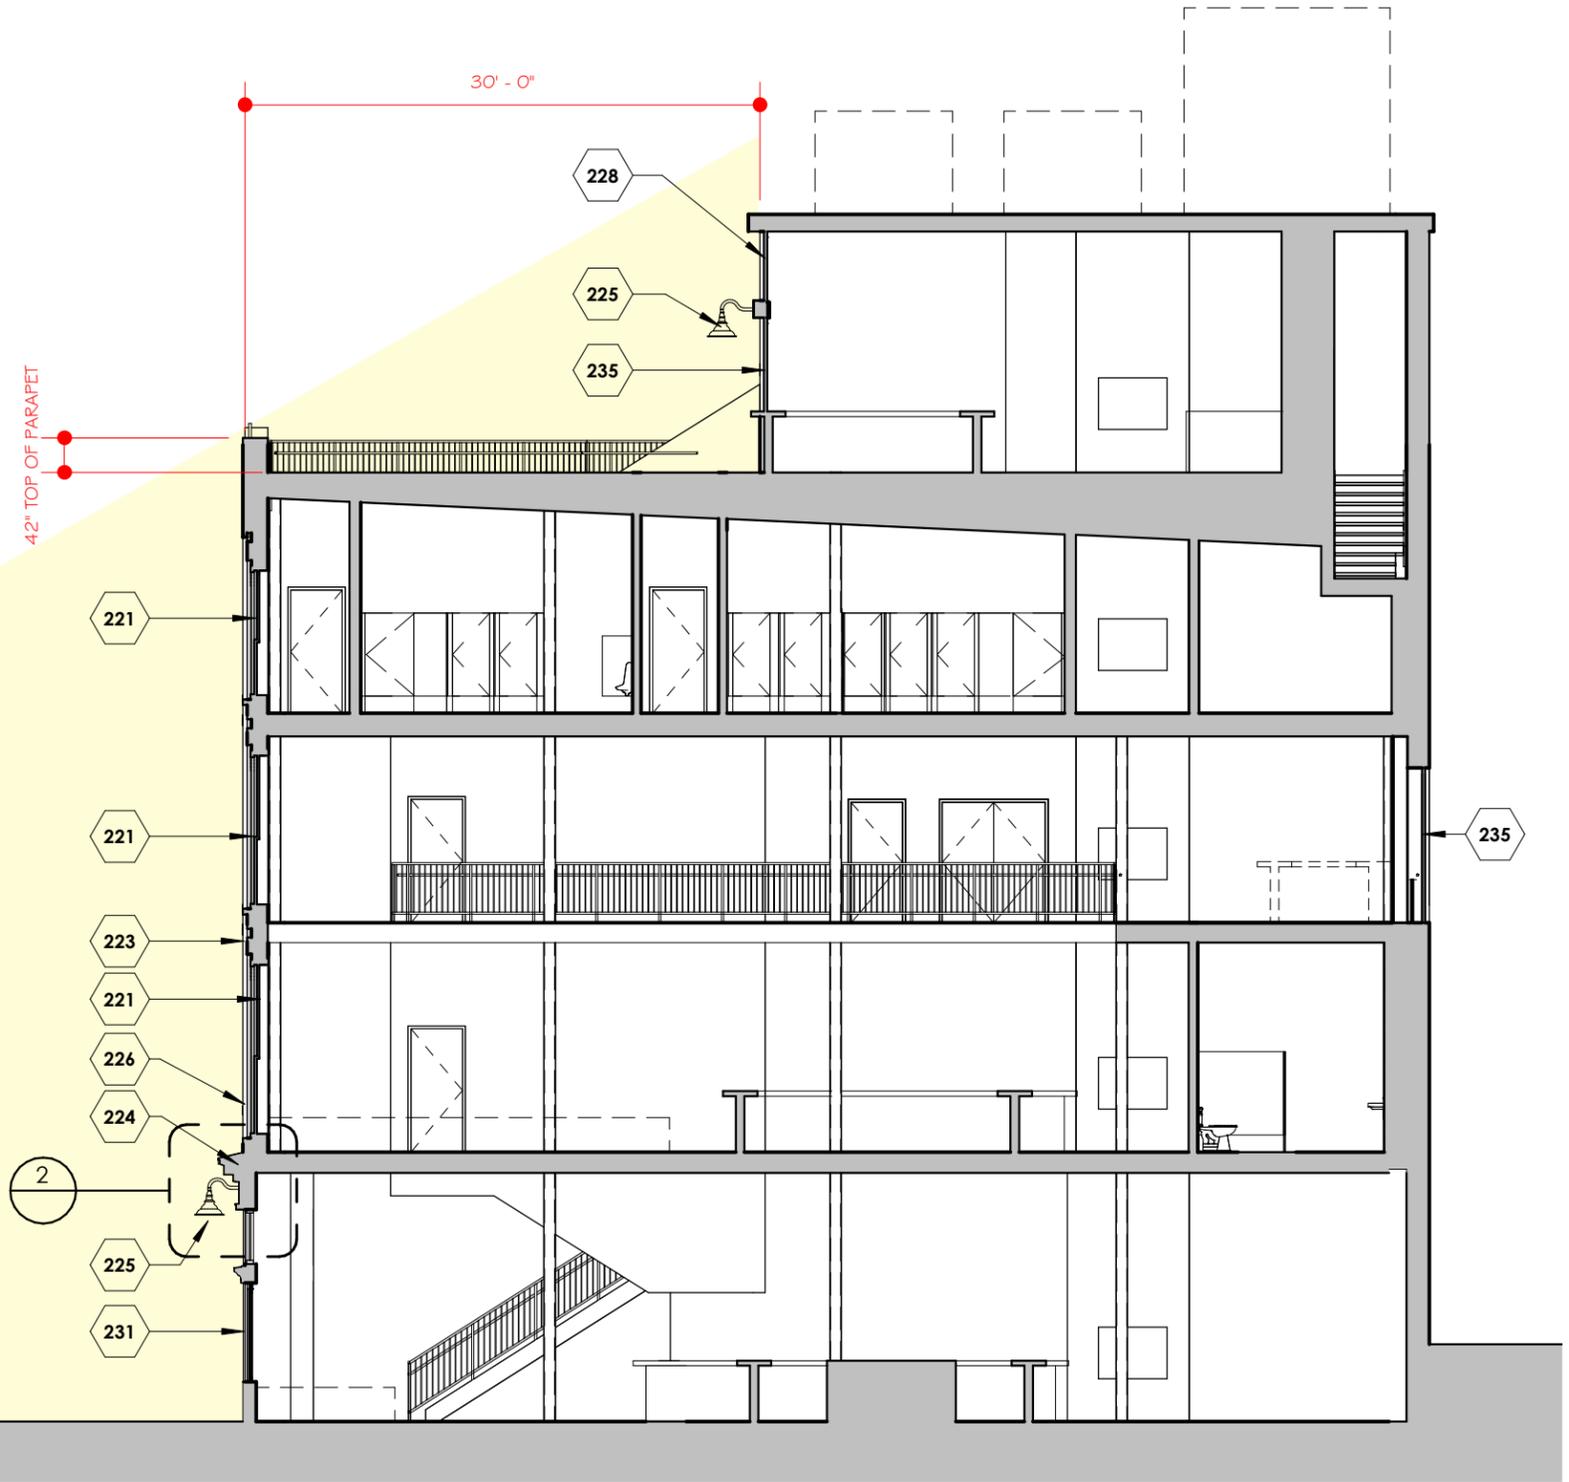
4TH AVE SECTION

- 221 NON-ORIGINAL WINDOWS TO BE REPLACED WITH FULLY OPERABLE CASEMENT WINDOW TO MATCH
- 224 EXISTING METAL CORNICE
- 225 EXTERIOR ACCENT LIGHTING - WALL MOUNTED DOWN LIGHT FIXTURE
- 226 EXTERIOR ACCENT LIGHTING - BUILDING UPLIGHTING
- 229 DECORATIVE METAL RAILING
- 231 NON-ORIGINAL STOREFRONT TO BE REPLACED WITH FULLY OPERABLE FOLDING GLASS WALL SYSTEM
- 235 FULLY OPERABLE FOLDING GLASS WALL SYSTEM
