Operations Monitoring Report

Second Quarter FY24

**Thermal Engineering Group, Inc.
105 Hazel Path Court, Ste 2
Hendersonville, TN 37075**

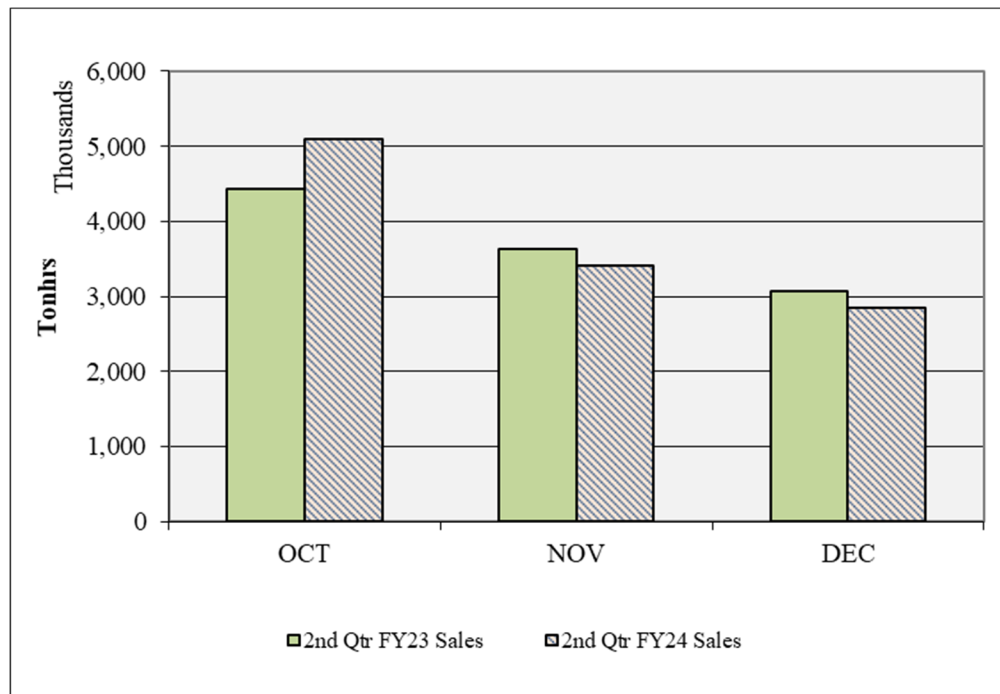
Figure 1. Chilled Water Sales Comparison

A comparison for the Second Quarter chilled water sales is shown in Figure 1. This data reflects a 2.1% increase in sales for the current quarter over the same quarter of the previous fiscal year.

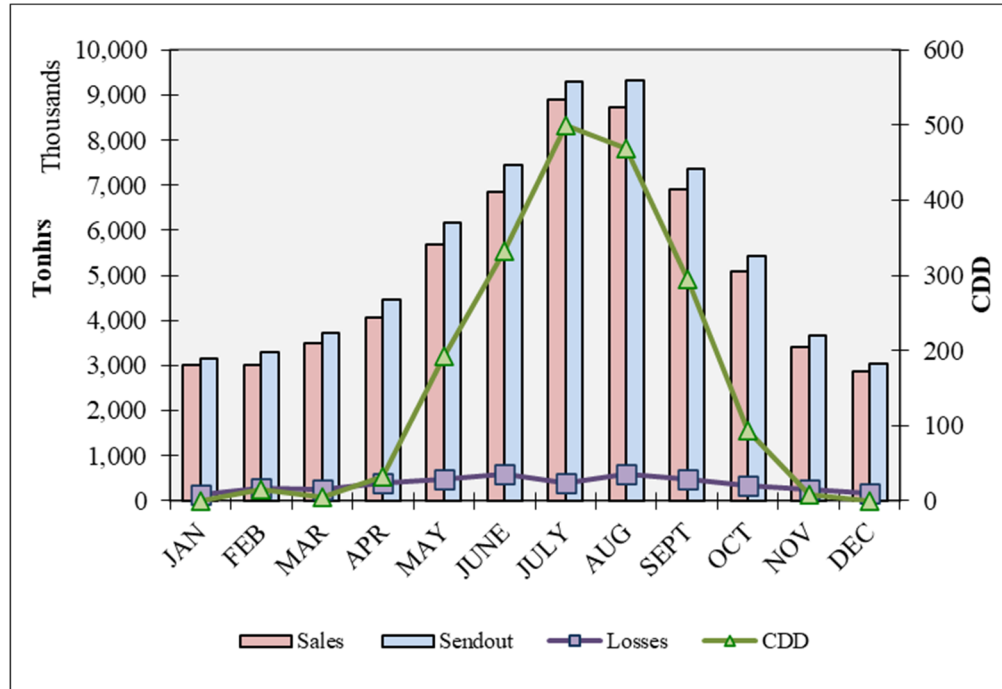
Figure 2. Chilled Water Sales, Sendout, Losses and CDD for the Previous Twelve Months

Figure 2 shows the chilled water sales, sendout and losses for the previous twelve months. The losses on this figure are defined as the difference in tonhrs per month between the recorded sendout and sales values and represent the total energy loss for chilled water in the EDS. The number of cooling degree days were 143% higher in FY24 than in FY23 and are tracked for comparison.

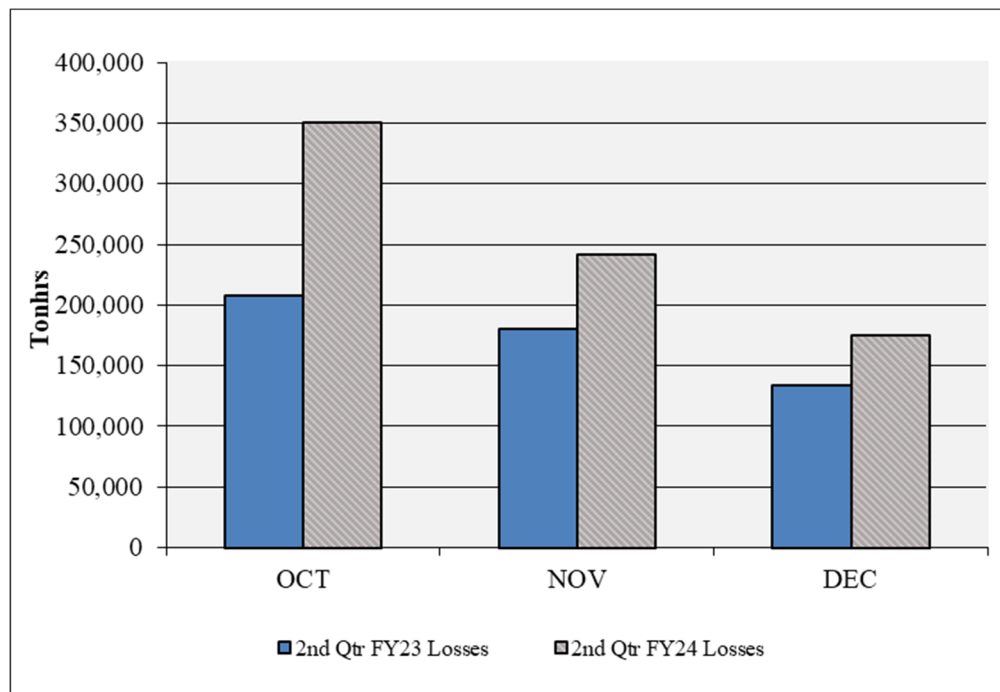
Figure 3. Chilled Water System Loss Comparison

A significant increase in the chilled water energy losses previously noted for the Fourth Quarter FY23 was determined to be related to an issue with the chilled water meter at the Bridgestone Arena. This issue was resolved prior to the First Quarter FY24. However, the losses for the Second Quarter have significantly increased (47.2%). TEG and CES will investigate the cause of these losses. A comparison of the total chilled water energy losses in the EDS for the Second Quarter is shown in Figure 3. These losses are the difference in chilled water sendout and sales and may reflect differences in the meter accuracy between the EGF sendout meter and the customer meters.

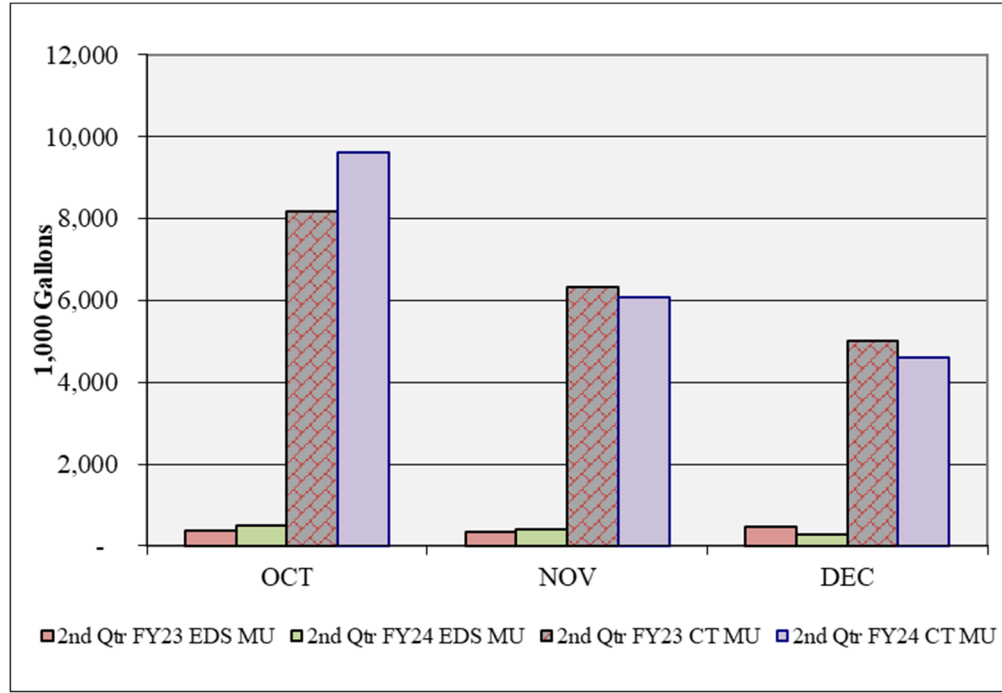
Figure 4. Chilled Water System City Water Usage Comparison

The make-up to the cooling towers increased 4.1% over the previous Second Quarter. The water usage in the cooling towers is typically proportional to the production of chilled water and should vary with chilled water sales, thus the increase in cooling tower make-up would be expected with an increase in sales. The

total chiller plant water use increased 3.8% over the Second Quarter FY23. The overall city water make-up comparison for the chilled water system Second Quarter is shown in Figure 4.

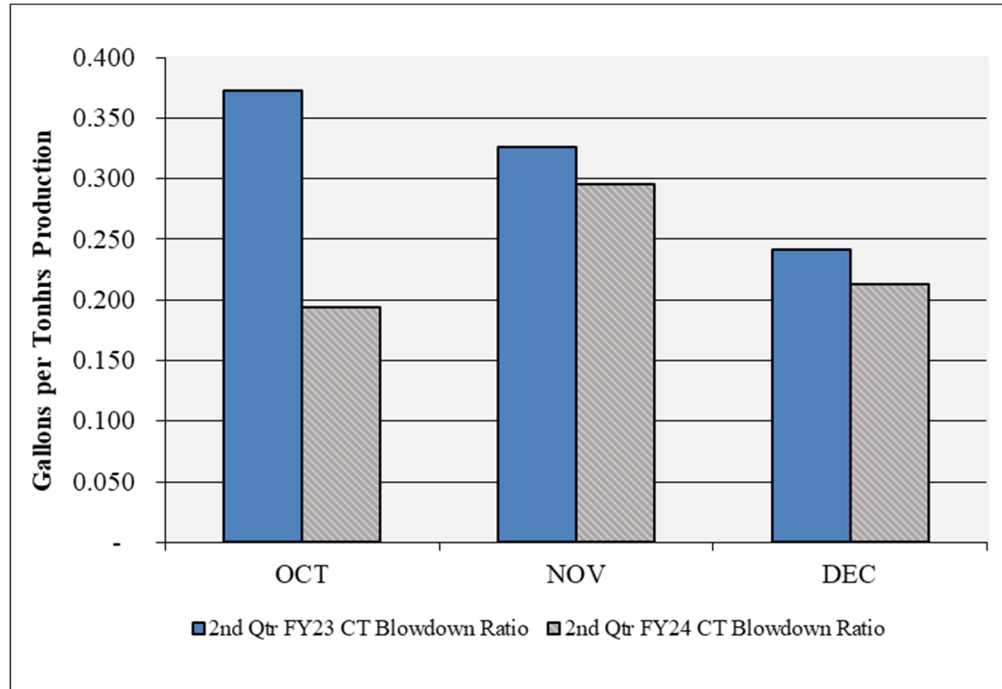
Figure 5. Cooling Tower Blowdown Ratio Comparison

Beginning in March 2023, CES and TEG began monitoring the cooling tower blowdown ratio in earnest. The relationship between the cooling tower blowdown and the chilled water production should be consistent and tracking this relationship may prove helpful in reducing the chiller plant water usage. CES has made operational changes with respect to this metric with the expectation of reducing the water usage and improving their performance relative to the chilled water-water guarantee. When a comparison is made between the Second Quarter FY24 and FY23, the ratio decreased 26.7%. This metric will continue to be tracked and monitored to verify operational changes made by CES at the EGF have resulted in a decrease in chiller plant water usage. Figure 5 shows the comparison of this metric for the Second Quarter.

- CES began monitoring and tracking the ratio of the cooling tower blowdown to the chilled water production. The average value for the quarter decreased 26.7% over the previous Second Quarter. TEG and CES continue to monitor various performance metrics within the EGF and EDS to look for ways to improve system efficiency.

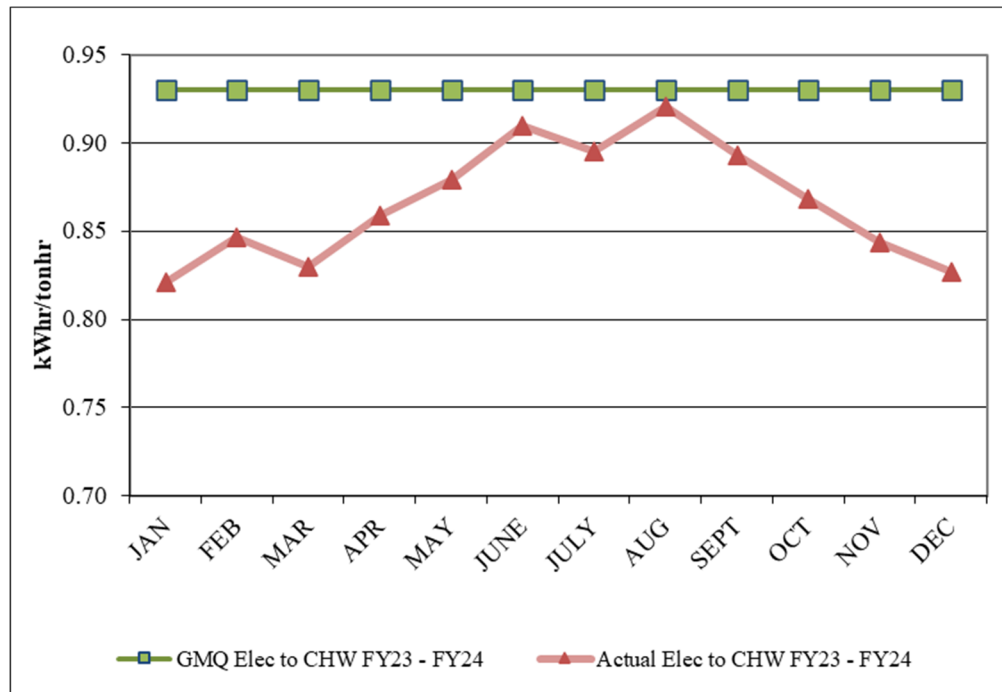
Figure 6. Chiller Plant Electric Performance Guarantee Comparison for the Previous Twelve Months

The performance of the chilled water portion of the EGF is presented in the following two charts, Figures 6 and 7, for the previous twelve months. The System Performance Guarantee levels as described in Amendment 2 of the ARMA were consistently achieved for the chilled water-electric for each month of the Second Quarter. The chilled water-electric guarantee has also been met for the previous twelve months. The chilled water-water guarantee was met each month during the quarter.

The chilled water allocation of the electric consumption falls under the GMQ limit of 0.93 kWhr per tonhr for the current quarter on average with no excursions reported for the current fiscal year. The electric usage per unit of sales increased 2.4% over the previous Second Quarter. The increase in the average value of the metric for this quarter may be attributable to the performance of the cooling towers and the warmer-than-usual quarter. CES and TEG continue to monitor the improvements created by CES’s operational changes.

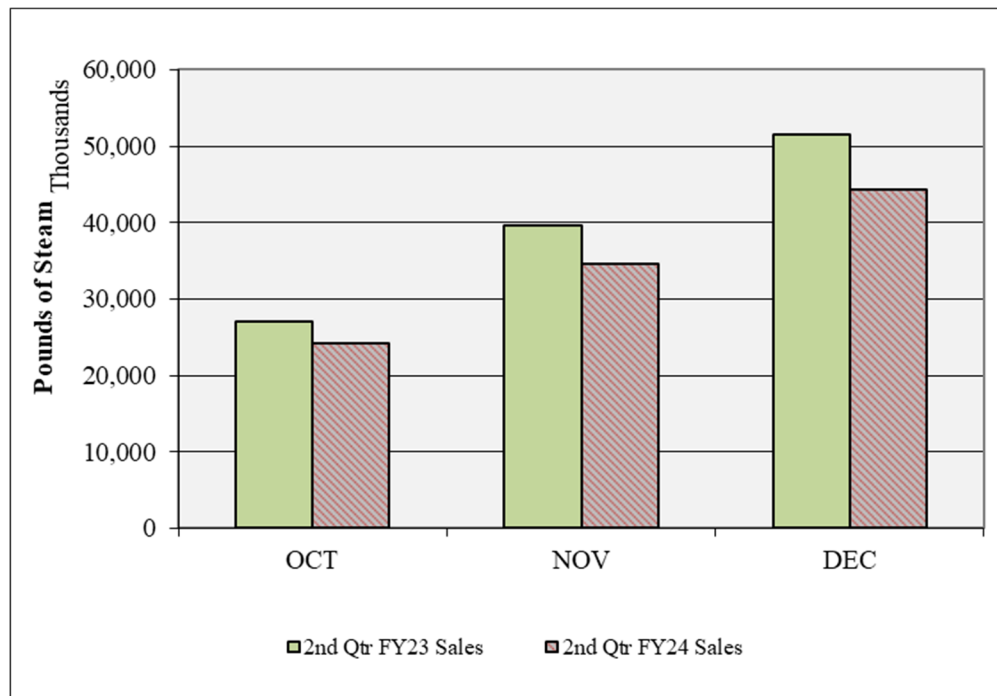
Figure 8. Steam Sales Comparison

The steam sendout decreased by approximately 12.6% over the previous Second Quarter (FY23), and the sales also decreased 12.6%. Similarly, the heating degree days during the quarter decreased 13.6% due largely to a warmer-than-normal quarter. The steam system losses decreased 12.5%, and the relative amount of condensate return decreased 19.6% during the quarter due to dumping condensate at several customer buildings for DES196 and in MH-18 for the work associated with DES198. DES198 was completed during the quarter, and condensate was being returned by mid-November. DES196 is expected to not be completed until mid-January. The peak steam demand for the current quarter was 103,025 pph, which reflects a 24.4% decrease in the peak steam production over the previous Second Quarter. A comparison for the Second Quarter steam sales is shown in Figure 8.

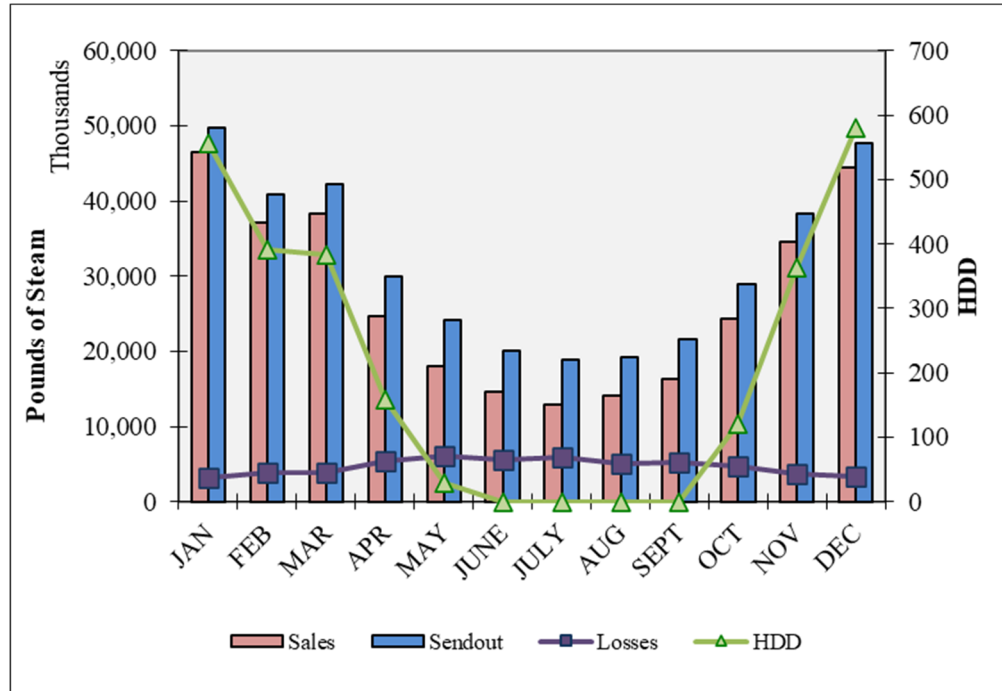
Figure 9. Steam Sales, Sendout, Losses and HDD for the Previous Twelve Months

Figure 9 shows the steam sales, sendout and losses for the previous twelve months. The losses on this figure are defined as the difference in pounds per month between the recorded sendout and sales values and represent the total mass loss in the EDS between the EGF and the customer meters.

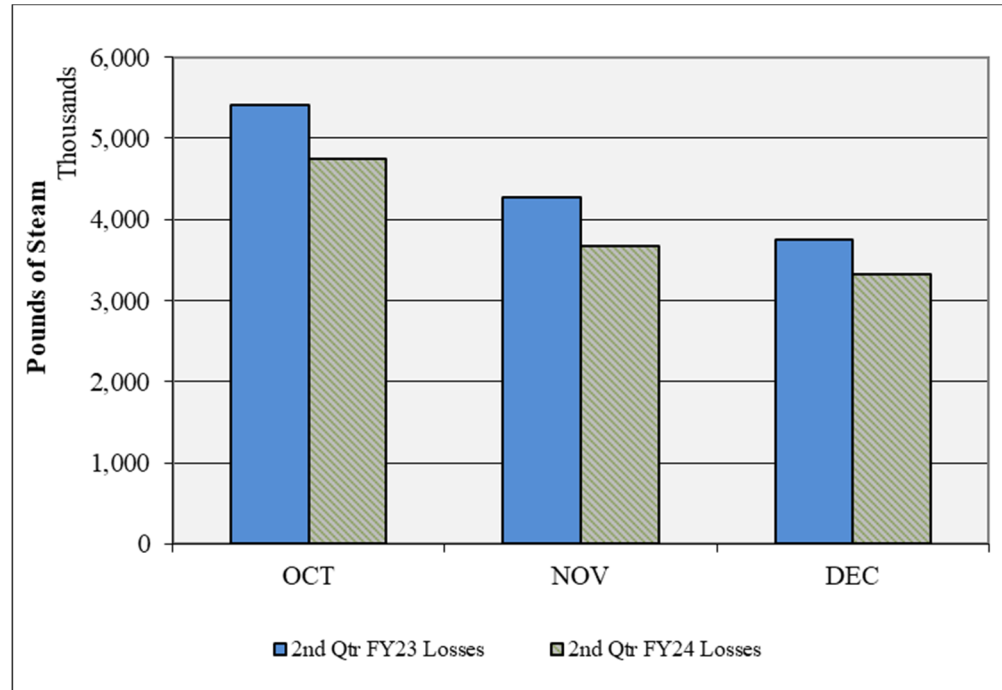
Figure 10. Steam System Losses

A comparison of the total steam mass losses in the EDS for the Second Quarter is shown in Figure 10. The mass loss is caused by the heat loss in the EDS between the EGF and the customer meters, resulting in a mass loss at steam traps. Faulty traps, steam leaks or meter error could also be a contributing cause of these losses.

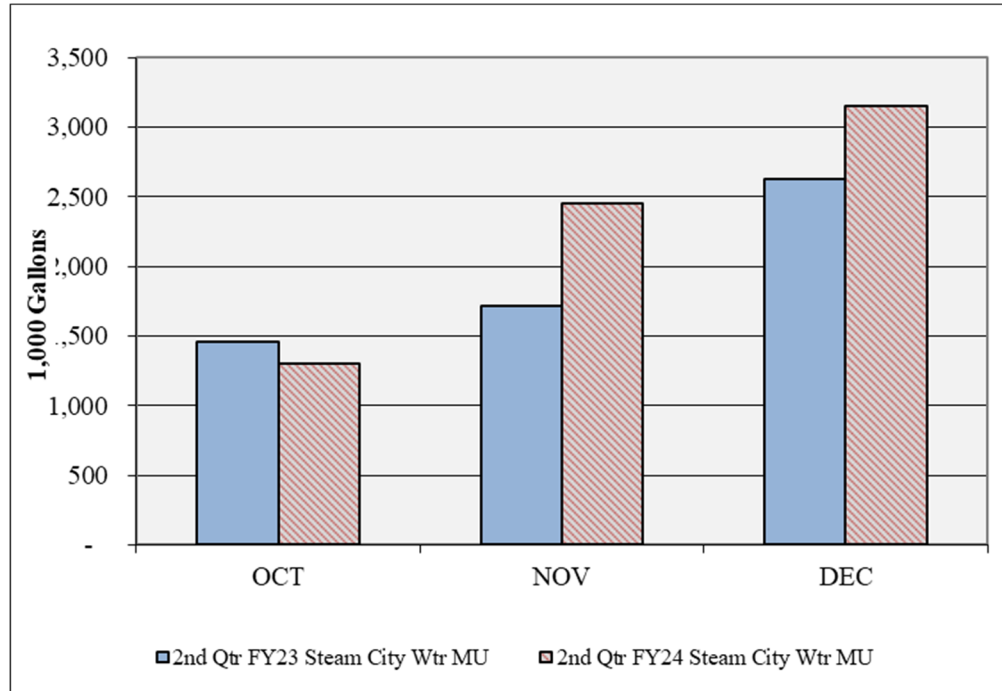
Figure 11. Steam System City Water Make-up Comparison

The amount of city water make-up (MU) to the steam system consists of the loss in mass between the EGF and the customers, in the condensate return from the customers to the EGF and losses at the EGF. The amount of make-up to the steam system increased 19.2% over the Second Quarter FY23. As discussed previously, condensate is being dumped for project DES196 and was dumped for part of the quarter for project DES198. The corresponding data for steam system make-up is shown in the comparison of Second Quarter data in Figure 11.

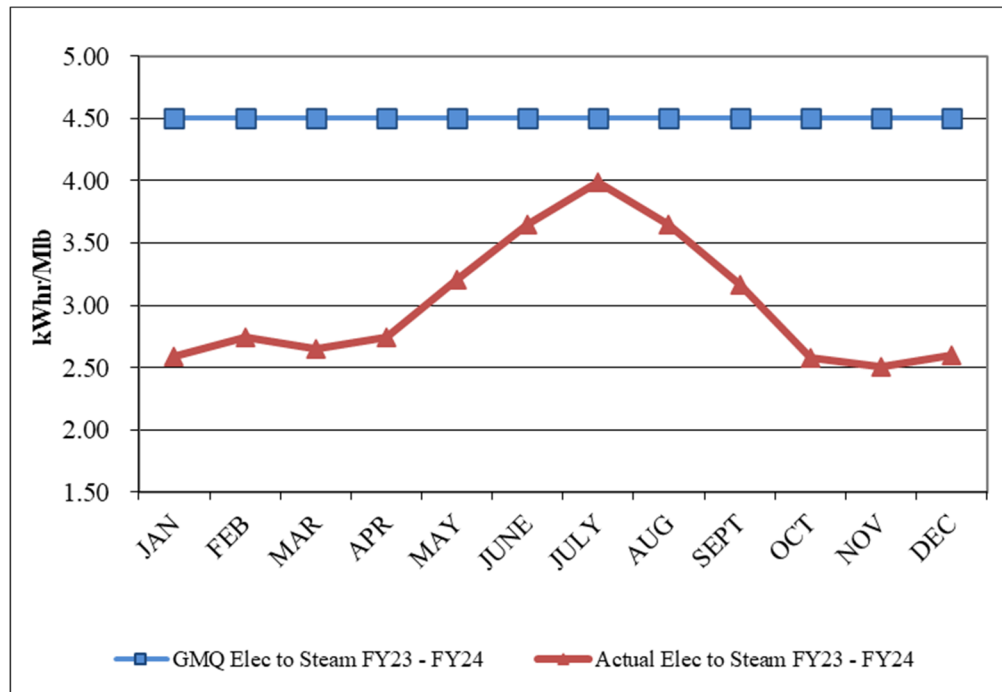
Figure 12. Steam Plant Electric Performance Guarantee for the Previous Twelve Months

The performance of the steam system of the EGF is presented in the following three charts, Figures 12, 13 and 14. The steam electric conversion factor was met each month of the quarter. The steam plant electric consumption for the current quarter was 9.0% lower in FY24 than in FY23. The steam-electric metric increased 3.4% over the previous Second Quarter. The monthly steam-to-electric conversion factors, along with the guaranteed values, are shown in Figure 12.

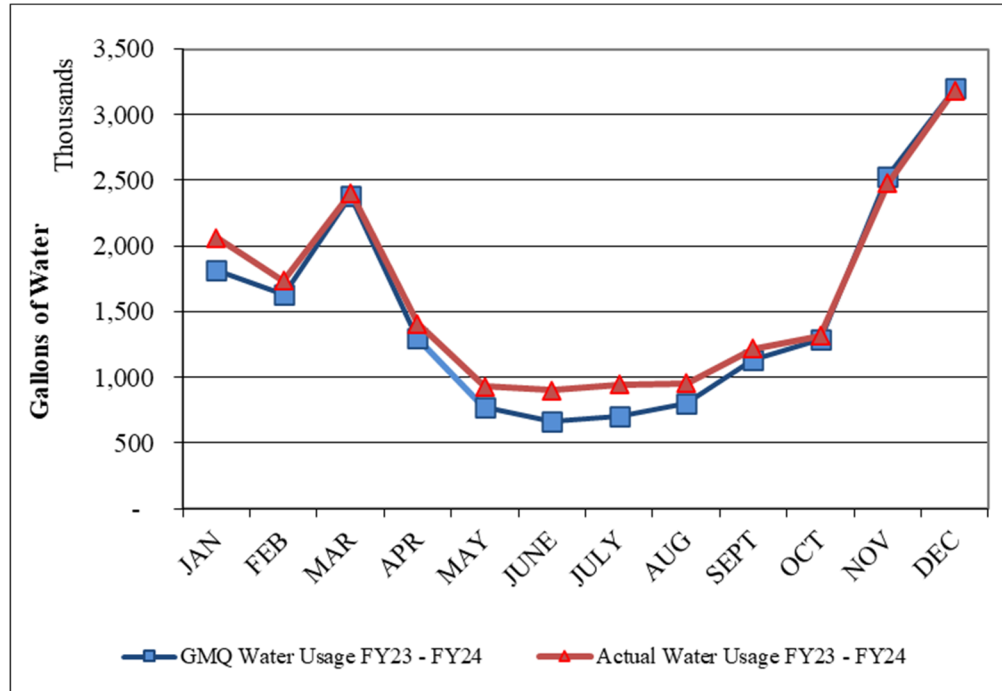
Figure 13. Steam Plant Water Performance Guarantee for the Previous Twelve Months

The steam water conversion factor exceeded the guaranteed values for only one month during the quarter. CES and TEG continue to monitor the performance of the EGF as CES makes efforts to improve the DES performance. The guaranteed steam-water performance value is based on an equation which incorporates the amount of steam sendout and condensate return and did not change with the adoption of the new performance values in Amendment 2. CES has verified the accuracy of the meter readings and continues to review the operation. The steam water conversion factors are shown in Figure 13.

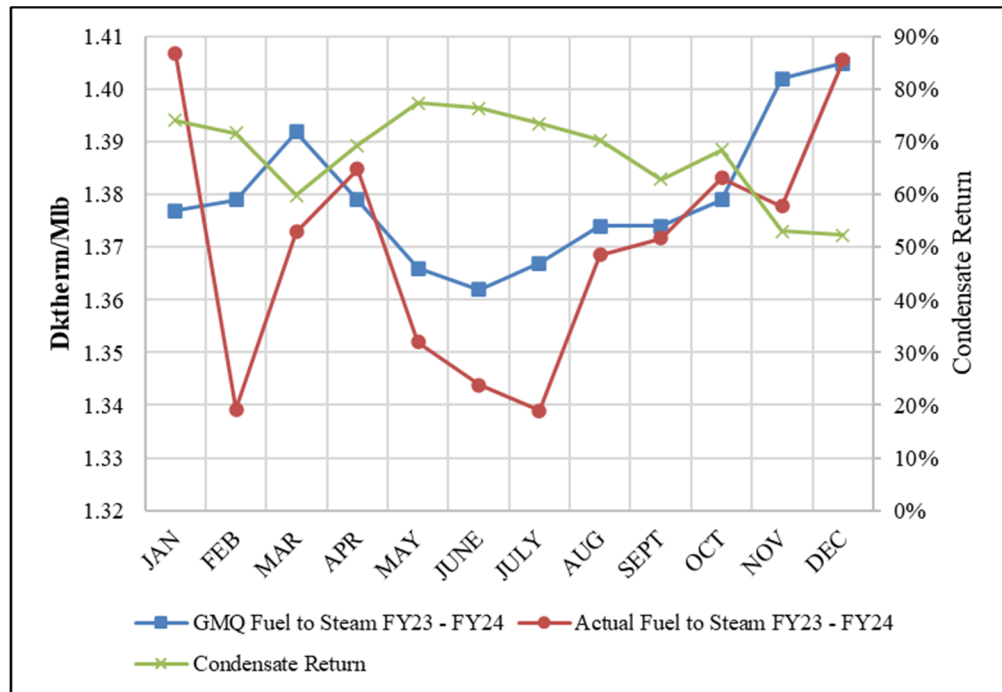
Figure 14. Steam Plant Fuel Performance Guarantee for the Previous Twelve Months

The steam fuel conversion factor met the guaranteed values for each month in the quarter. The fuel consumption per unit of steam sendout increased 0.2% over the previous Second Quarter. The relative amount of condensate return is shown on this graph to reflect the influence that the condensate return has on the plant efficiency. Although the performance level for this metric changed with the adoption of Amendment 2, the equation used to calculate the value relies heavily on readings from the condensate return and steam sendout meters. Figure 14 shows the performance of the conversion factors for the previous twelve months.

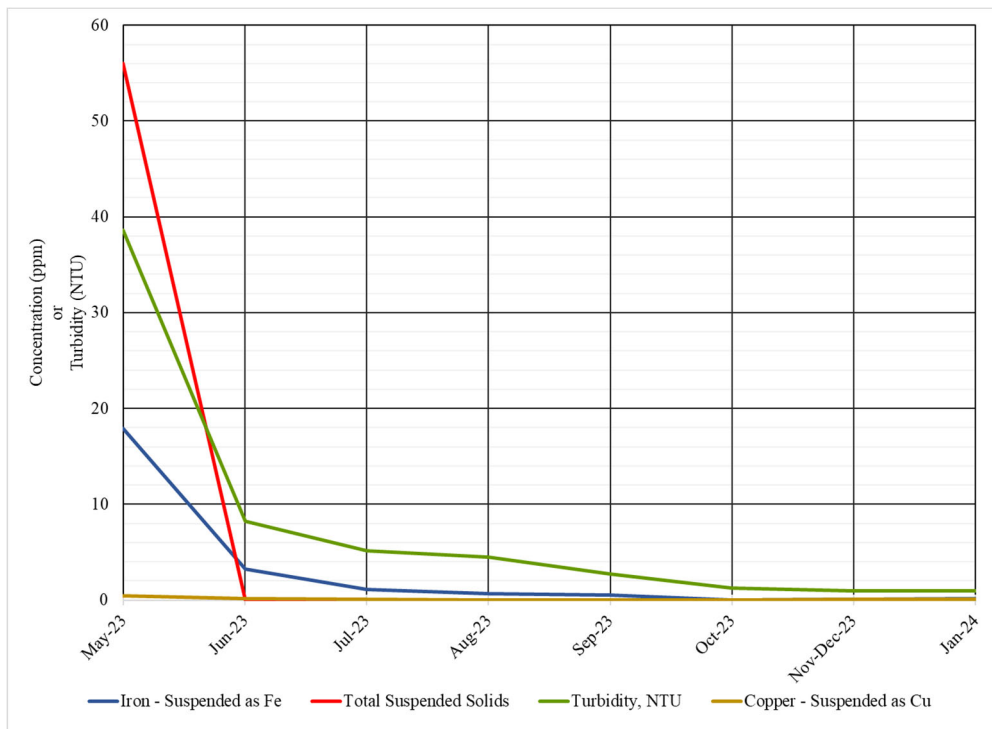
Figure 15. Chilled Water Composition Downstream of Side Stream Filter

- Chilled Water System
 - CES continues to monitor and test for the presence of bacteria in the system. The biological growth in the system, as measured at the EGF and at the customer buildings, has become essentially non-existent. Chem-Aqua’s proprietary biological treatment system continues to function properly.
 - The side stream filter was installed in FY23 and became operational on May 9, 2023. The filter has significantly reduced the amount of suspended solids in the chilled water and improved the turbidity of the system. Figure 15 shows the results of several measured metrics within the chilled water system.
