**METROPOLITAN GOVERNMENT OF NASHVILLE AND DAVIDSON COUNTY**

**STAFF RECOMMENDATION**  
**301 Broadway and 105 3<sup>rd</sup> Avenue South**  
**December 19, 2012**

**Application:** New construction-rooftop addition, Signage, Alterations  
**District:** Broadway Historic Preservation Zoning Overlay  
**Council District:** 19  
**Map and Parcel Number:** 09306402700, 09306402800  
**Applicant:** John Barnett, B3 Studio  
**Project Lead:** Robin Zeigler, robin.zeigler@nashville.gov

**Description of Project:** The applicant proposes alterations and a rooftop addition to two buildings at the corner of Broadway and Third Avenue South. For 105 3<sup>rd</sup> Avenue North the plan is to install windows where windows have been removed and more appropriate doors. The rooftop addition and signage will be on 301 Broadway.

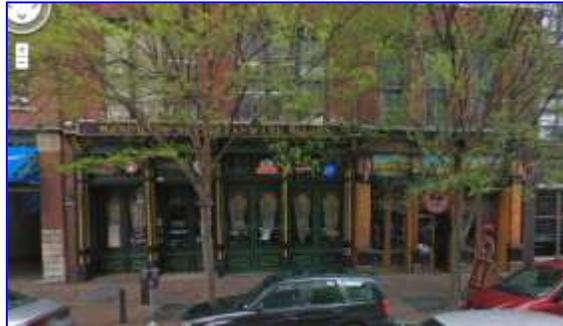
Example of double-window above a bulkhead type of design on Second Avenue.

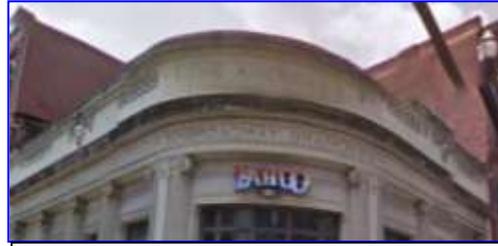
Historic signage includes the address. The neon “tattoo” sign will be removed.

This building is very detailed and the signage is located in a smooth portion that divides a pilaster, which is one of the few locations where it will not cover details. One of the connection points is at a decorative floret. Staff finds the location to be appropriate if the connection point is moved below the floret.

The existing historic signage will be retained. Only one sign is proposed which meets the sign number limit for this building.

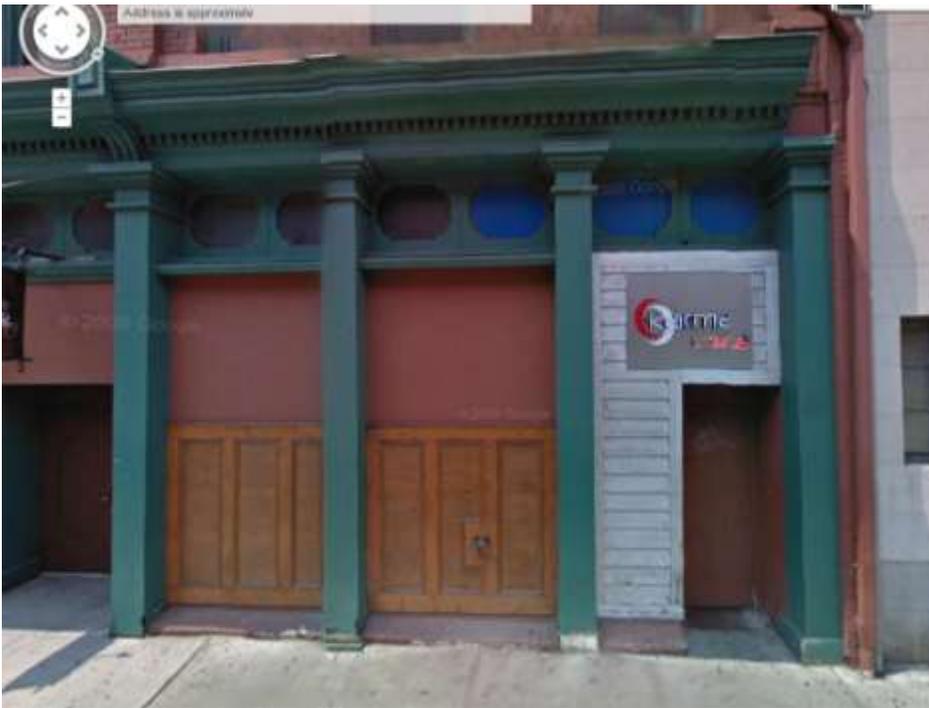
Existing conditions on the right side of 105 3<sup>rd</sup> Avenue South.

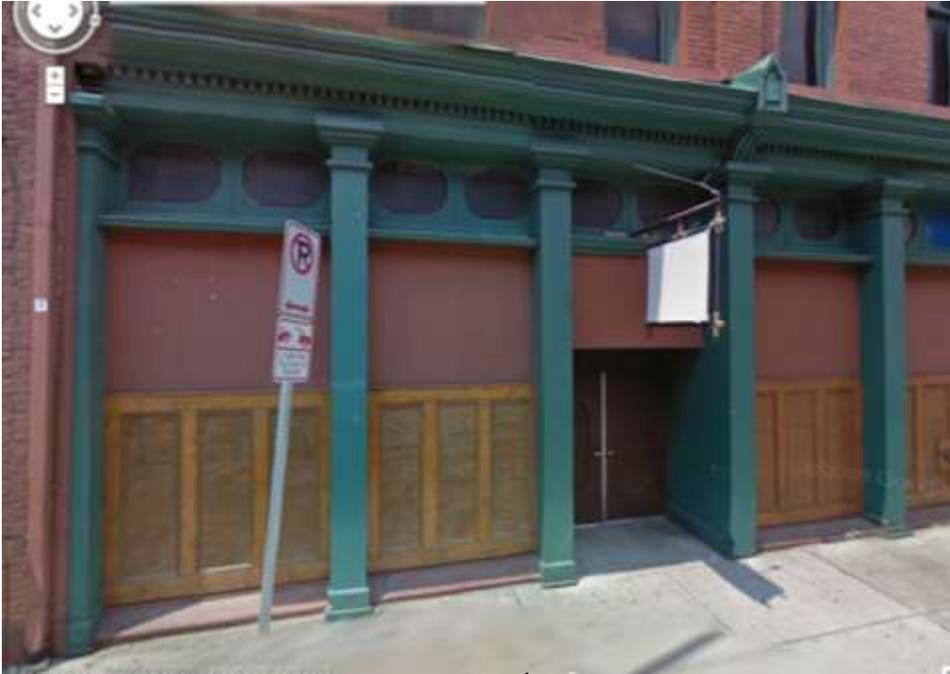
Existing conditions on left side of 105 3<sup>rd</sup> Avenue South

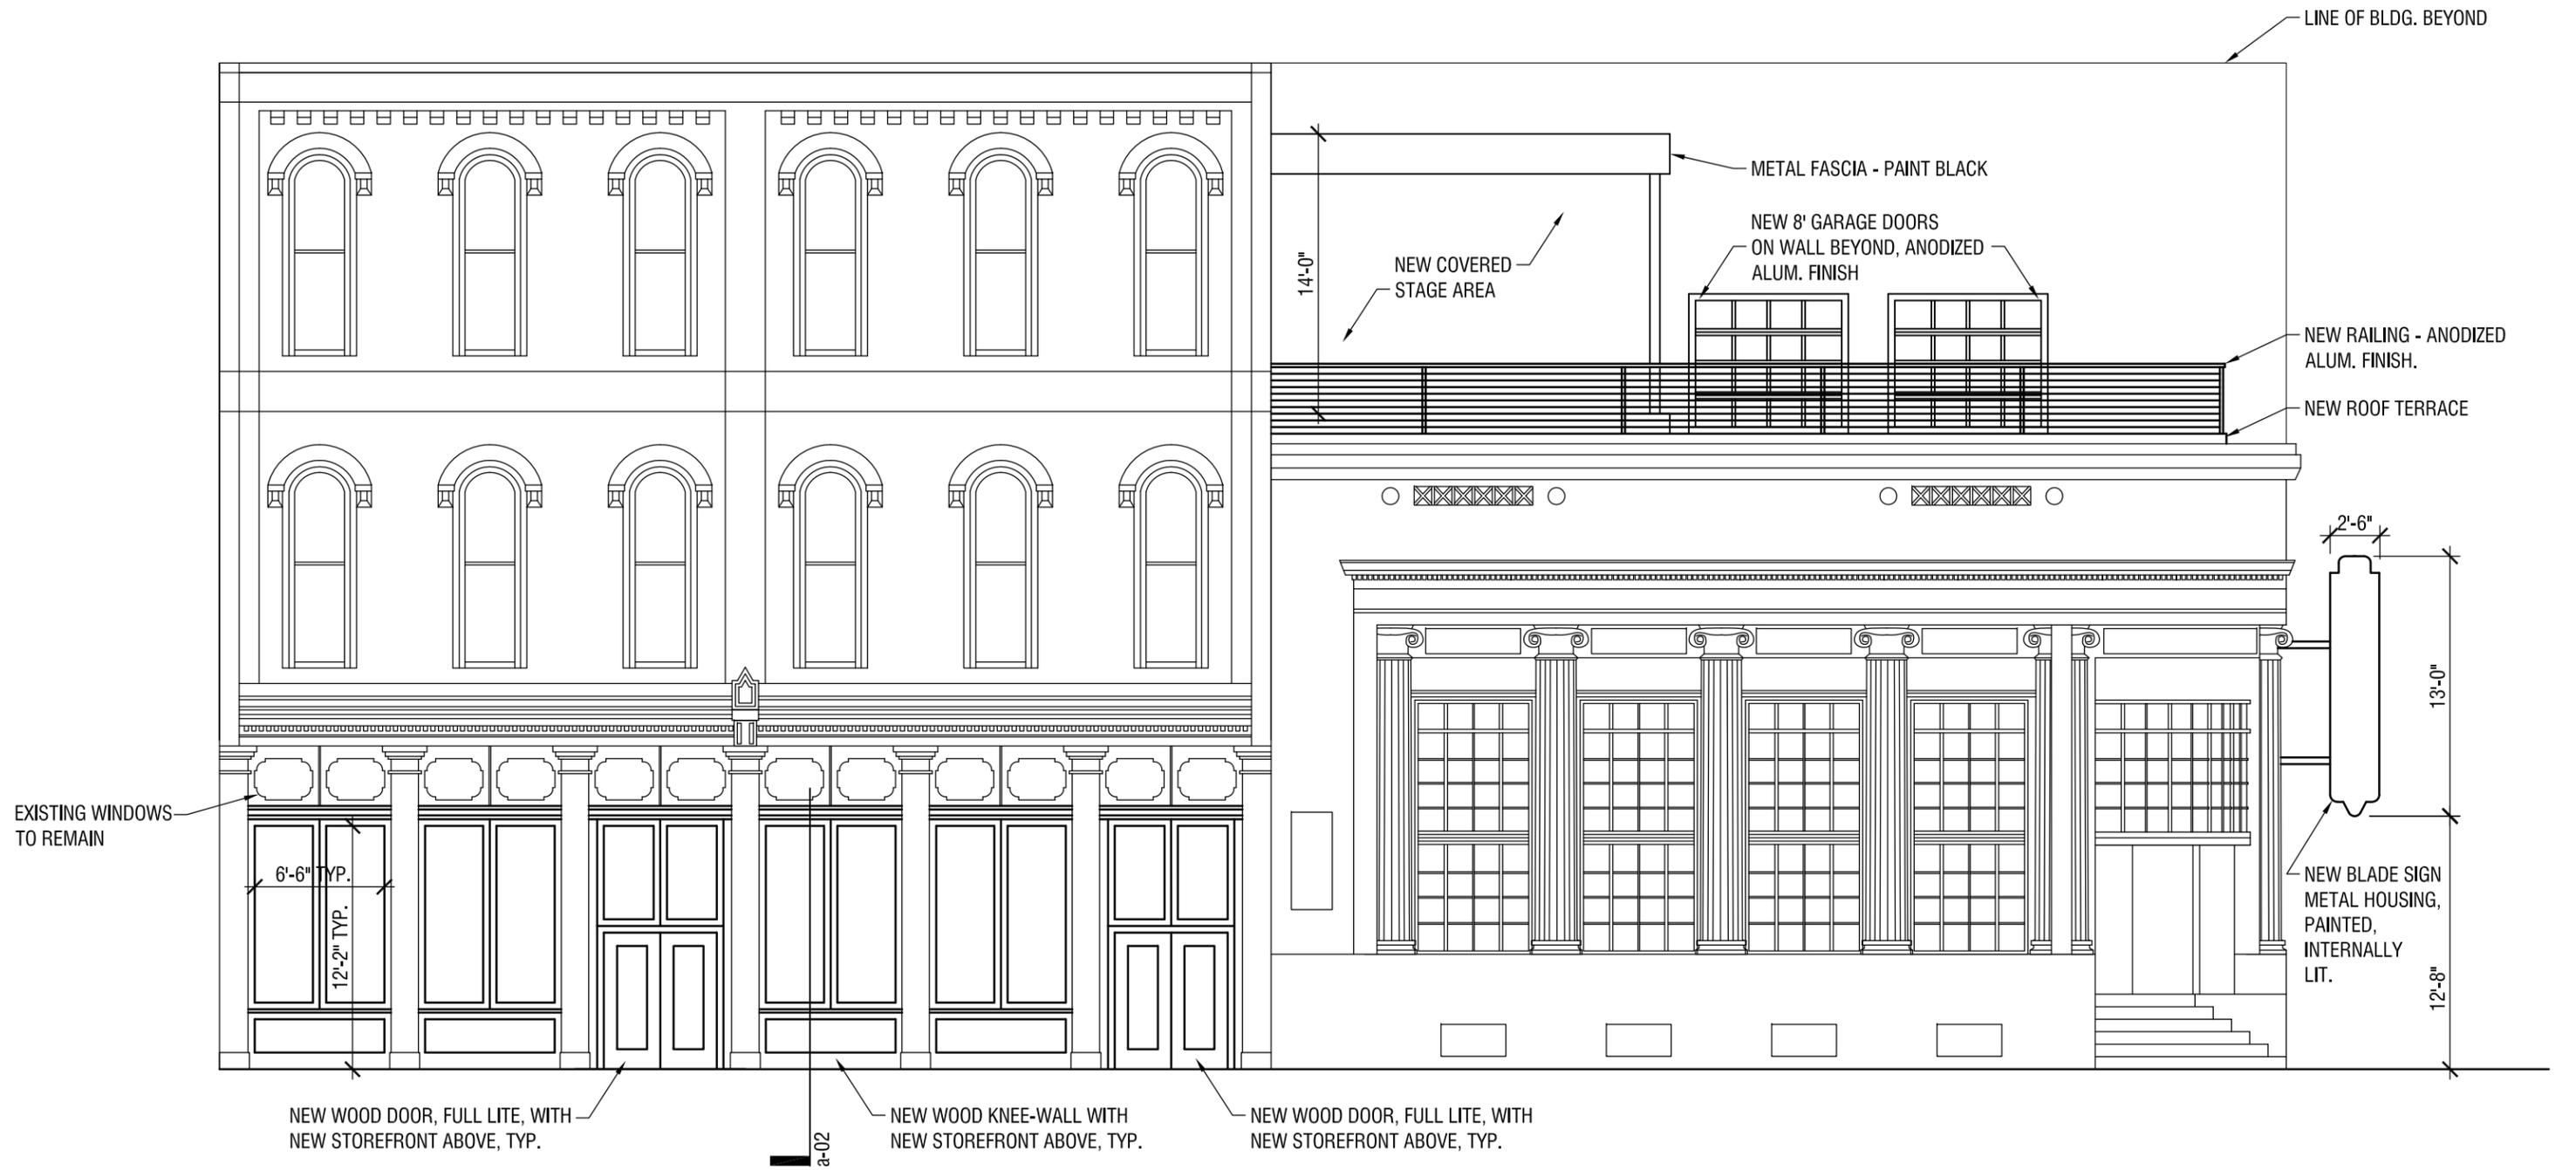
east elevation (along 3rd ave.)

scale: 1/8" = 1'-0"

The primary entrances will be double full-light and wood glass doors, which keeps the proportion of glass to door comparable to the proportion of display windows.

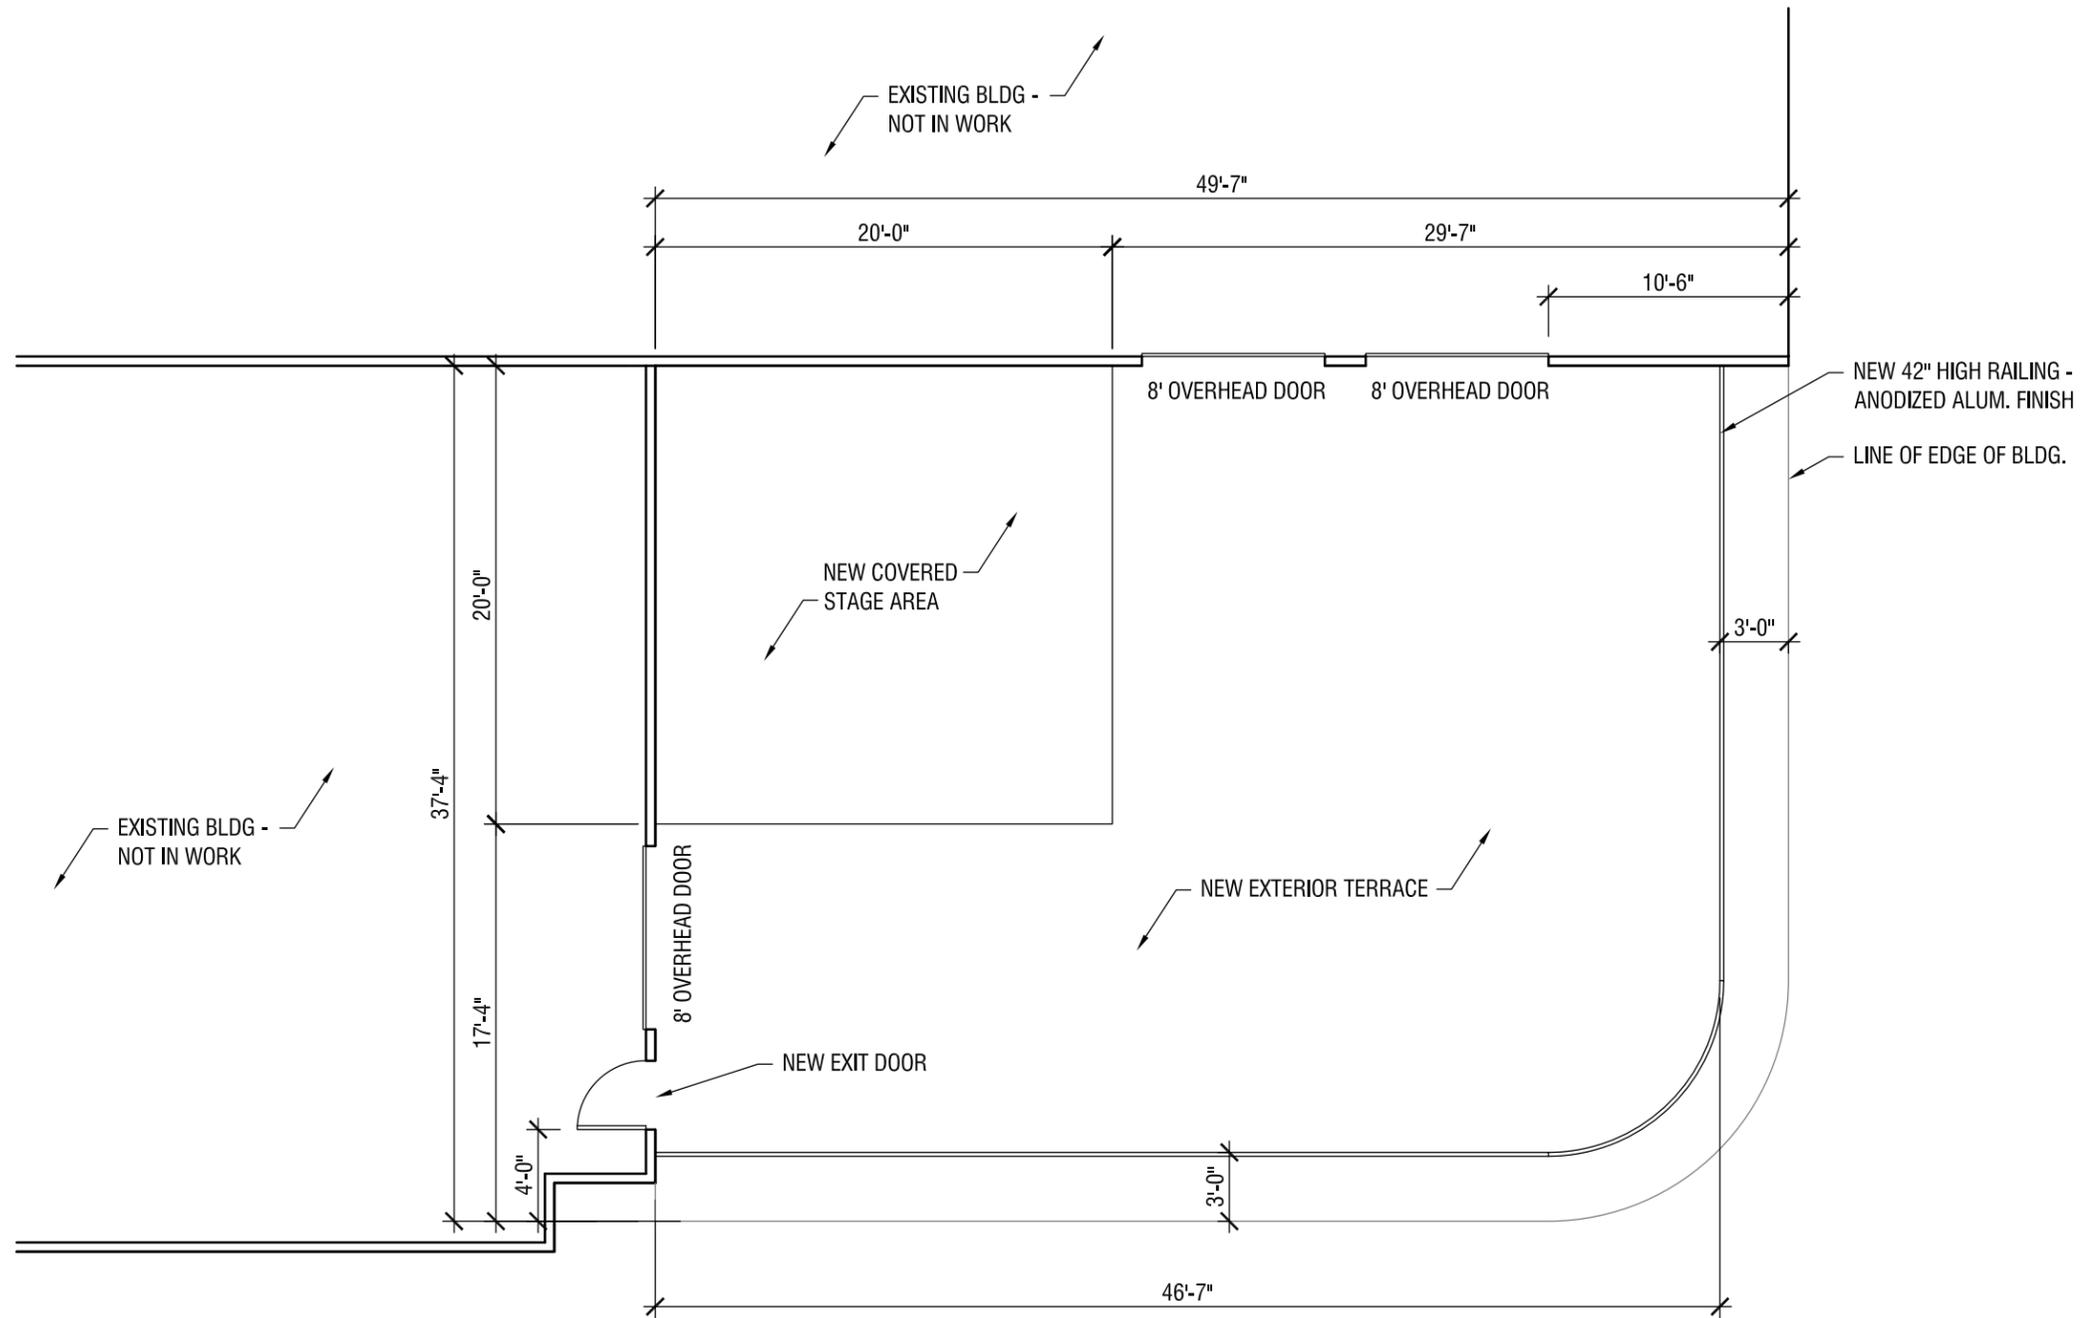
roof plan

scale: 1/8" = 1'-0"

The guidelines require that rooftop additions be set back from side elevations by twenty feet (20') and the proposed structure is setback seventeen feet and four inches (17' 4"). The addition should sit back from the front elevation by thirty feet (30') and the proposed structure is twenty-nine feet and seven inches (29' 7"). Because the structure portion of the addition does not have walls and therefore should have a minimal visual impact, staff finds the setbacks for the covered stage area to be appropriate. Staff recommends that the structure not have permanent or temporary sides added without a permit, as has been required of other similar projects and not have anything attached to the exterior of the structure.

The railing is proposed to sit off the front wall of the existing building three feet (3'). Although the railing is part of the addition and should sit back the required amount, the Commission has made allowances for railings in the past since they can be minimally visible. On two recent cases, the Commission has required for one of them the railing sit back eight feet (8') and the other nine feet (9') because the building had a low parapet wall. Staff recommends that the railing be setback at least eight feet (8') and that it never has anything attached to it such as lighting or signage, as has been required of other similar projects.
