STAFF RECOMMENDATION
104 Fifth Avenue South
July 18, 2012

Application: New construction of rooftop additions
District: Broadway Historic Preservation Zoning Overlay
Council District: 06
Map and Parcel Number: 09306311200
Applicant: Mark Bixler, Manuel Zeitlin Architects
Project Lead: Robin Zeigler, robin.zeigler@nashville.gov

Description of Project: The applicant proposes a collection of rooftop additions to replace work that was completed without Preservation or Building Permits by the previous owner. The project includes replacing windows, doors and the storefront of the commercial building.

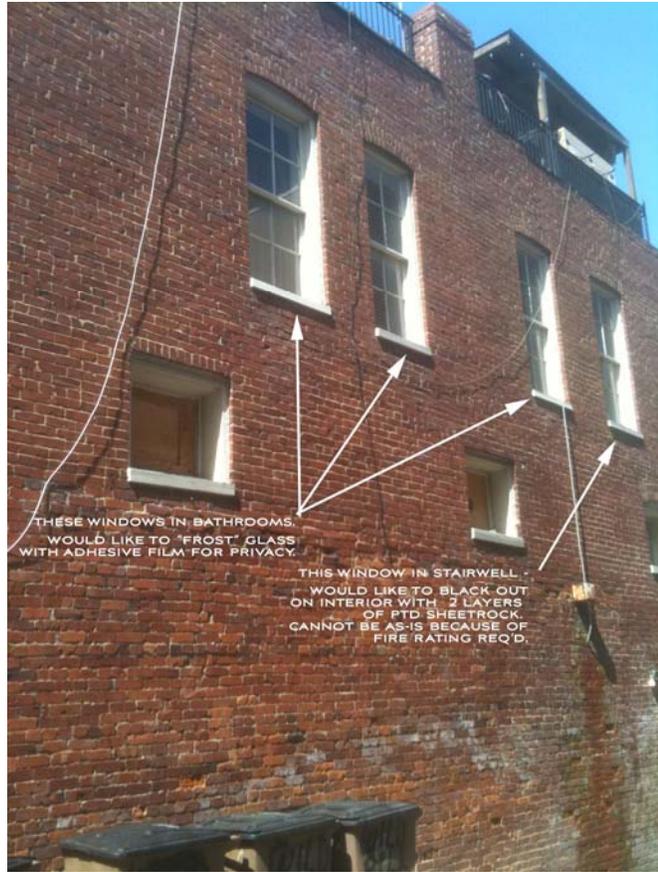
Windows & Doors: Applicant proposes to replace all existing windows with new Jeld-wen wood windows that match the existing dimensions and design. Some secondary windows will be blacked out and others frosted. (See image to right.) In addition, a bricked-in window opening will be restored. The windows are not original and the window openings to be changed are secondary so these alterations meet Section II.H.3 and 4.

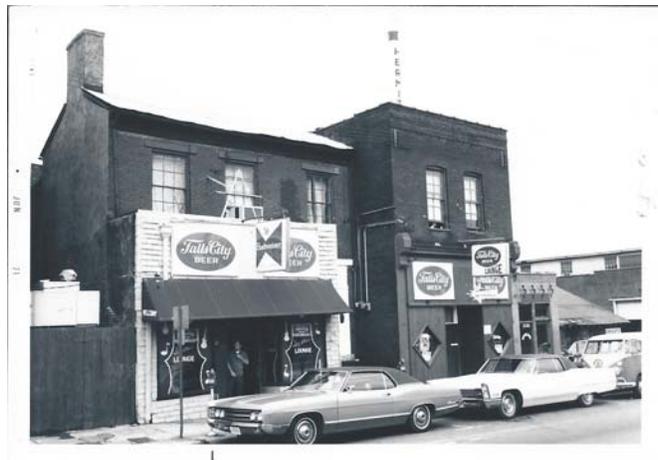
The exact configuration and design of the original storefront is unknown as the earliest photograph found, at this time, is from 1971 and shows the windows enclosed. The applicant proposes a simple storefront design that is typical of this style and age of commercial building, as required of Section C.3.1 of the Broadway design guidelines.

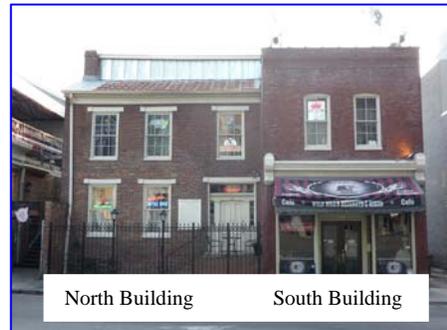
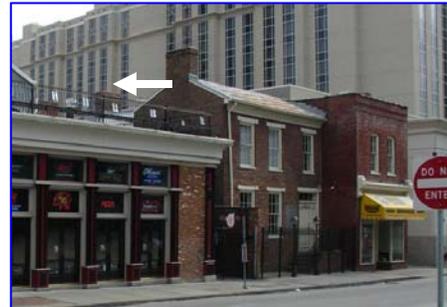
Recommend additions only be located in the area between the ridgeline and the rear of the buildings.

Height & Setbacks: 104 Fifth Avenue includes two attached historic buildings. The north building, which was originally a residential structure, sits back five feet and eight and a half inches (5'-8.5") from the south commercial building. To meet the required thirty feet (30') setback, any rooftop additions would need to be located in approximately the rear five (5') of the north building and the rear ten feet (10') of the south building. The roof shape, height and depth of the north building is somewhat unique for the district. The north building has the least amount of depth for the lot than any other building on the block. It is the shortest building on the block and among the shortest in the district and has a low-sloped gable roof. Only a handful of buildings in the district have gabled roofs. Because of these unique conditions, staff recognizes that a lesser setback is necessary to allow for rooftop use.

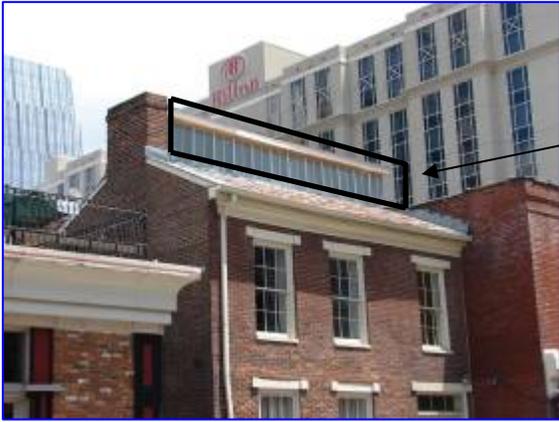
This portion was added without permits and will be removed.

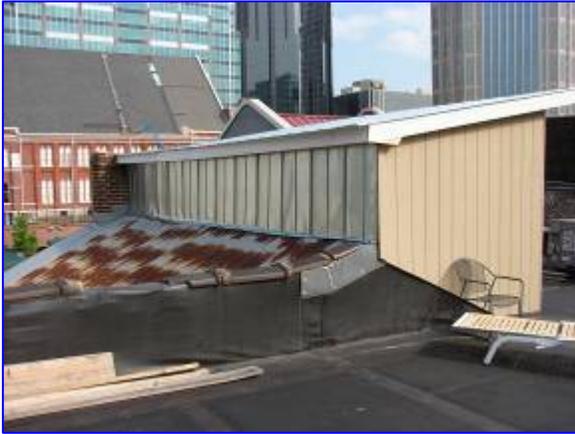
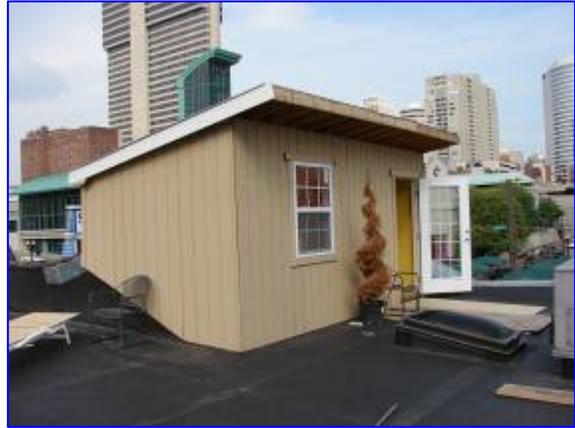
This stairwell (above), railing (below left) and bar (below right), constructed without permits by the prior owner, will be removed.
