METROPOLITAN GOVERNMENT OF NASHVILLE AND DAVIDSON COUNTY

STAFF RECOMMENDATION
409 Broadway
March 16, 2016

Application: Alterations

The applicant proposes alterations to the storefront façade of 409 Broadway, historically the Lawrence Record Shop.

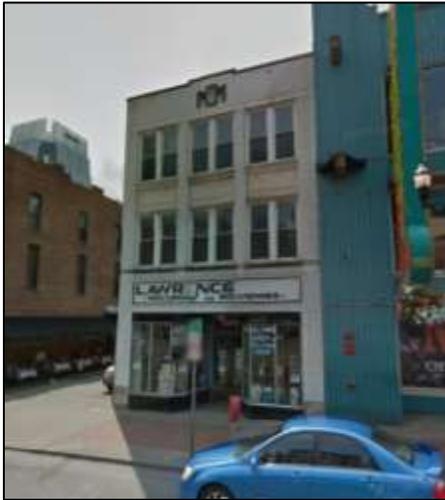
Figure 1. 409 Broadway

Background: 409 Broadway is a three-story commercial building. The National Register nomination dates the building to 1910. According to the city directories, it was a grocery for its first few years and was then Phillips & Quarles Hardware Store at least from 1931 to 1951. The Lawrence Brothers Shoe and Western Wear Store started in 1954 and the family switched to the Lawrence Brothers Record Shop in 1964. The name changed to Lawrence Record Shop in 1994 when Jack Lawrence, Sr died and the business was run by his widow Ida Lawrence and one of her sons.

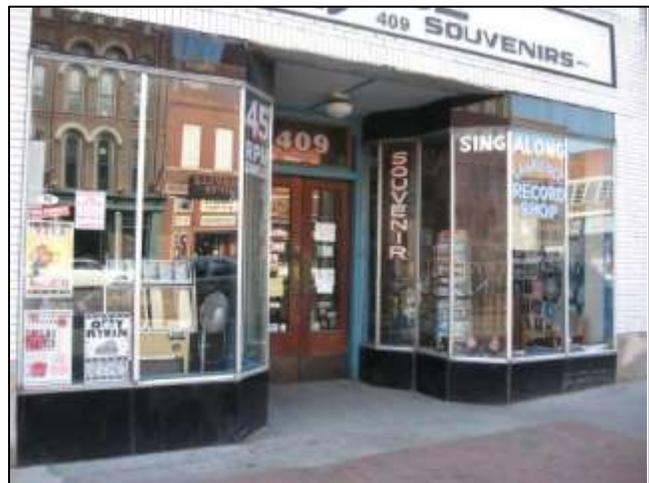
Figure 2. Historic storefront

Storefront, Display Windows, Bulkheads: The current storefront includes structural glass and storefront windows. In the 1930s, structural glass such as Carrerra and Vitrolite, became popular as a way to update earlier storefronts and across the country is commonly considered a historic character defining feature. This particular glass may have been installed a little later. The family dramatically changed their business in 1964 from a Western Wear store to a record shop which may have been the time of the update. The earliest photograph the department has on file is from the 1970s and shows the black glass. Although it may not be as early as 1930, it is still considered a historic feature of the building.

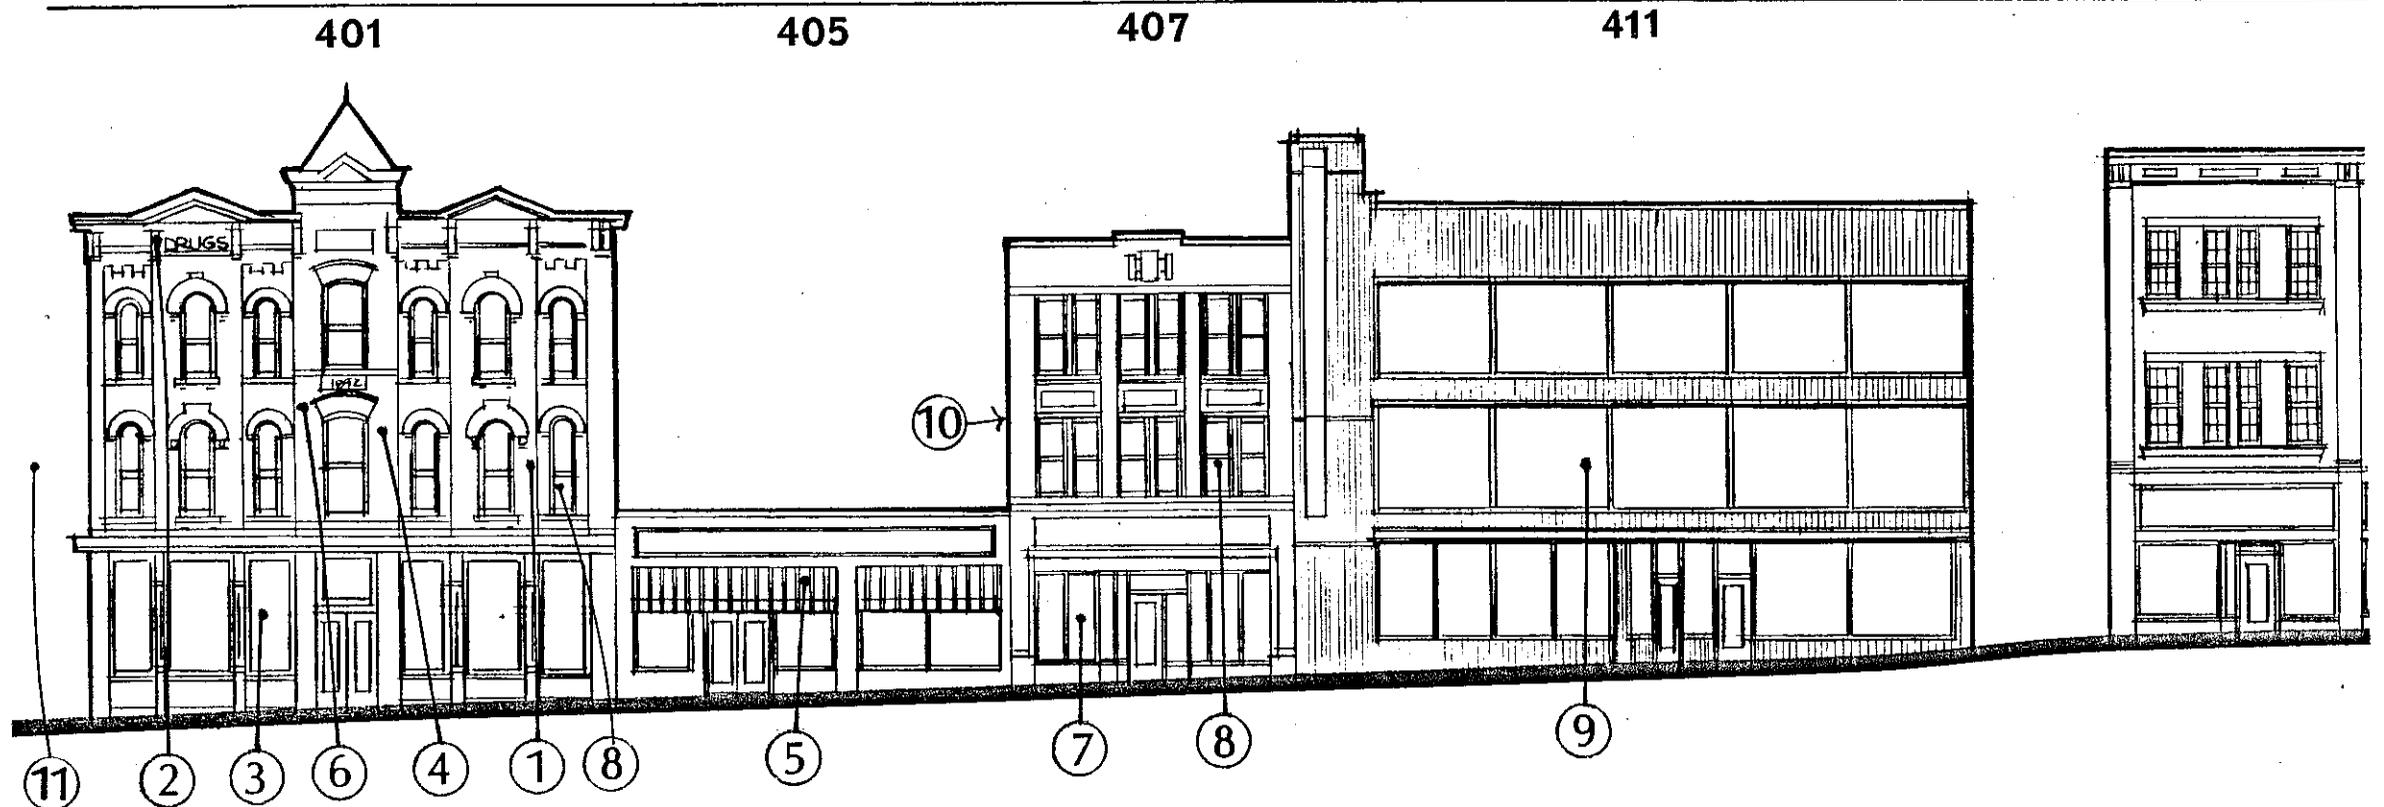
400 BLOCK, SOUTH SIDE

FACADE RECOMMENDATIONS

| ① Remove paint and repair brick as necessary. | ④ Repair structure and restore brick facade. | ⑥ Remove fire escape, if possible. | ⑨ Maintain in existing good condition with interesting window displays. |
| ② Restore original cornice. | ⑤ Install canvas awning and new sign as shown. | ⑦ Repair existing storefront or install compatible contemporary storefront. | ⑩ Maintain or restore painted sign at side of building. |
| ③ Reconstruct original storefronts or remove inappropriate elements and rehabilitate existing storefronts. | | ⑧ Restore upper facade windows. | ⑪ Remove projecting sign and install more appropriate signage according to sign guidelines. |

A Market and Design Study for the Broadway National Register Historic District, commissioned in 1982, called the building an “architecturally significant structure” and made the following recommendations:

- Repair existing storefront or install compatible contemporary storefront;
- Restore upper façade windows;
- Maintain or restore painted sign at side of building.

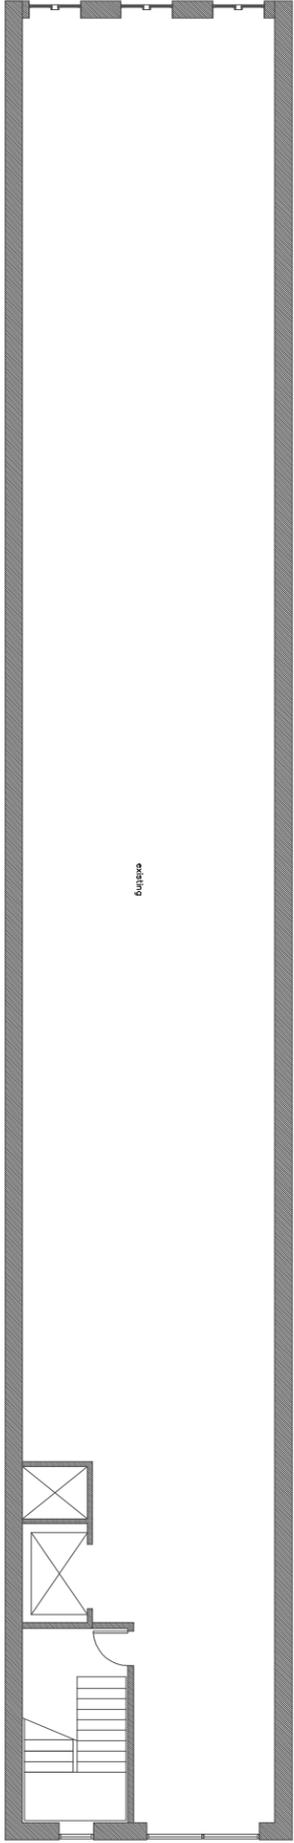
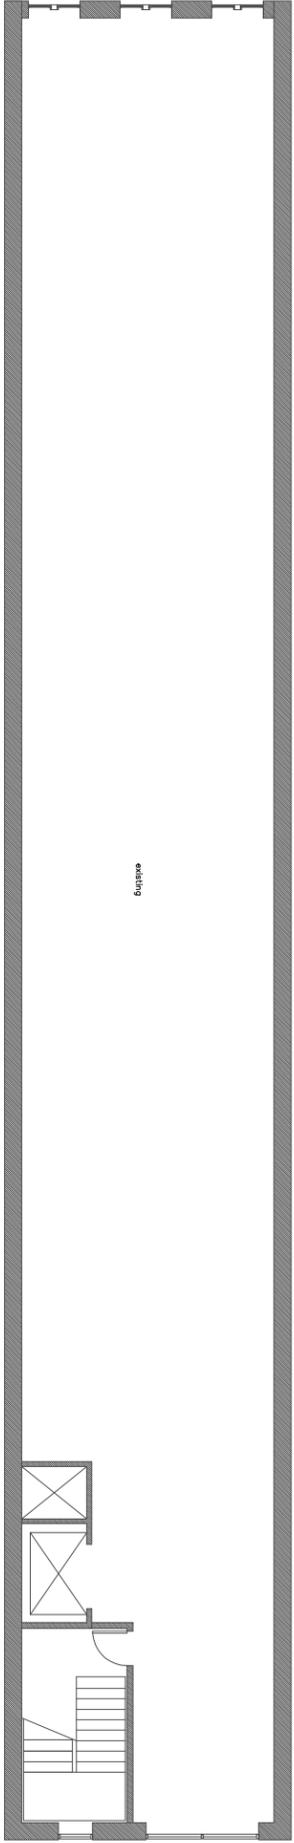
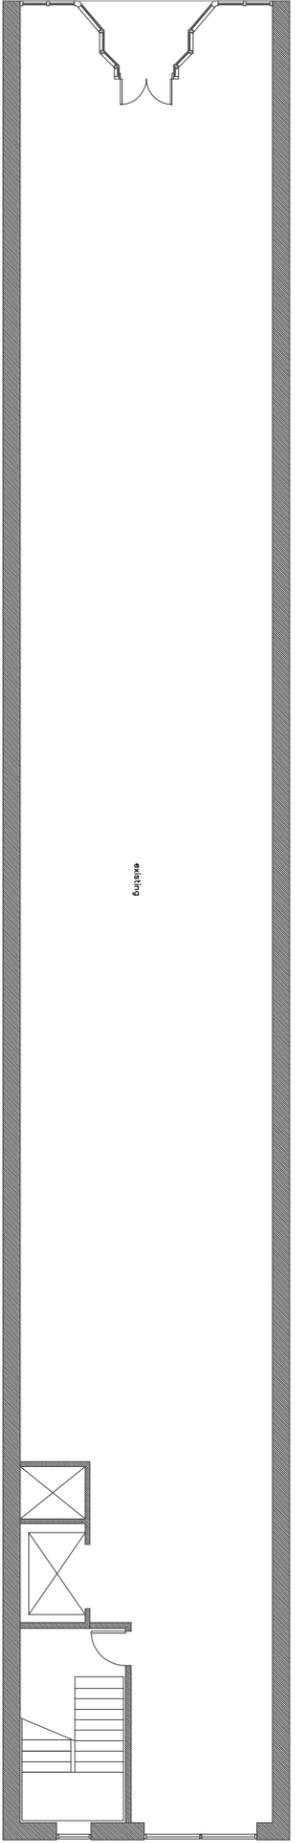
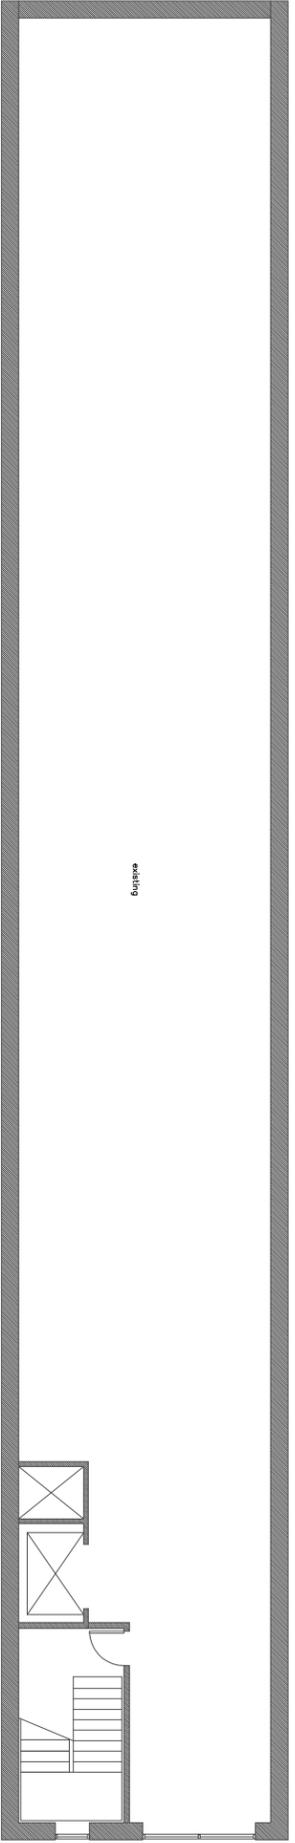
4 3rd floor
1/16" = 1'

3 2nd floor
1/16" = 1'

2 first floor
1/16" = 1'

1 basement
1/16" = 1'

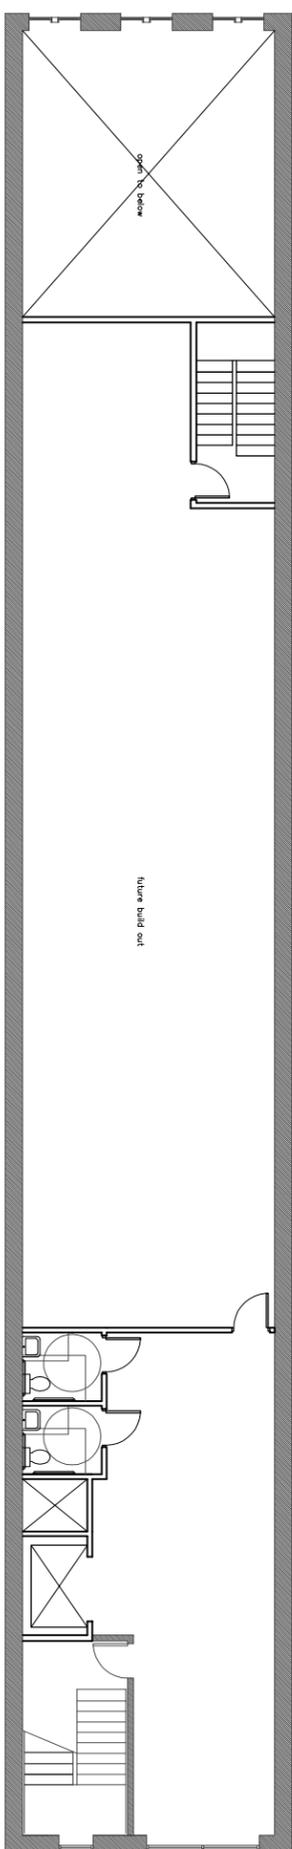
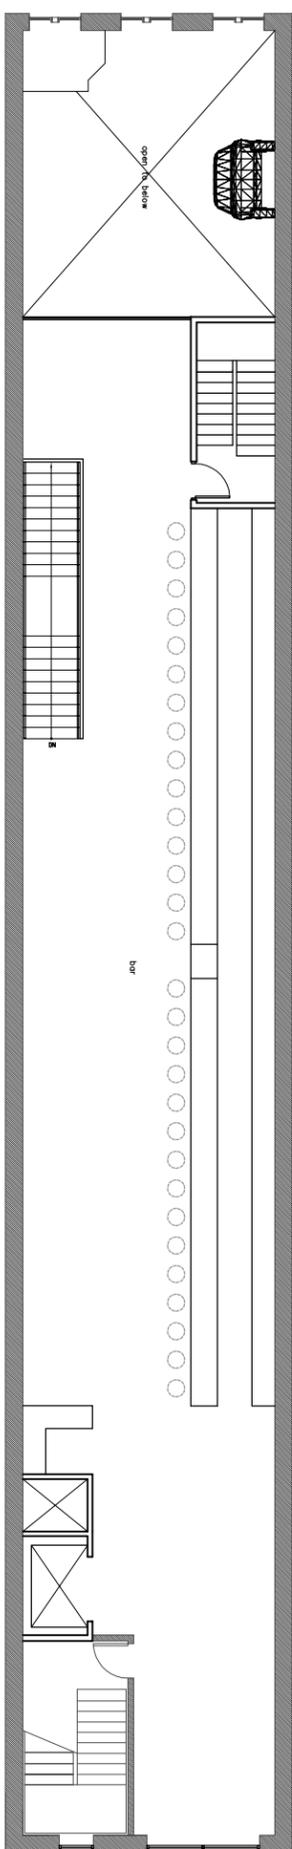
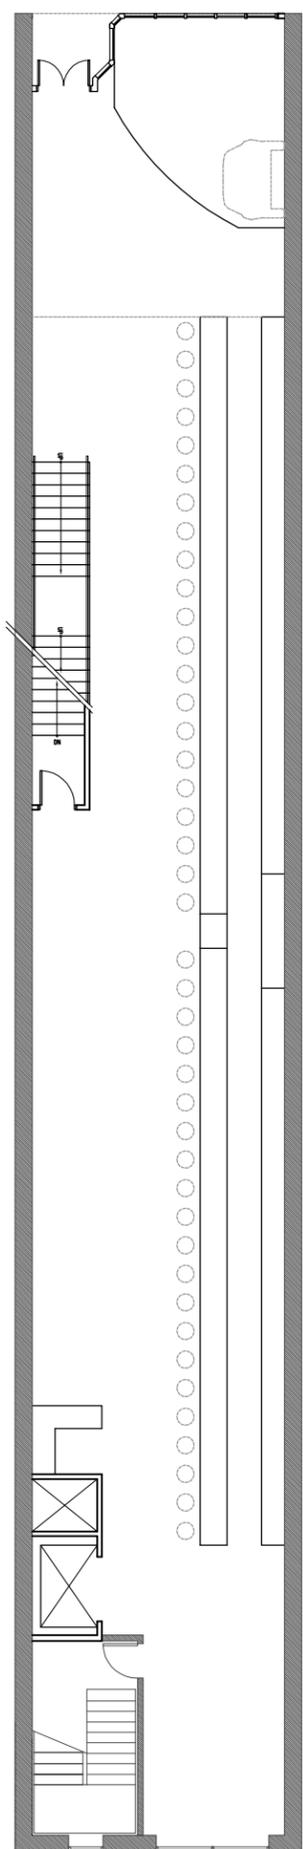
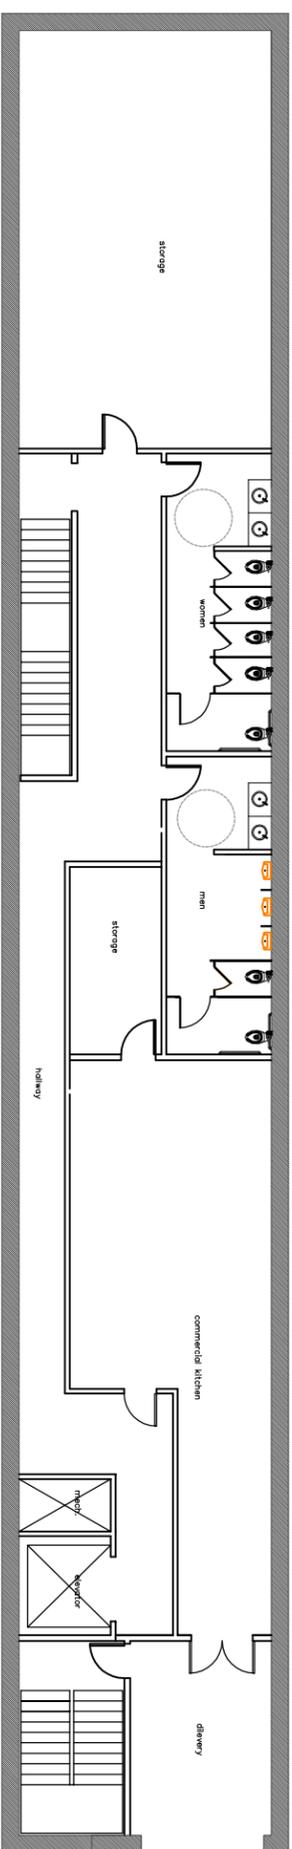
4 3rd floor
1/16" = 1'

3 2nd floor
1/16" = 1'

2 first floor
1/16" = 1'

1 basement
1/16" = 1'

The applicant proposes to alter the storefront at 409 Broadway by relocating the central entrance to one side and reconstructing the storefront in order to construct a two-story atrium in the interior.

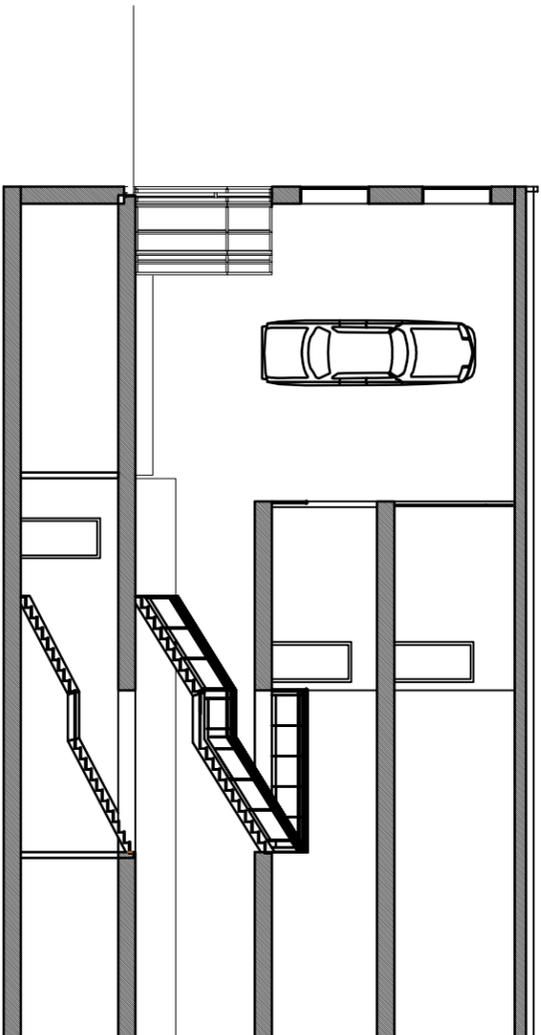
1 CONCEPTUAL SECTION OF ATRIUM
1/8" = 1'

The applicants are requesting the reconstruction of the storefront because of the desire to construct an atrium inside. Under section II. *Rehabilitation, general principles*, the design guidelines state that “interior changes that affect the exterior appearance of upper facades including changing original floor levels should be avoided.” Although this section states it is for upper level windows, staff believes this is only because it was not contemplated that interior alterations, such as changing floor levels, would negatively affect the storefronts. This is in keeping with the Secretary of Interior Standards, on which the design guidelines are required to be based on according to state law. Secretary of Interior Standard #1 for Rehabilitation (design guidelines section I.B) states that “A property shall be used for its historic purpose or be placed in a new use that requires minimal changes to the defining characteristics of the building and its site and environment.” Staff finds that the interior changes are the only reason for the reconstruction of the historic storefront and therefore the proposal does not meet section II.A. and E of the design guidelines.

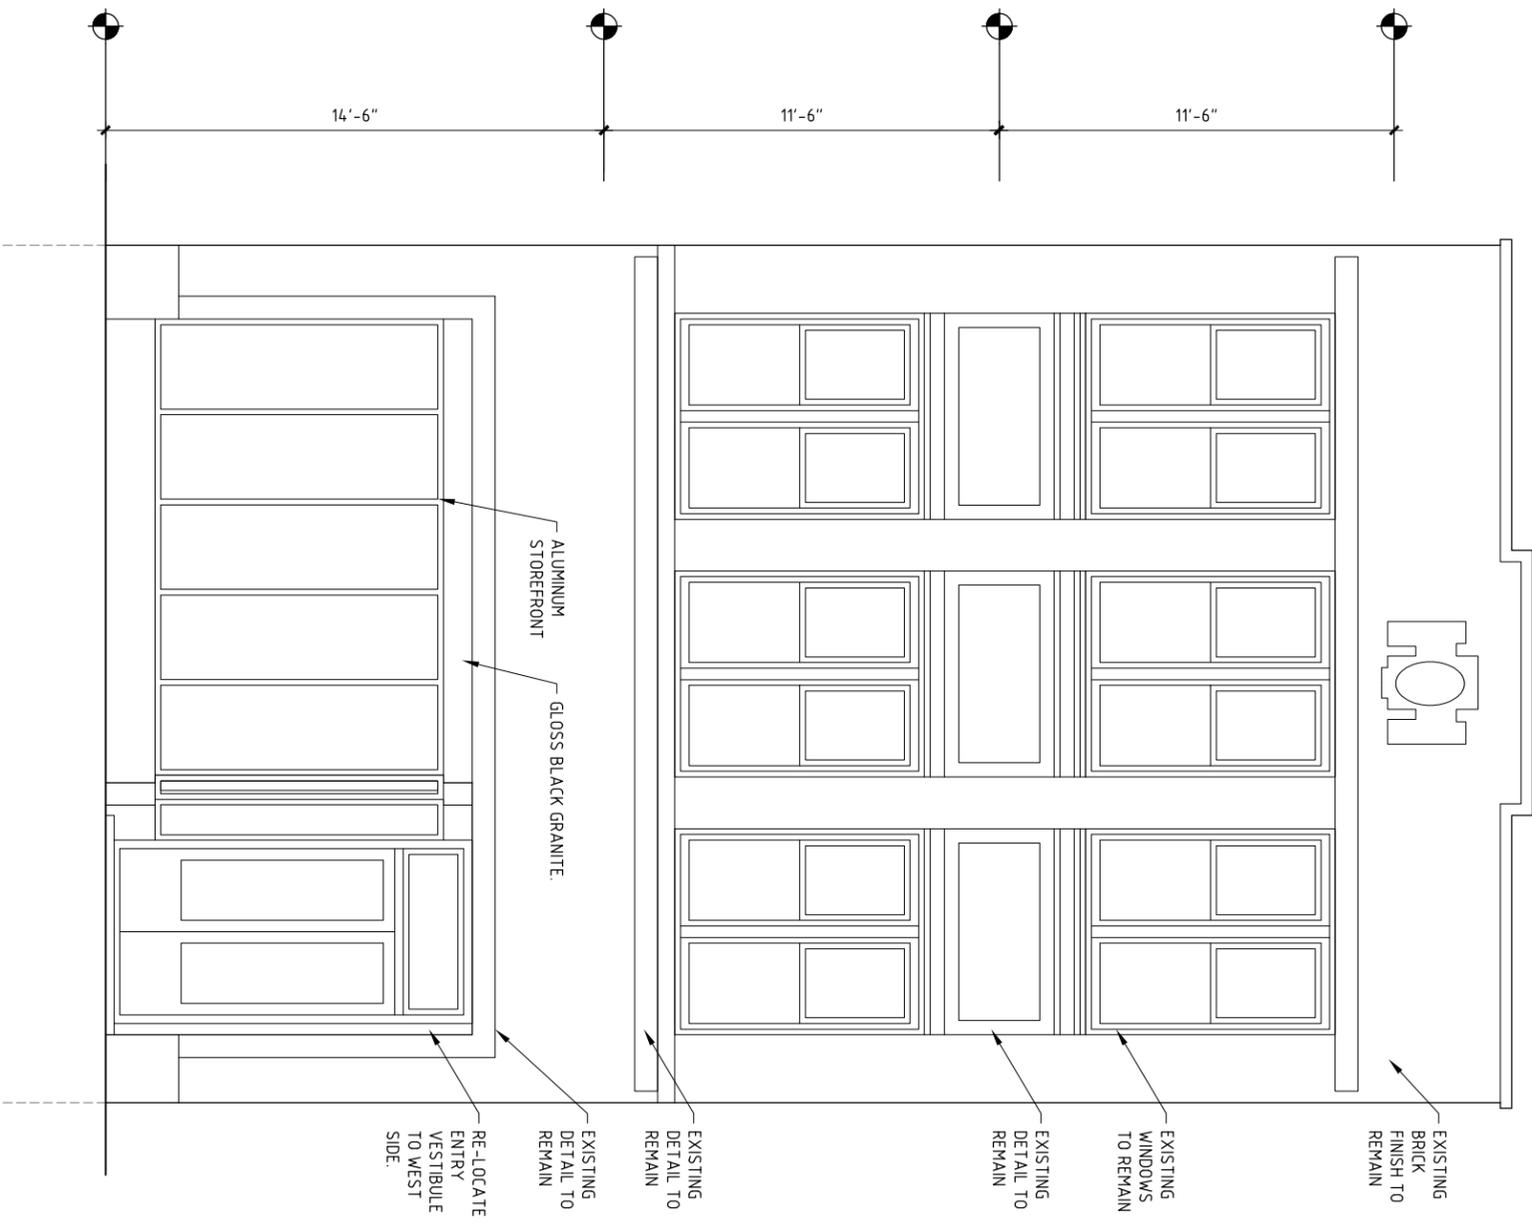
1 BROADWAY ELEVATION
3/16" = 1'

Doors and Entryways: The applicant proposes relocating the entryway to the right side of the storefront. The existing configuration is a historic element of this building. The design guidelines require to the configuration of historic doors and entrances be retained. In addition, the need for the relocation is due to interior alterations as described previously, which does not meet the Secretary of Interior’s Standards. Staff finds that the project does not meet section II.A and B
