STAFF RECOMMENDATION
208-210 Broadway
October 19, 2016

Application: New construction-addition, Alterations
District: Broadway Historic Preservation Zoning Overlay
Council District: 19
Map and Parcel Number: 09306211100
Applicant: Kristy Angyal/ Kip A. Moore & Associates
Project Lead: Robin Zeigler, robin.zeigler@nashville.gov

<p>Description of Project: The project is for rehabilitation of two contributing buildings and a rooftop addition on one of the buildings.</p>	<p>Attachments A: Photographs B: Site Plan C: Elevations</p>
<p>Recommendation Summary: Staff recommends disapproval finding that the project does not meet section II.of the design guidelines for alterations to historic buildings.</p>

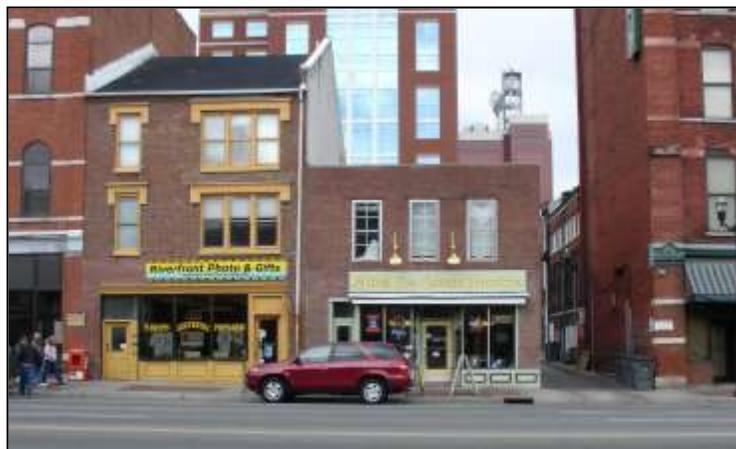
Figure 1: 210 and 208 Broadway

Register Nomination for the Broadway Historic District, is a mid-nineteenth century residence that originally had a third story with pitched roof. The third story was removed

and the roof form changed to a flat roof in the 1950s. The nomination also notes that the first story was altered. The current storefront, signage and light fixtures were constructed in 2003. Staff recently approved relocation of the signage, which is later signage than that mentioned as inappropriate in *A Market Study*.

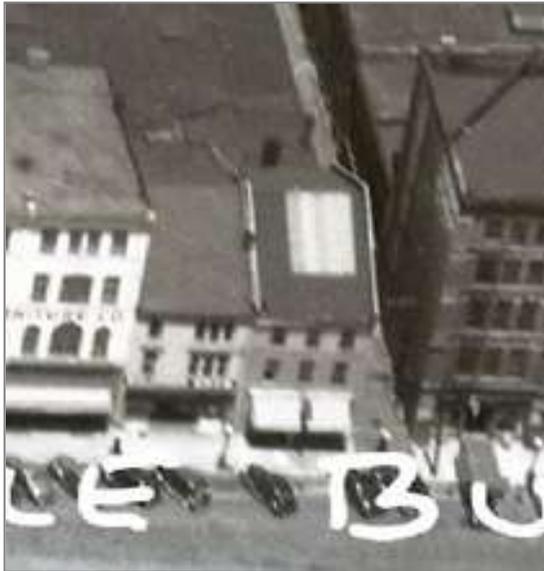
Figure 2: This image shows 210 Broadway in the middle and 208 Broadway to the right with its original 3rd story.

210 Broadway is a mid-nineteenth century residence with metal window hoods. The nomination notes that this building's first story has also been altered. It is only 1 of 2 intact pre-Civil War residences.

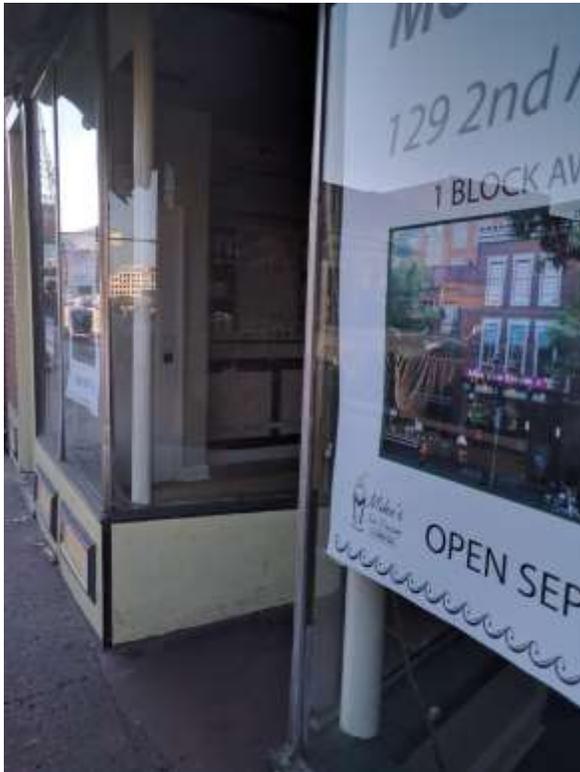
Figure 3: Existing storefront. Support posts are interior.

The proposed storefront façade for 208 Broadway is stepped back to be behind two support posts that are currently interior elements, located to each side of the central entrance. The proposal also includes NANA walls and a non-operable door. Although storefronts historically do sit back a few inches from the brick façade, the proposed does not meet the design guidelines as the structural supports are exposed. The NANA wall should be seamless in a two-window storefront type configuration to meet section II C. for storefronts. In addition, the entrance does not appear as a principle entrance, which does not meet section II.B of the design guidelines.

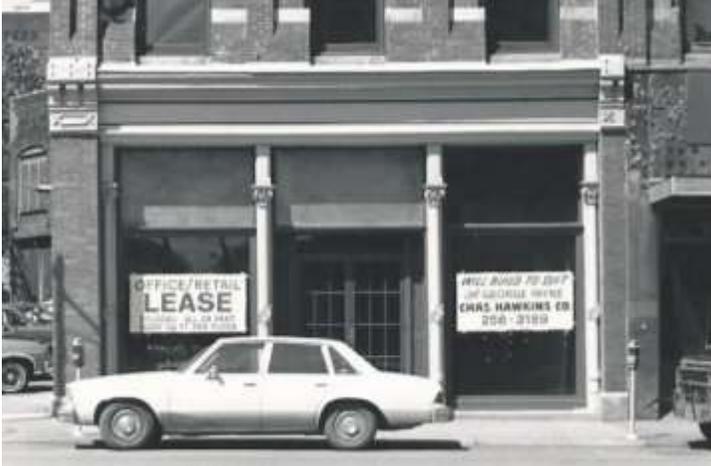
Figure 4: The posts at 308 Broadway is an example of how the support posts at 207 Broadway could be incorporated into the design of the new storefront for 208 Broadway.

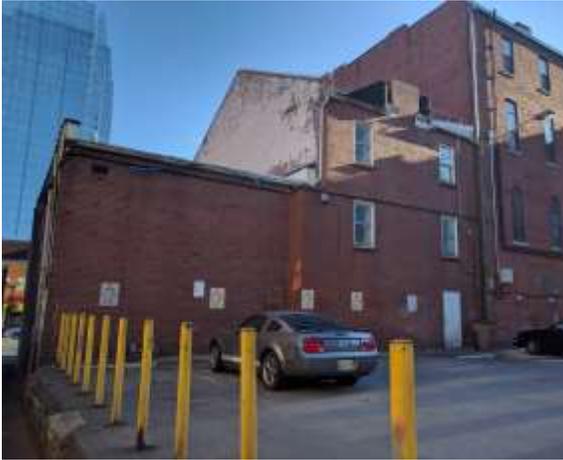
Figure 5: Rear façade of 208-210 Broadway.

Rear façade: A metal staircase will be added to the rear façade which meets section II.N.3 and II.Q
