Metropolitan Historic Zoning Commission  
Sunnyside in Sevier Park  
3000 Granny White Pike  
Nashville, Tennessee 37204  
Telephone: (615) 862-7970  
Fax: (615) 862-7974

**STAFF RECOMMENDATION**  
**208-210 Broadway**  
**November 16, 2016**

**Application:** New construction-addition, Alterations  
**District:** Broadway Historic Preservation Zoning Overlay  
**Council District:** 19  
**Map and Parcel Number:** 09306211100  
**Applicant:** Kristy Angyal/ Kip A. Moore & Associates  
**Project Lead:** Robin Zeigler, robin.zeigler@nashville.gov

<p><b>Description of Project:</b> The project is for rehabilitation of two contributing buildings and a rooftop addition on one of the buildings.</p> <p><b>Recommendation Summary:</b> Staff recommends approval with the conditions that:</p> <ol style="list-style-type: none"><li>1. Staff approve all materials, such as masonry, windows and doors, and the rooftop addition;</li><li>2. The setback area of the rooftop on 208 Broadway not have railings, lighting, poles, posts, signage, covering or any other alterations and the addition not be enclosed without approval of the MHZC; and,</li><li>3. The upper level windows of 208 Broadway be 4/4, 2/2

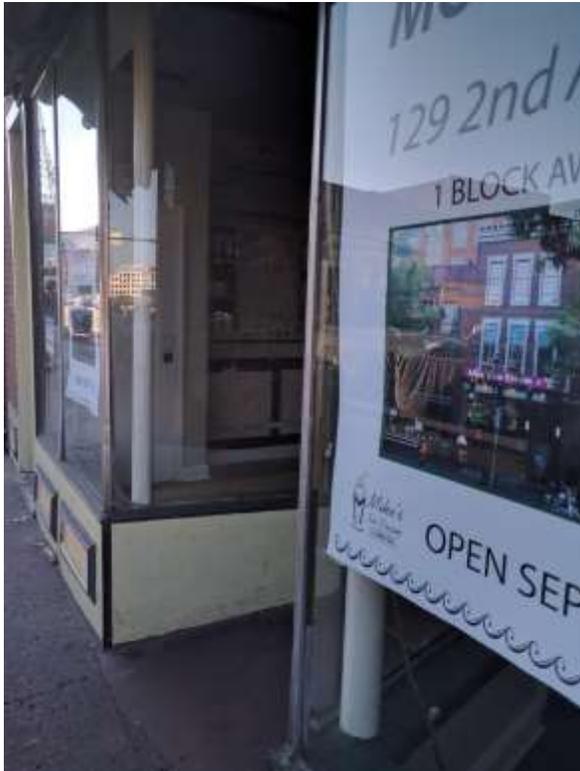
Figure 3: Existing storefront. Support posts are interior.

For 210 Broadway, the proposal includes NANA walls and a non-operable central door. Existing round structural supports, currently located within the building, will now be located outside the building and faced with wood to look like traditional columns. This slight recessed of the front storefront is seen historically in the district and more appropriate than the current storefront. The project meets sections II.A, B, C, E and F.

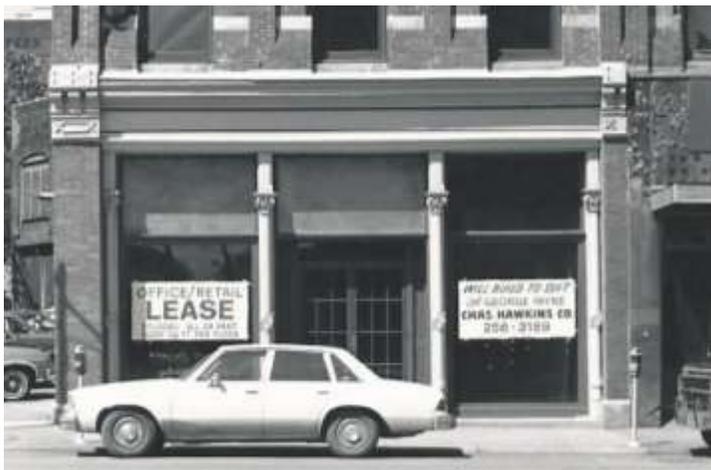
Figure 4: The posts at 308 Broadway is an example of how the support posts at 207 Broadway will be incorporated into the design of the new storefront for 208 Broadway.

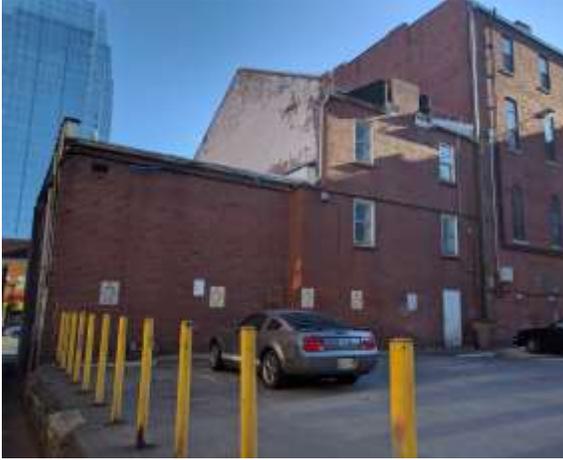
Figure 5: Rear façade of 208-210 Broadway.

Rear façade: A metal staircase will be added to the rear façade which meets section II.N.3 and II.Q
