**STAFF RECOMMENDATION**

**1514 Clayton Avenue**

**Application:** New construction- infill; Demolition

**Description of Project:** Application is to demolish a non-contributing house and to construct two-story infill.

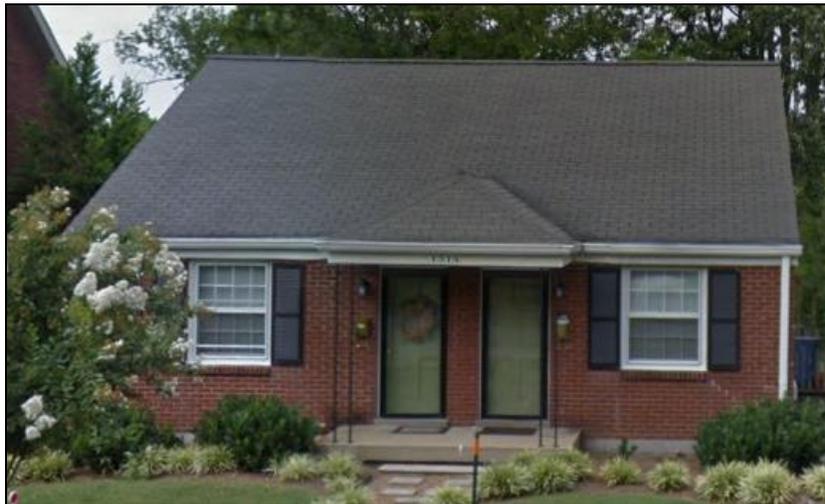
Figure 1: 1514 Clayton Avenue

**Background:** The house at 1514 Clayton Avenue is a 1950s house that does not contribute to the historic context of the Belmont - Hillsboro Neighborhood Conservation Zoning Overlay (Figure 1). At fifty feet (50') wide, the subject property is the narrowest lot on Clayton Avenue between Belmont Boulevard and Granny White Pike/12<sup>th</sup> Avenue South.

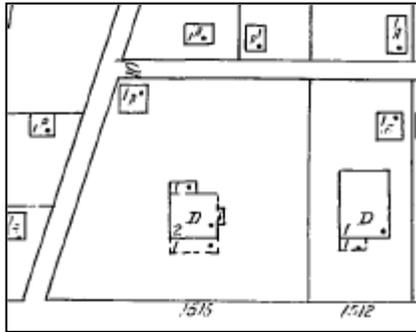
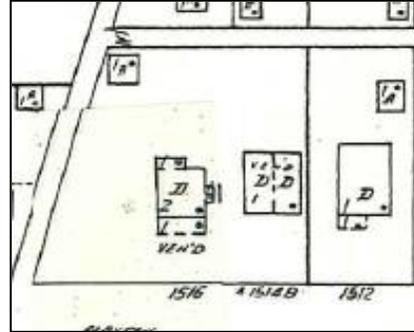
Figures 2 (left) is the 1951 Sanborn Map, and Figure 3 (right) is the 1957 Sanborn Map. 1514 Clayton Avenue appears on the 1957 map but not on the 1951 map.

**Demolition:** The house at 1514 Clayton Avenue was constructed between 1951 and 1957, as it does not appear on the 1951 Sanborn map but does on the 1957 Sanborn Map (Figures 2 & 3). This is outside the period of historic significance for the Belmont-Hillsboro neighborhood. In addition, the house lacks details common in historic Belmont-Hillsboro houses, like eave overhangs and porches. Staff finds that existing

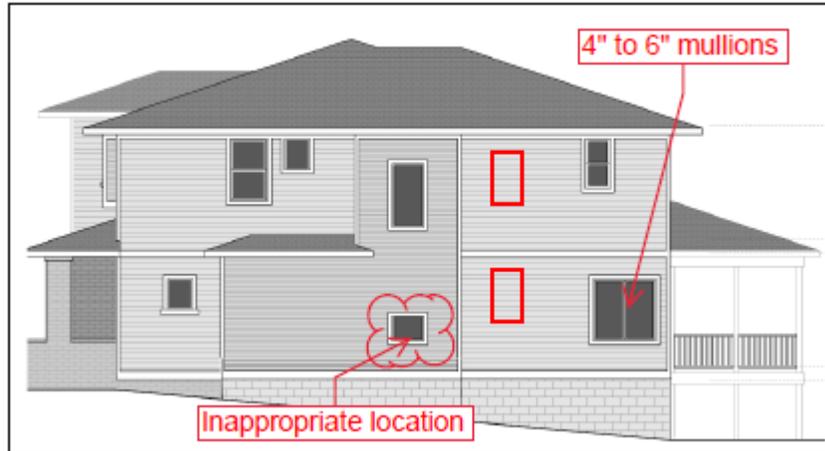
Figure 4 shows the fenestration issues on the right side façade

Proportion and Rhythm of Openings: The infill's fenestration pattern does not meet the historic context. A number of windows on the proposed infill are not twice as tall as they are wide; and, therefore, do not meet the historic proportion of windows. On the right elevation, the low window on the first floor, at about the midpoint, is not appropriate. Its location, so low on the wall, is not appropriate as it does not meet historic conditions for rhythm of openings. In addition, a four to six inch (4"-6") mullion is required in between the two windows towards the rear. See Figure 4 for illustration.

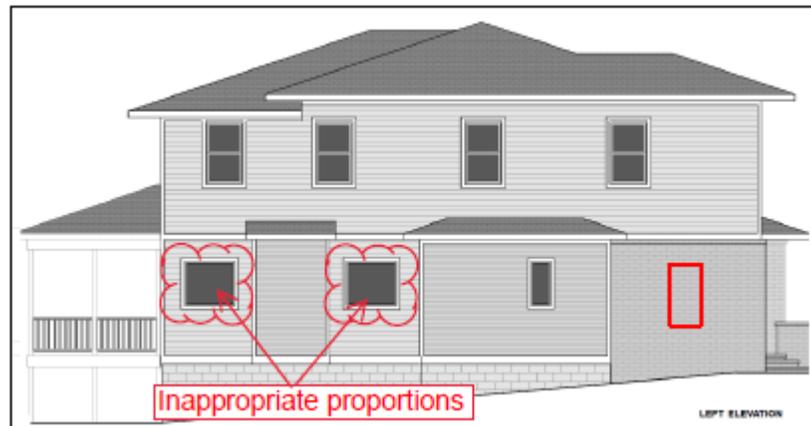
Figure 5 shows the fenestration issues on the left façade.

On the left elevation, there should be a window opening on the brick portion, first level, near the front of the house. In addition, the picture windows towards the back of the house are not twice as tall as they are wide, and therefore do not meet the historic proportion of window openings. See Figure 5 for illustration.

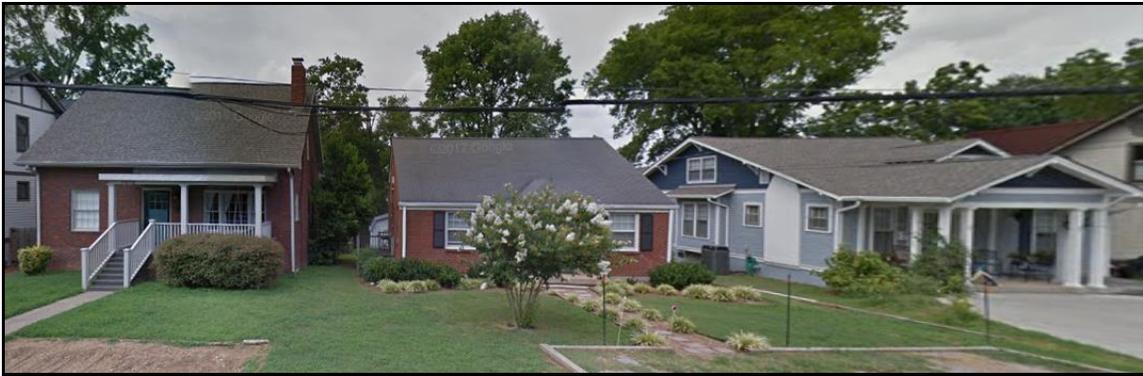
From left to right: 1516 Clayton Avenue (contributing), 1514 Clayton Avenue (subject property; non-contributing), and 1512 Clayton Avenue (contributing)

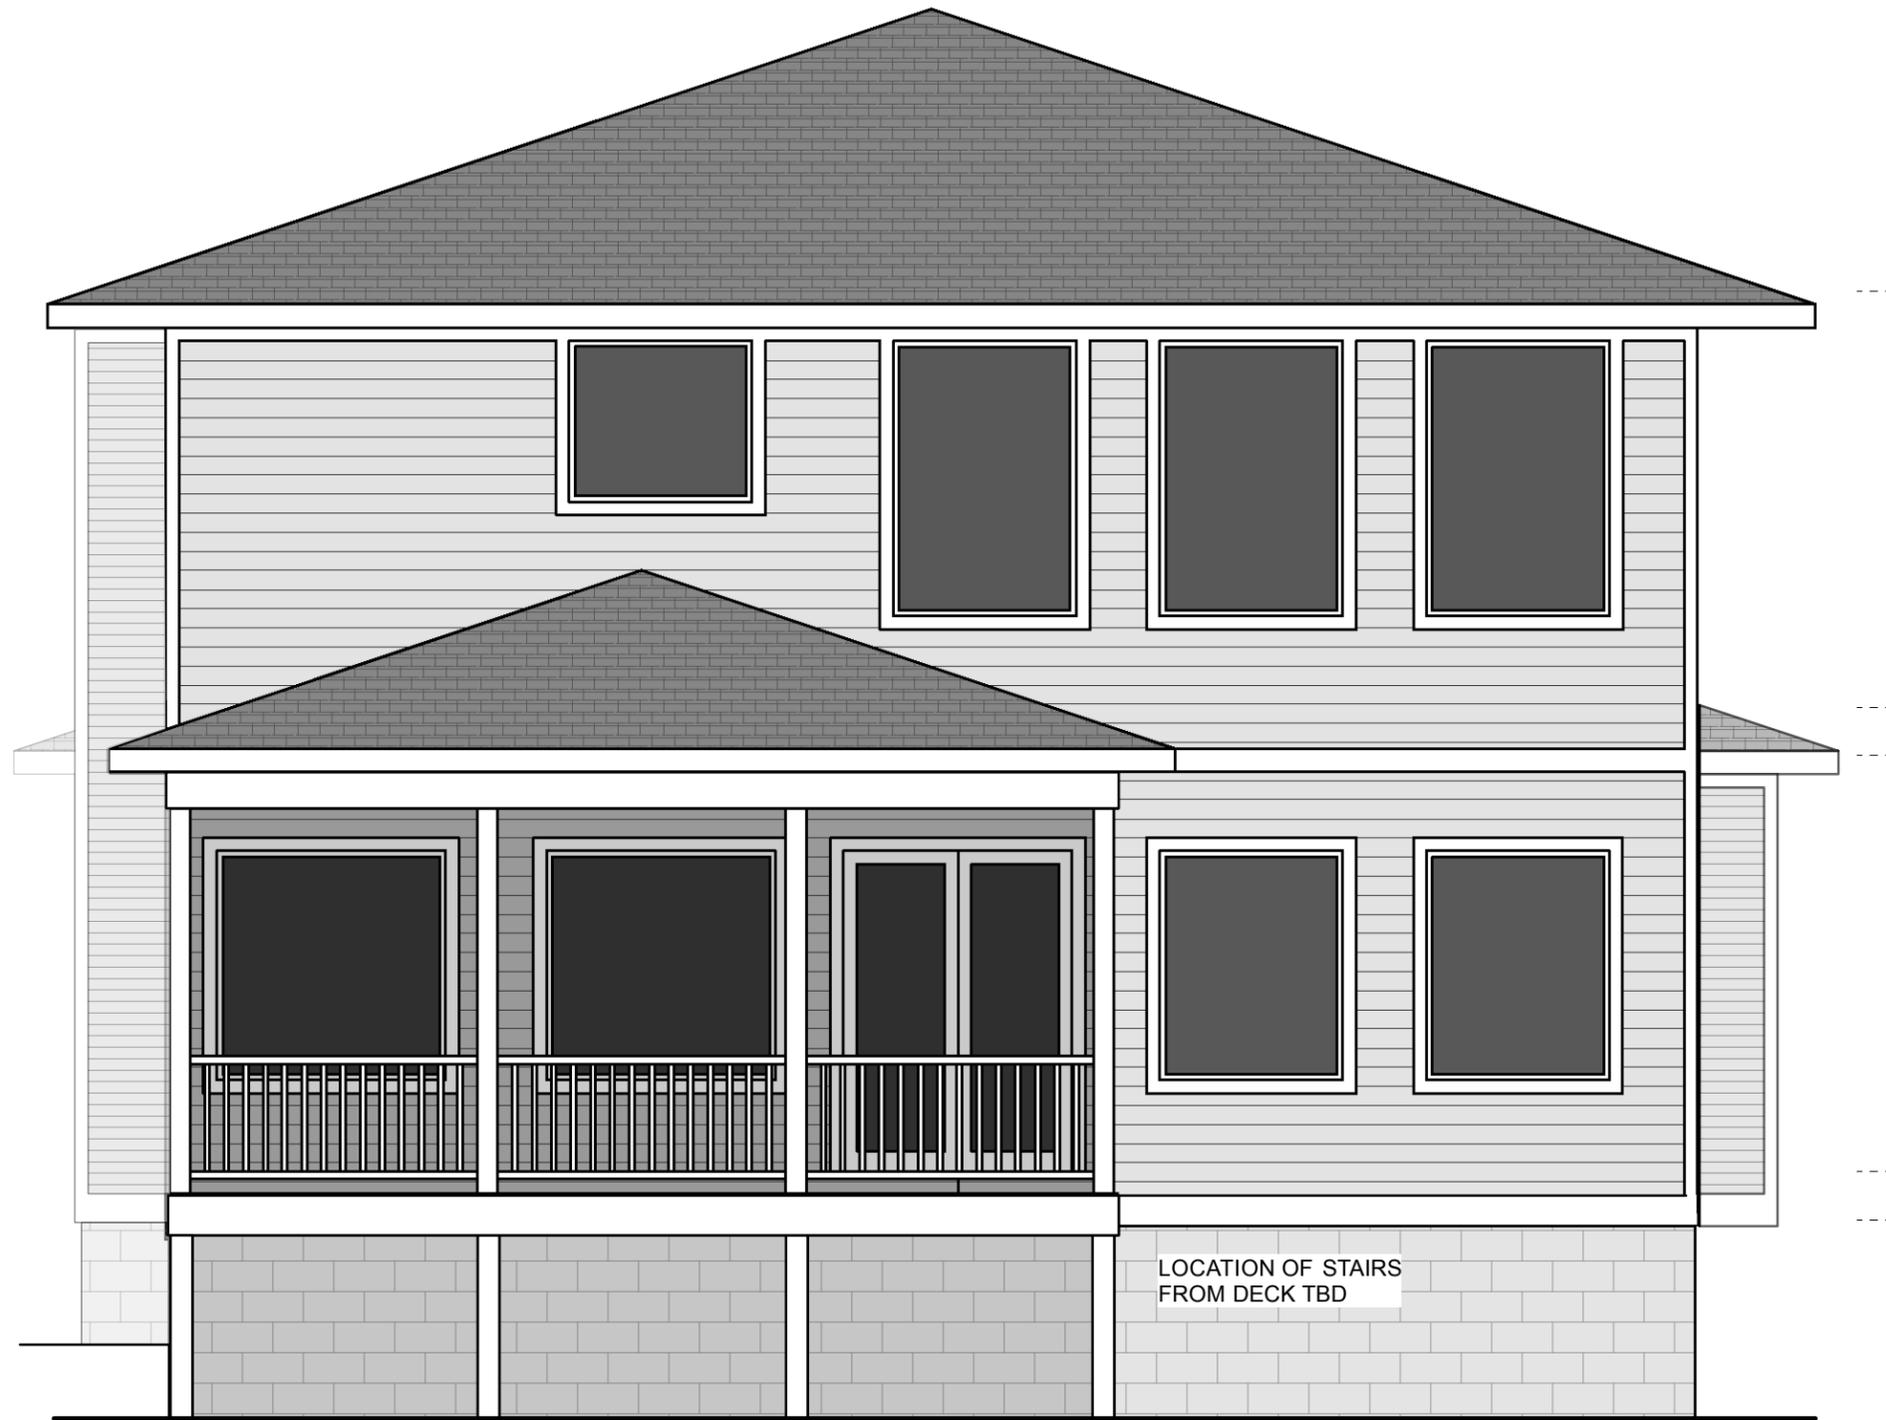
REAR ELEVATION

LOCATION OF STAIRS  
FROM DECK TBD
