STAFF RECOMMENDATION

1404 Linden Avenue

Application: New construction – infill

Description of Project: Application is to construct new infill on a vacant lot.

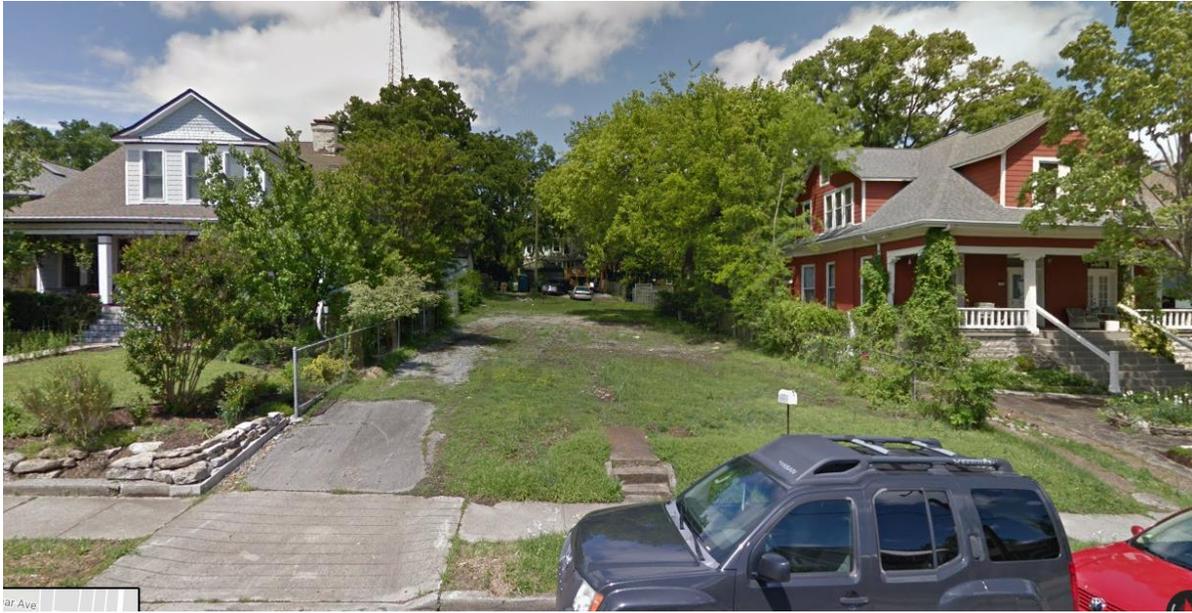
Figure 2. The vacant lot at 1404 Linden Avenue.

Background: In 2016, MHZC issued a preservation permit for demolition of the c. 1955 house previously on the lot (Figure 1). The house was demolished, and now the lot is vacant (Figure 2). MHZC also approved an infill design for the property in 2016, but that design was never constructed. This application represents a new design from a new applicant.

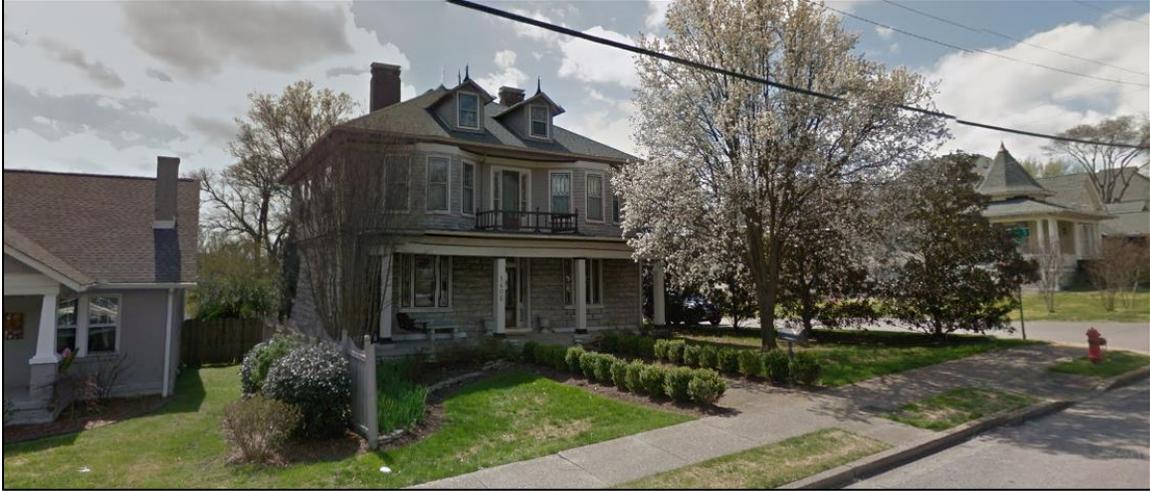
1405 Linden is two and one-half stories tall, but is on a fifty-nine foot (59') wide corner lot.

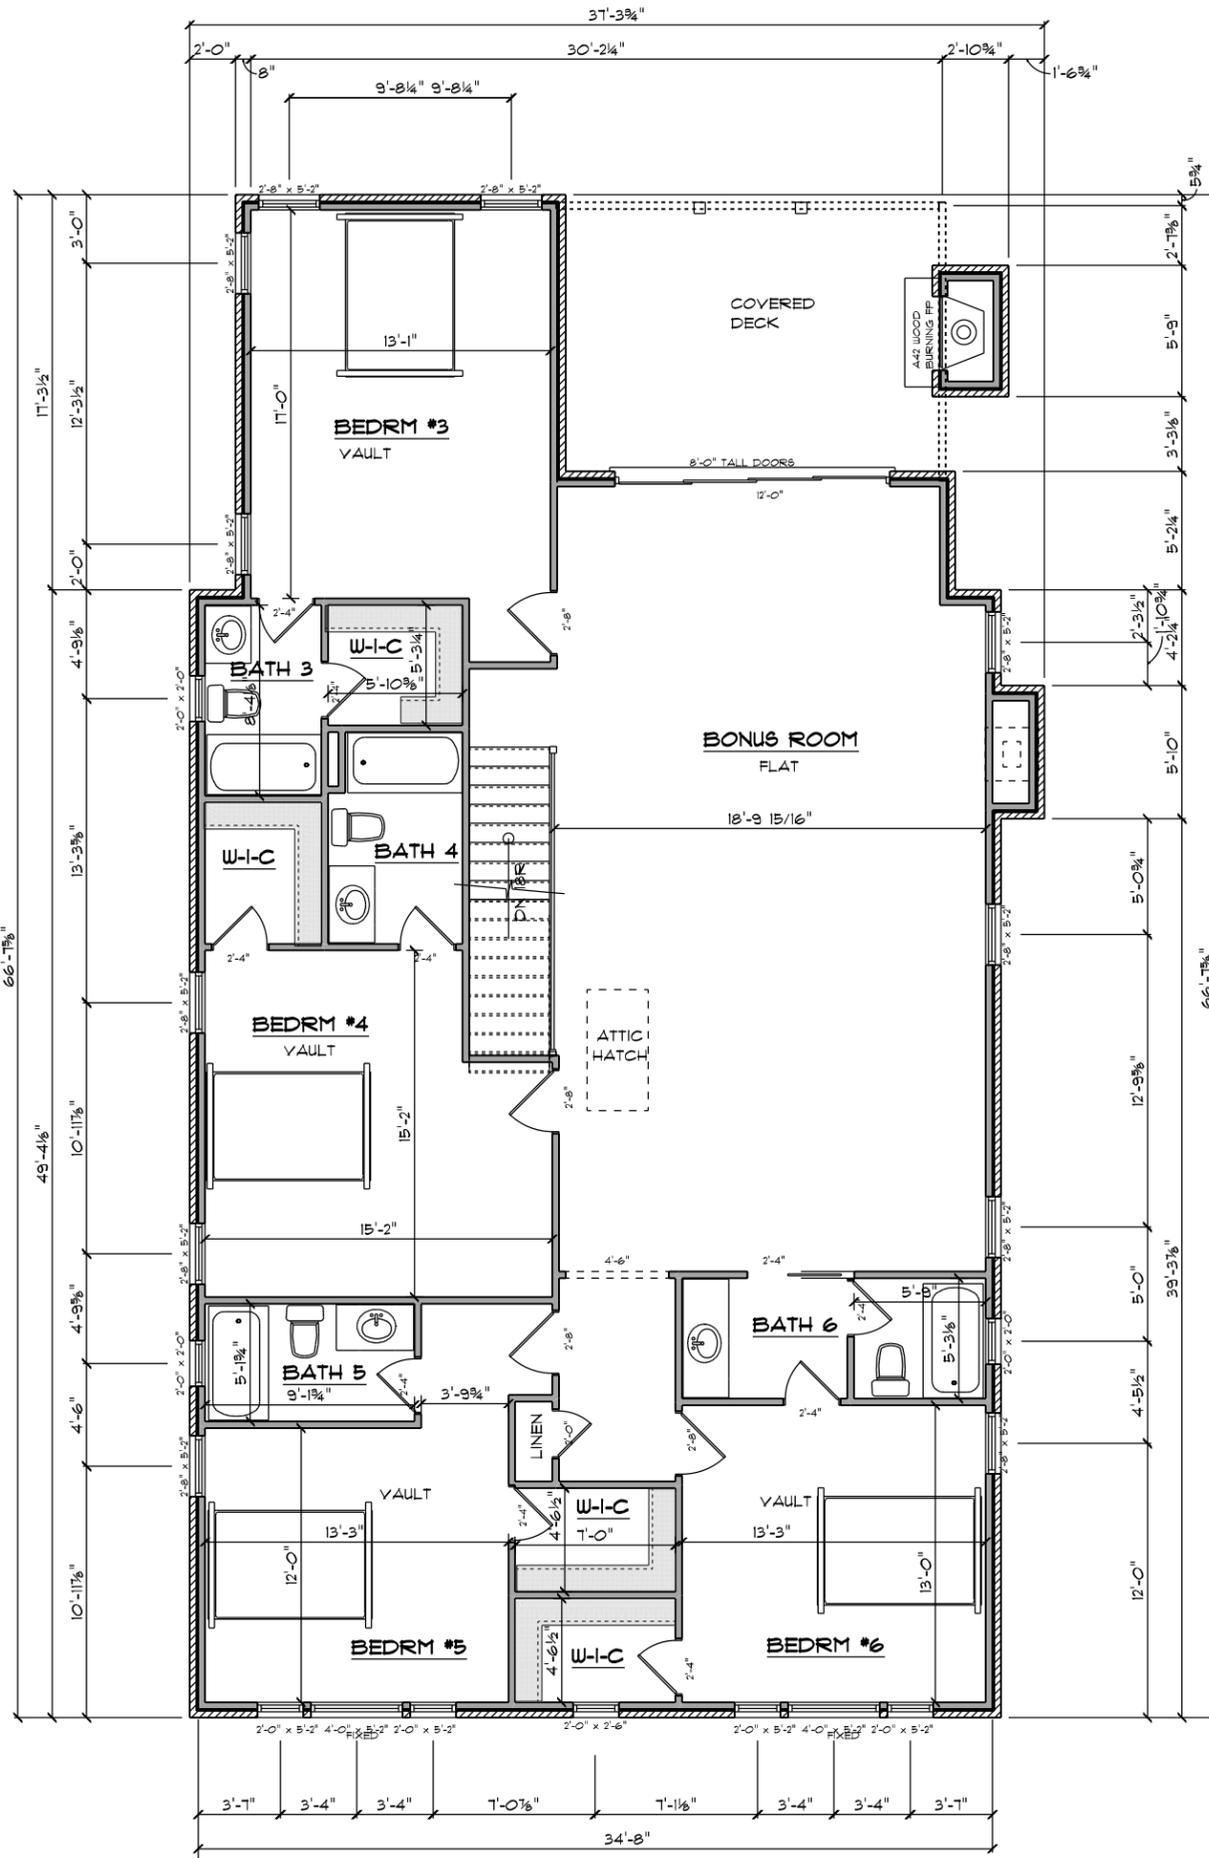
SECOND FLOOR PLAN

ALL 2ND FLOOR CEILINGS ARE 9' TALL
 AND ALL DOORS ARE 6'8\"/>
