STAFF RECOMMENDATION
128 Second Avenue North
February 20, 2019

Application: Rehabilitation: Window Replacement
District: Second Avenue Historic Preservation Zoning Overlay
Council District: 19
Map and Parcel Number: 09306207900
Applicant: Mark Bixler, Manuel Zeitlin Architects, LLC
Project Lead: Robin Zeigler, robin.ziegler@nashville.gov

<p>Description of Project: The applicant proposes to replace the non-historic windows on the top floor of the First Avenue side of 128 2nd Avenue North with roll-up doors, pushed back from the existing wall plane.</p> <p>Recommendation Summary: Staff recommends disapproval finding that the proposal does not meet sections H.3-5 and 9 of the Second Avenue design guidelines for replacement windows, sections I.1 and 2 for wall alterations and section J for replacement materials.</p>	<p>Attachments A: Elevations</p>
--	--

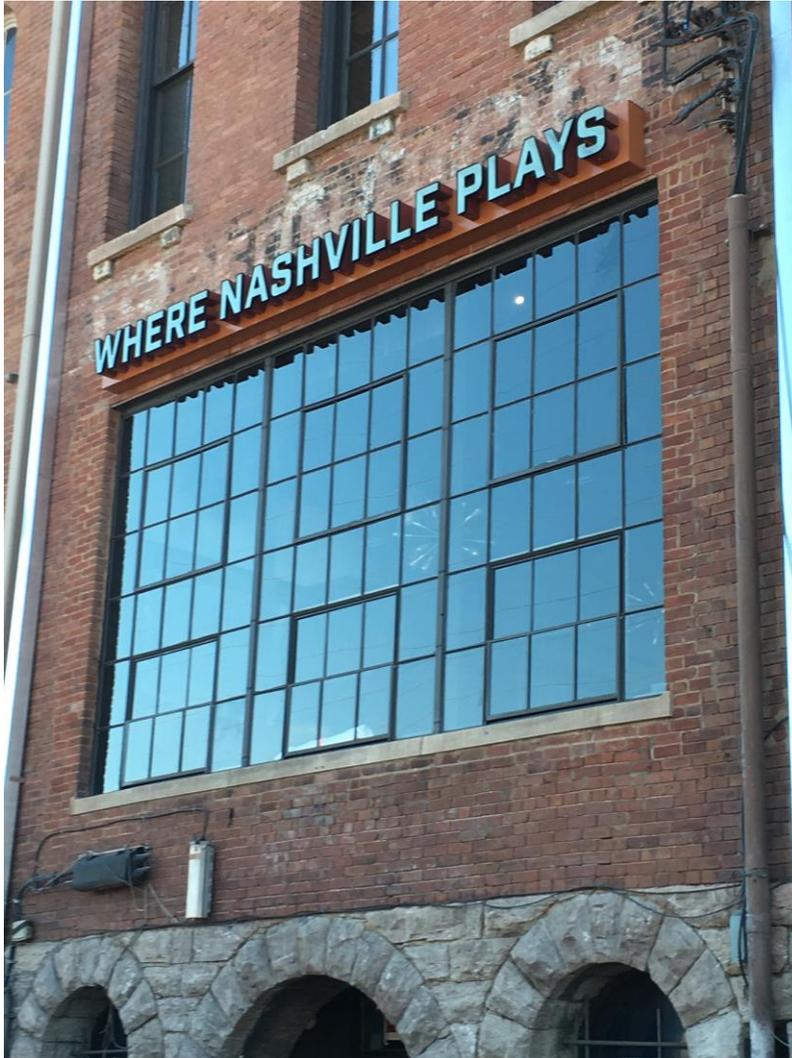
Figure 3: This business nearby at 110 2nd Ave North has an industrial window. The darker outlines of 6 panes shows the sections that are operable.

central portion and no part of the window would remain visible. With historic windows, because the design was a hopper or awning type, the open portion of the window remained fully visible when open. (See Figure 3.) In addition, the proposal locates the windows three feet (3') back from the exterior wall with a partial covering of a railing, both design features that do not mimic historic conditions.

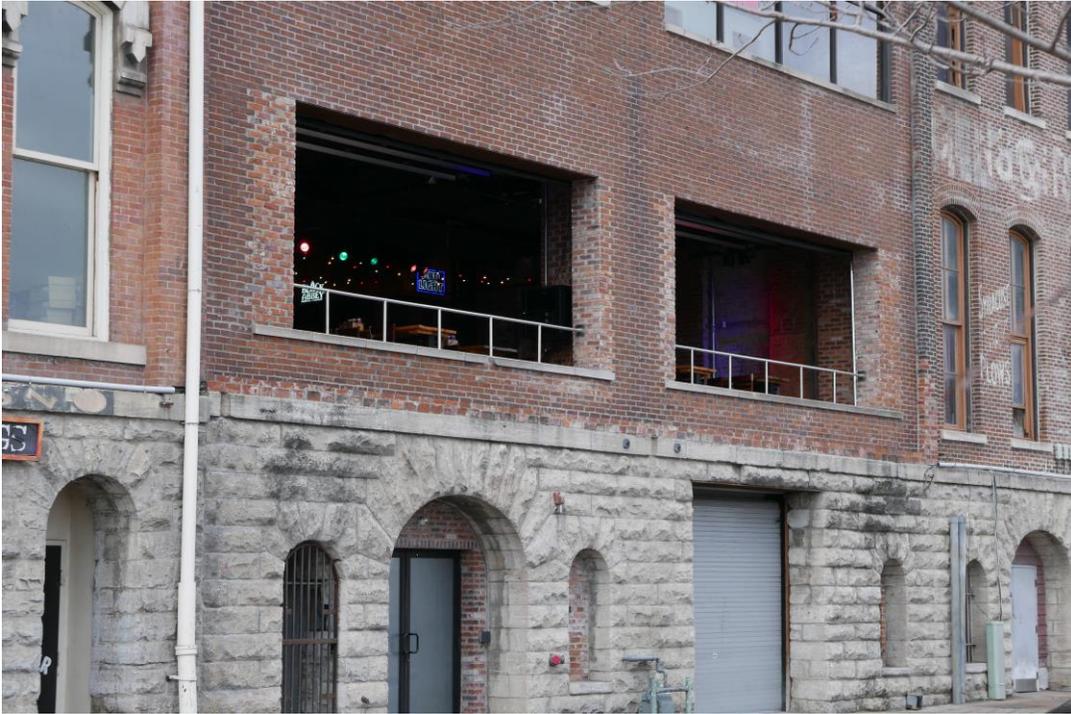
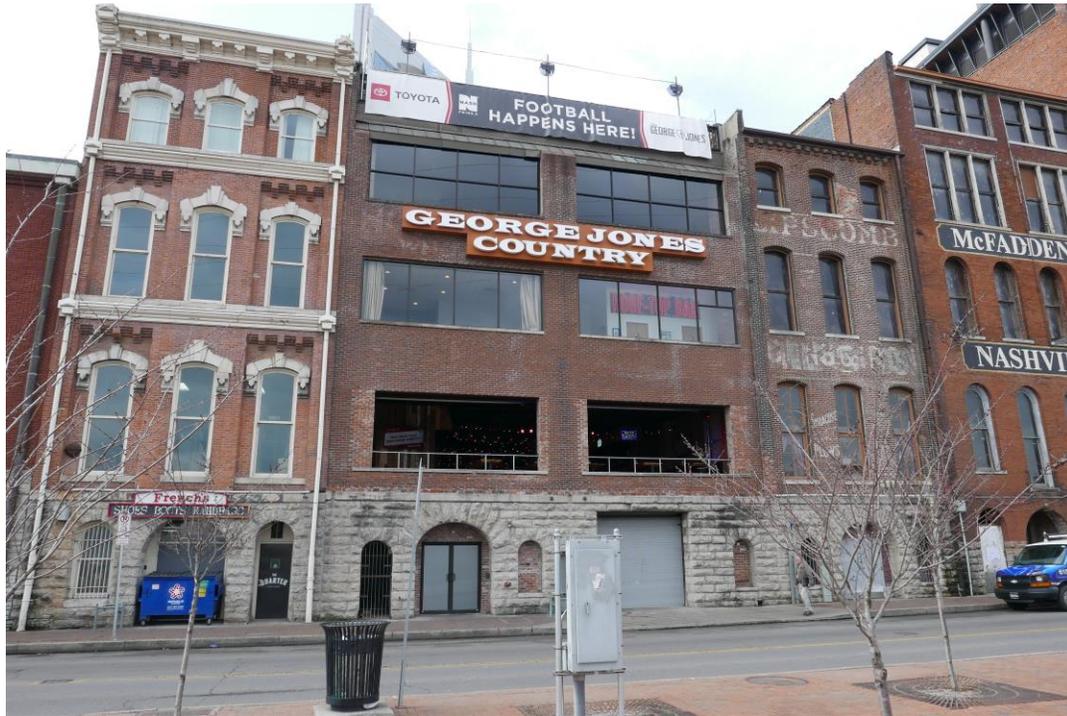
Figures 4 and 5: The 2nd level of the building on the First Avenue Side had roll up doors prior to the establishment of the overlay. These images show the visual gap created when the windows are open.

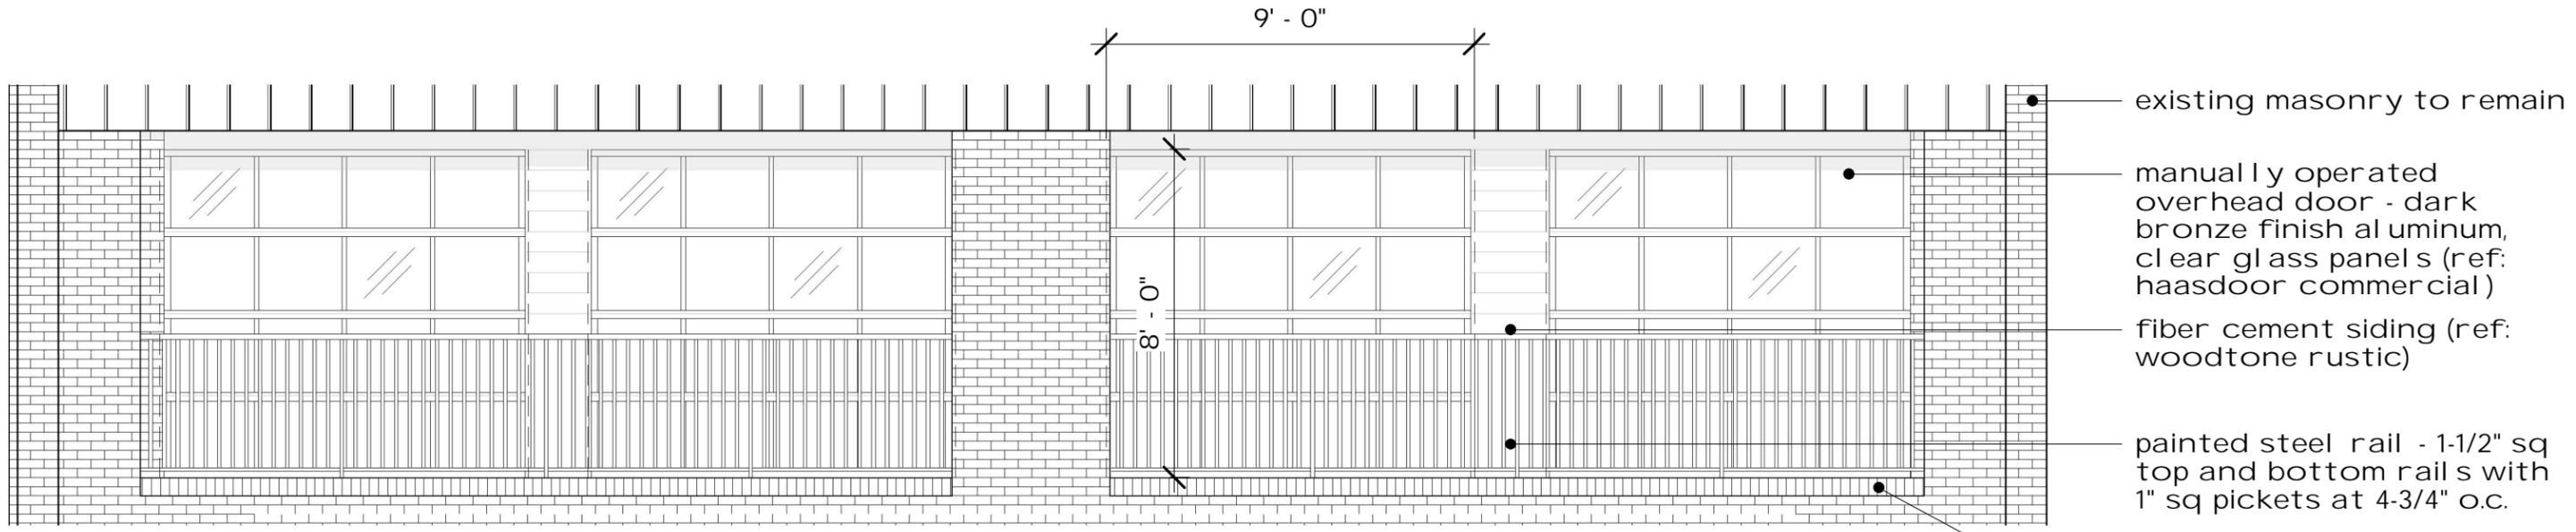
① 1st Ave facade detail
1/4" = 1'-0"

- existing masonry to remain
- manually operated overhead door - dark bronze finish aluminum, clear glass panels (ref: haasdoor commercial)
- fiber cement siding (ref: woodtone rustic)
- painted steel rail - 1-1/2" sq top and bottom rails with 1" sq pickets at 4-3/4" o.c.
- existing masonry sill to remain

Materials include a painted steel rail, dark bronze aluminum windows with clear glass and fiber-cement siding between each pair of proposed doors. Aluminum is listed as an appropriate material for replacement steel windows; however, fiber-cement siding is not an appropriate wall replacement material. Historically, it appears that the steel windows of the top floor were continuous and did not have areas of wall between them. (The entirety of the wall cannot be seen in the historic photo.) Staff finds that introducing this section of wall is inappropriate as it will effectively change the dimension of the windows within the historic masonry openings. The project does not meet section J for materials.

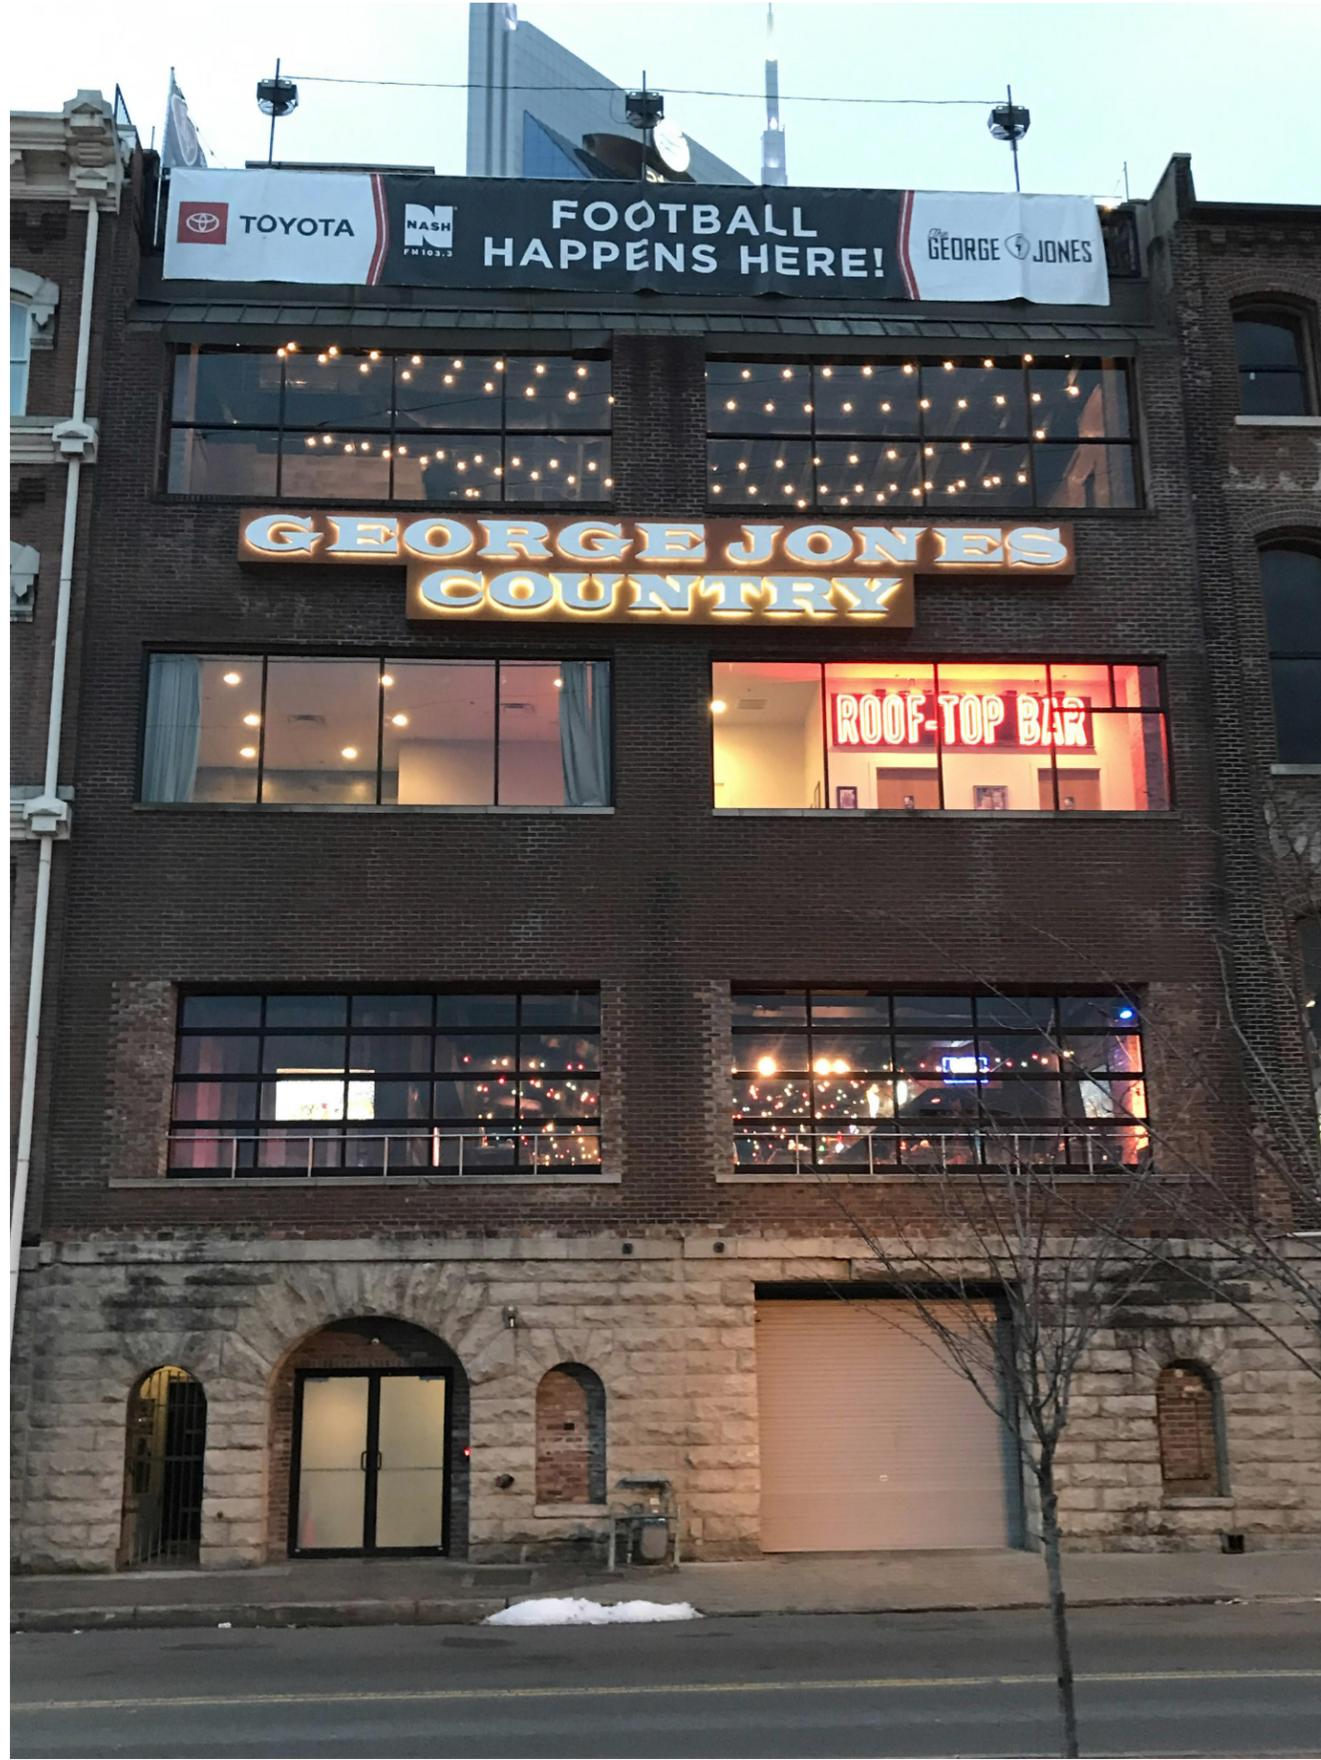
1st avenue north facade

existing aluminum storefront to be removed

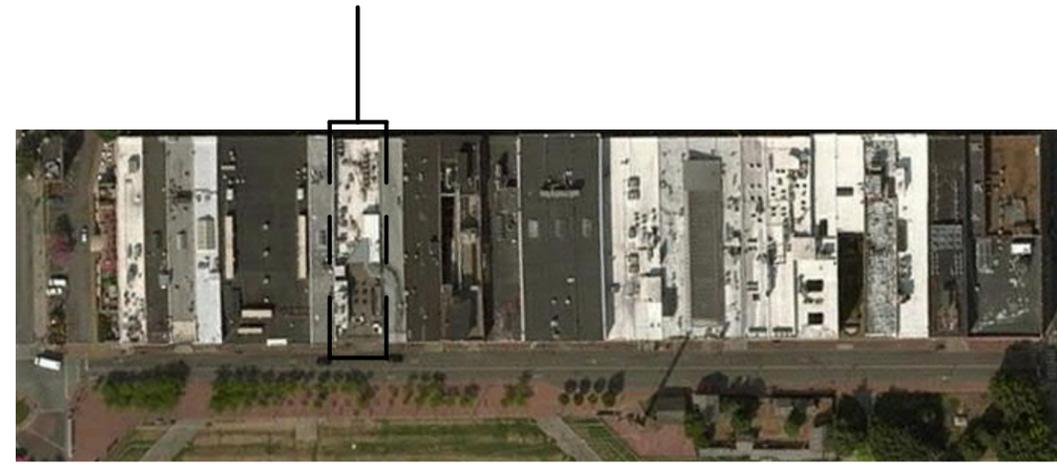
4th floor windows removed, railing inserted, new wall constructed pulled back from face

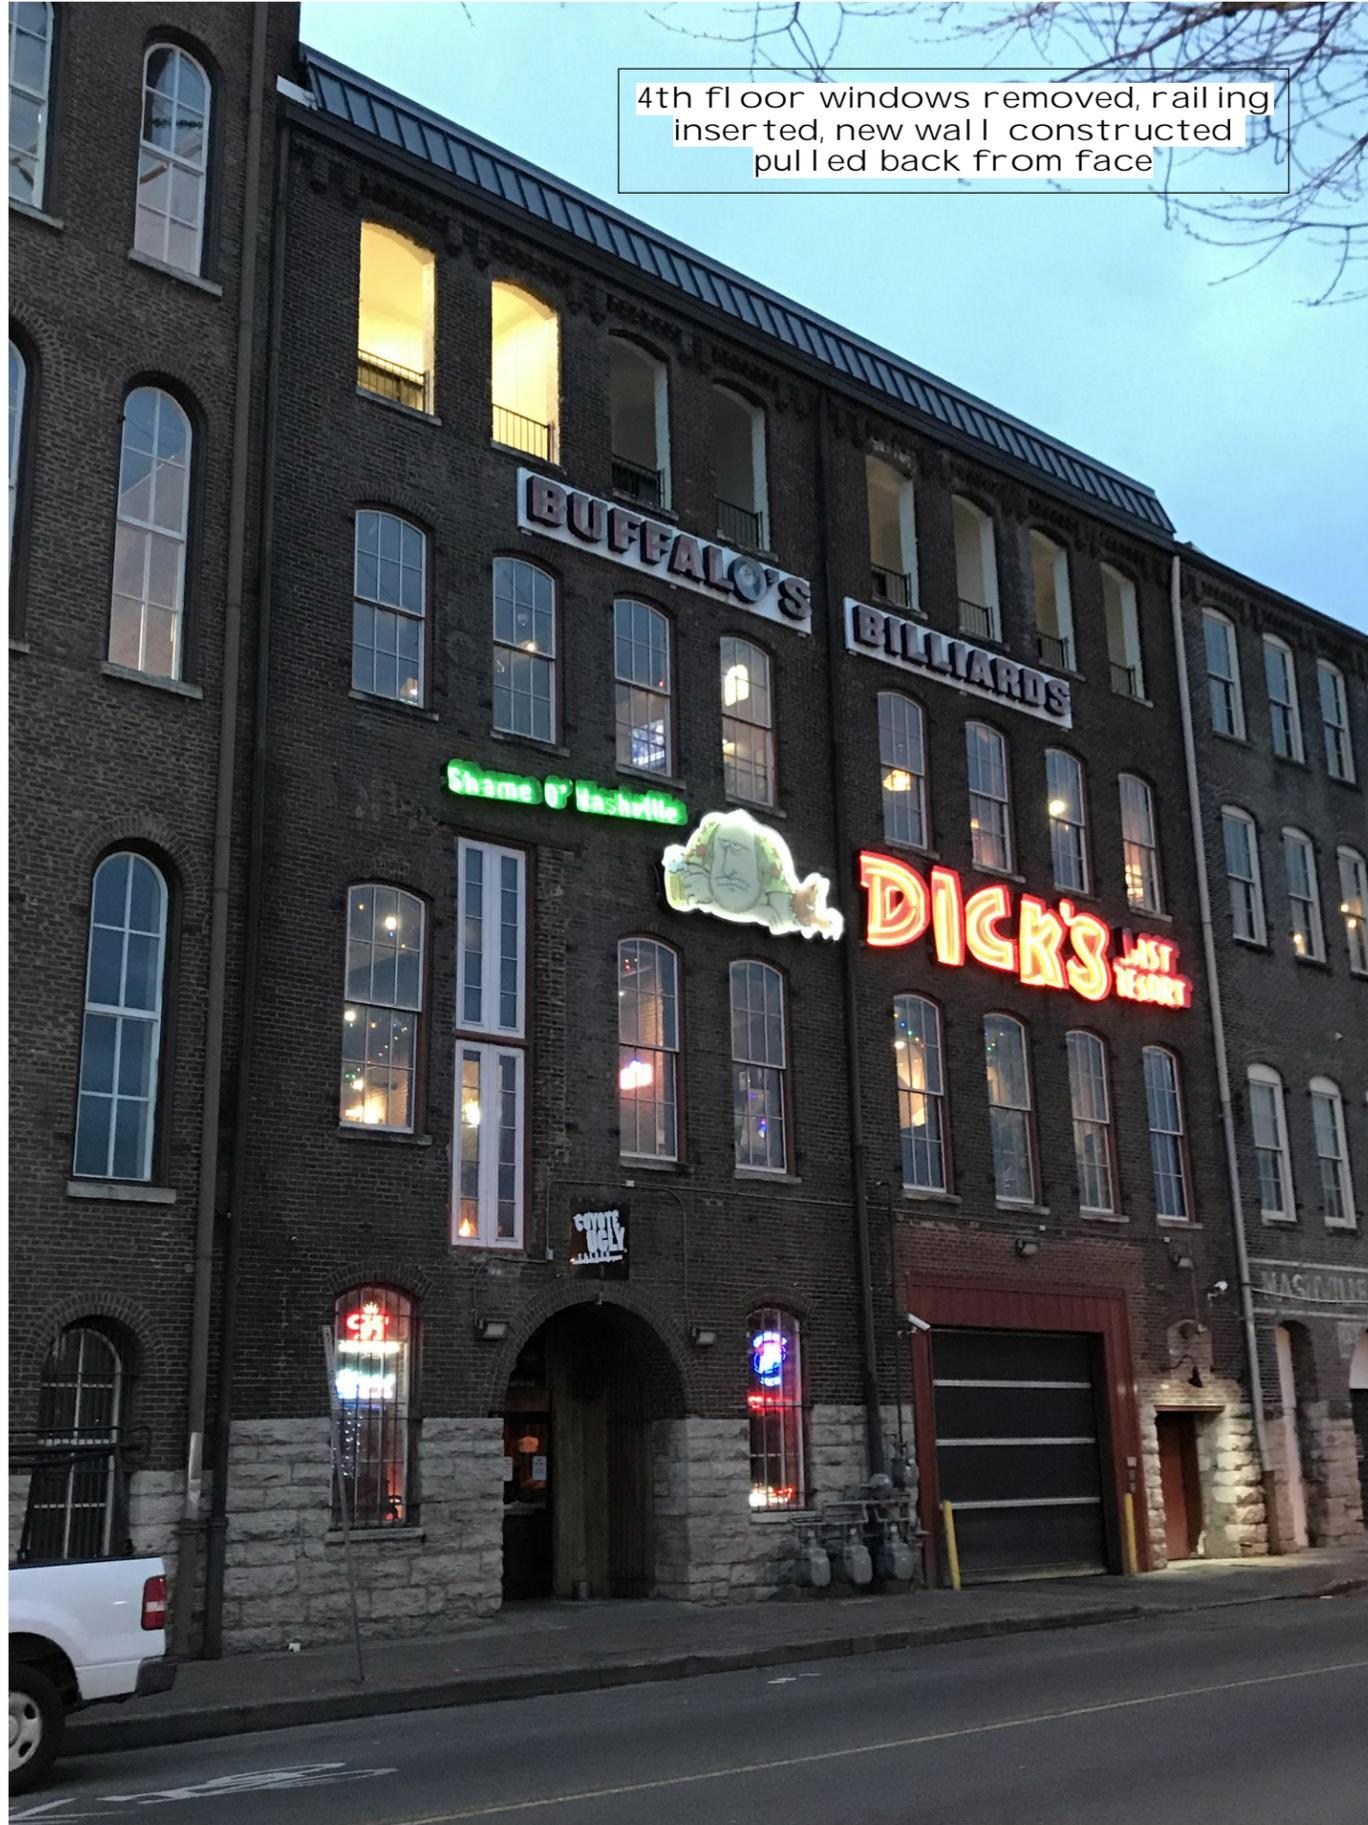
4th floor windows removed, railing inserted, new wall constructed pulled back from face
