## STAFF RECOMMENDATION

0 Plymouth Ave  
May 20, 2020

**Application:** New Construction - Infill  
**District:** Eastdale Place Neighborhood Conservation Zoning Overlay  
**Council District:** 7  
**Base Zoning:** RS-10  
**Map and Parcel Number:** 061120091.00  
**Applicant:** Jon Duke  
**Project Lead:** Jenny Warren, jenny.warren@nashville.gov

**Description of Project:** Application for new construction of a single-family house on a vacant lot.

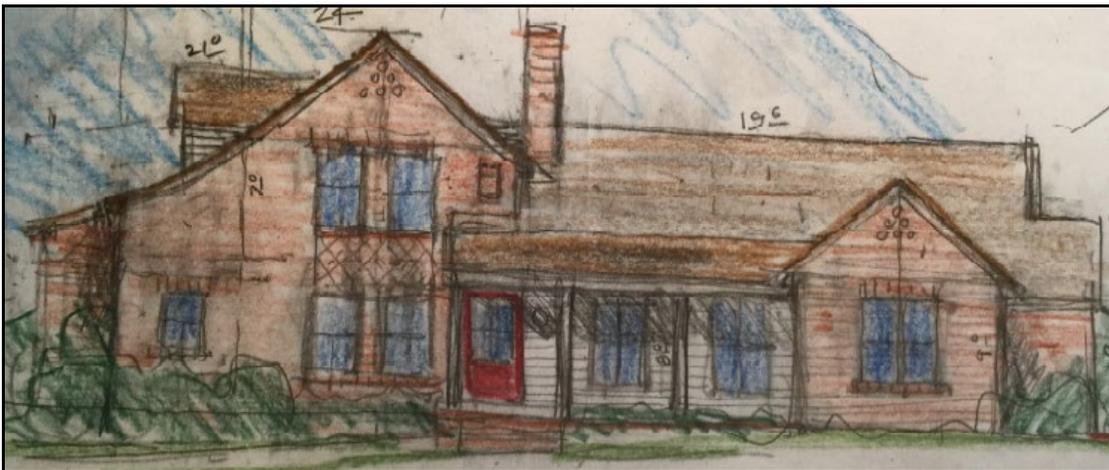
Figure 2: Proposed front elevation

The houses in the immediate historic context are mostly one-and-a-half story forms with a few one stories. The average height in the historic context is about seventeen to twenty-four feet (17-24'). The proposed house has a one-and-a-half story form on the front elevation and a maximum height of twenty-four feet (24'); however, the eave height of portions of the home, especially on the right side elevation (Figure 4), are more consistent with a two-story home. Staff finds that the tall eave on the left-front side, above the front door, could be appropriate as a feature that is typical of the style of home and because it does not rise to a full two-story level. However, the right-side and rear-left side eave heights are not consistent with the neighborhood. This is the first infill for this neighborhood since the overlay was created and so could set a precedent for future projects.

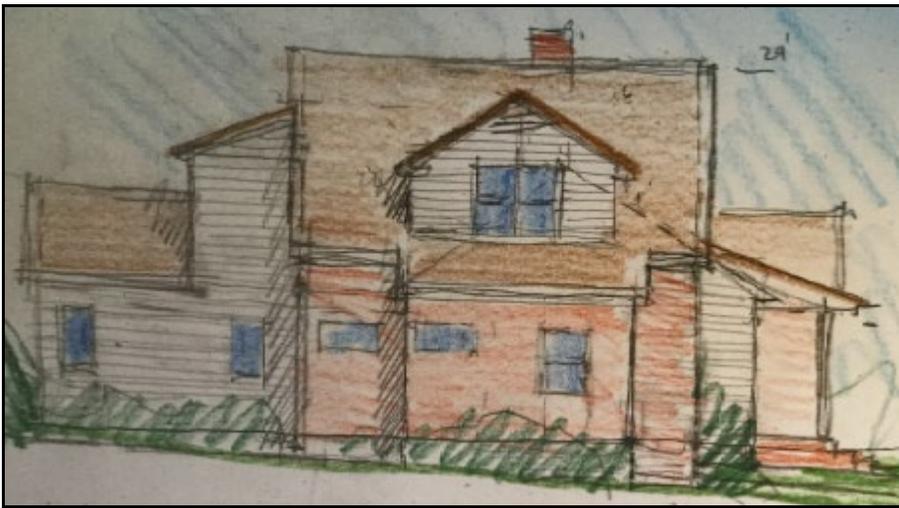
Figure 3: Left side elevation

The width of the front elevation is proposed to be about sixty feet (60') which is appropriate for the historic context where the average width of houses varies from roughly forty to sixty feet (40'-60') wide.

With the condition that the side elevation eave heights are lowered to be consistent with a one and one-half story house, staff finds that the project's height and scale meet Sections III.A. and III.B. of the Eastdale Place design guidelines.

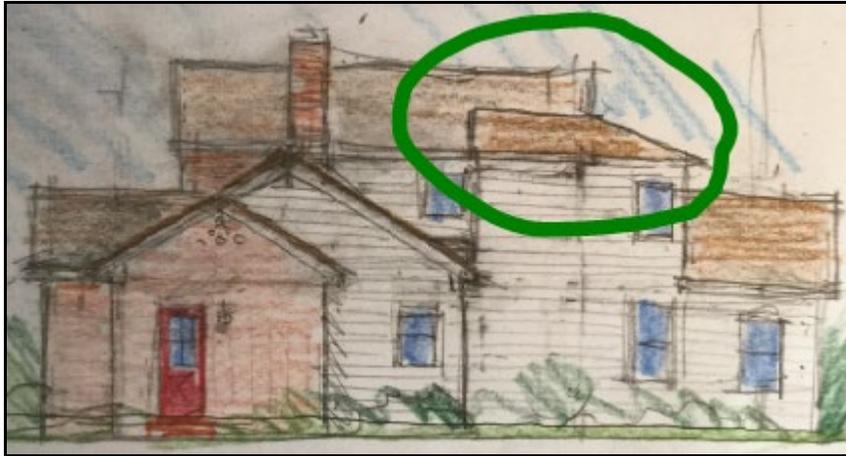
Figure 4. Right side elevation. Circled area is irregular roof form.

On the right side elevation, a hipped portion of roof steps out from the primary front-facing gable. The roof projection is not reflected on the front elevation, though it appears that in elevation, it should be visible. This is an atypical roof form but could be appropriate if the eave heights are lowered, lessening its visibility from the street. With the condition that eave heights are lowered to be consistent with a one and one-half story house, the project could meet Section III.E. of the Eastdale Place design guidelines.

The roof incorporates both front and side gabled components, which are typical of the neighborhood. The primary gables have a roughly 9/12 slope. The front porch has a shed roof, as does a one-story side bay on the left elevation. There is a dormer on the left side elevation with a typical front gabled form.

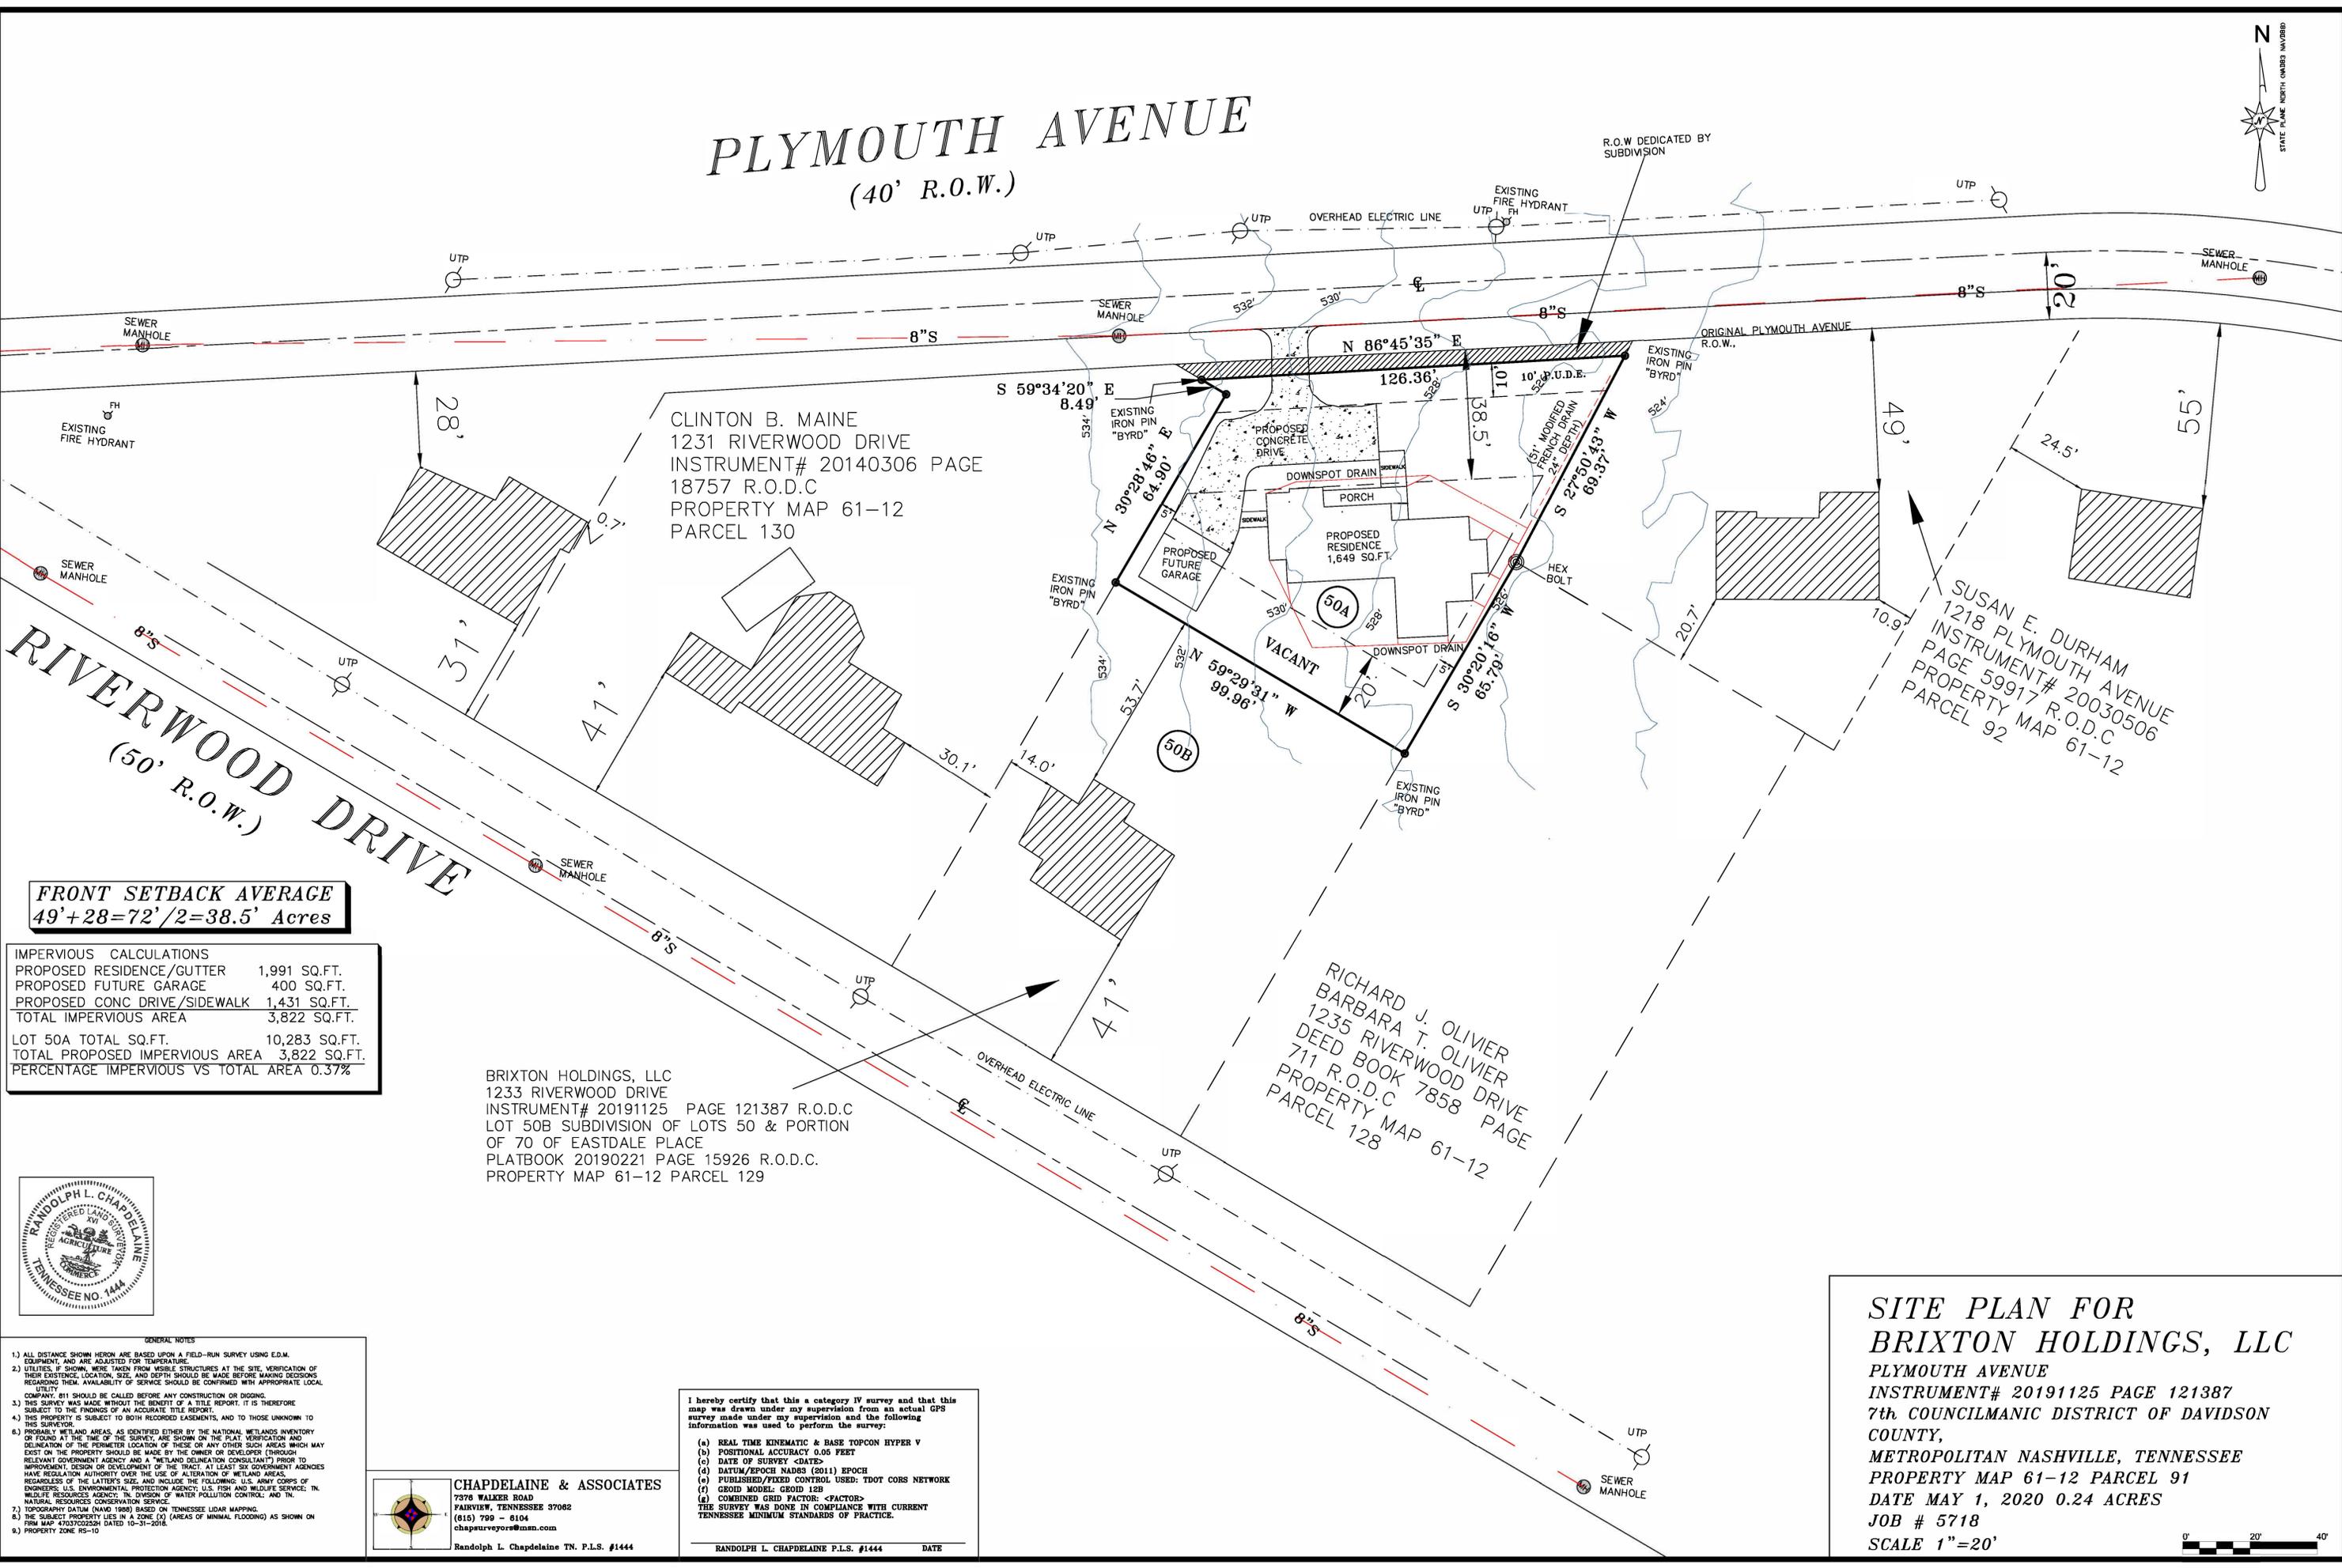
# PLYMOUTH AVENUE (40' R.O.W.)

CLINTON B. MAINE  
1231 RIVERWOOD DRIVE  
INSTRUMENT# 20140306 PAGE  
18757 R.O.D.C  
PROPERTY MAP 61-12  
PARCEL 130

SUSAN E. DURHAM  
1218 PLYMOUTH AVENUE  
INSTRUMENT# 20030506  
PAGE 59917 R.O.D.C  
PROPERTY MAP 61-12  
PARCEL 92

**Background:** This lot is located at the back of 1233 Riverwood. The property line between the two lots was recently moved to make the vacant lot a buildable lot. This is the first infill project for this neighborhood since the creation of the overlay. A garage is shown on the site plan; however, no plans were presented. The outbuilding has not been reviewed with the guidelines.

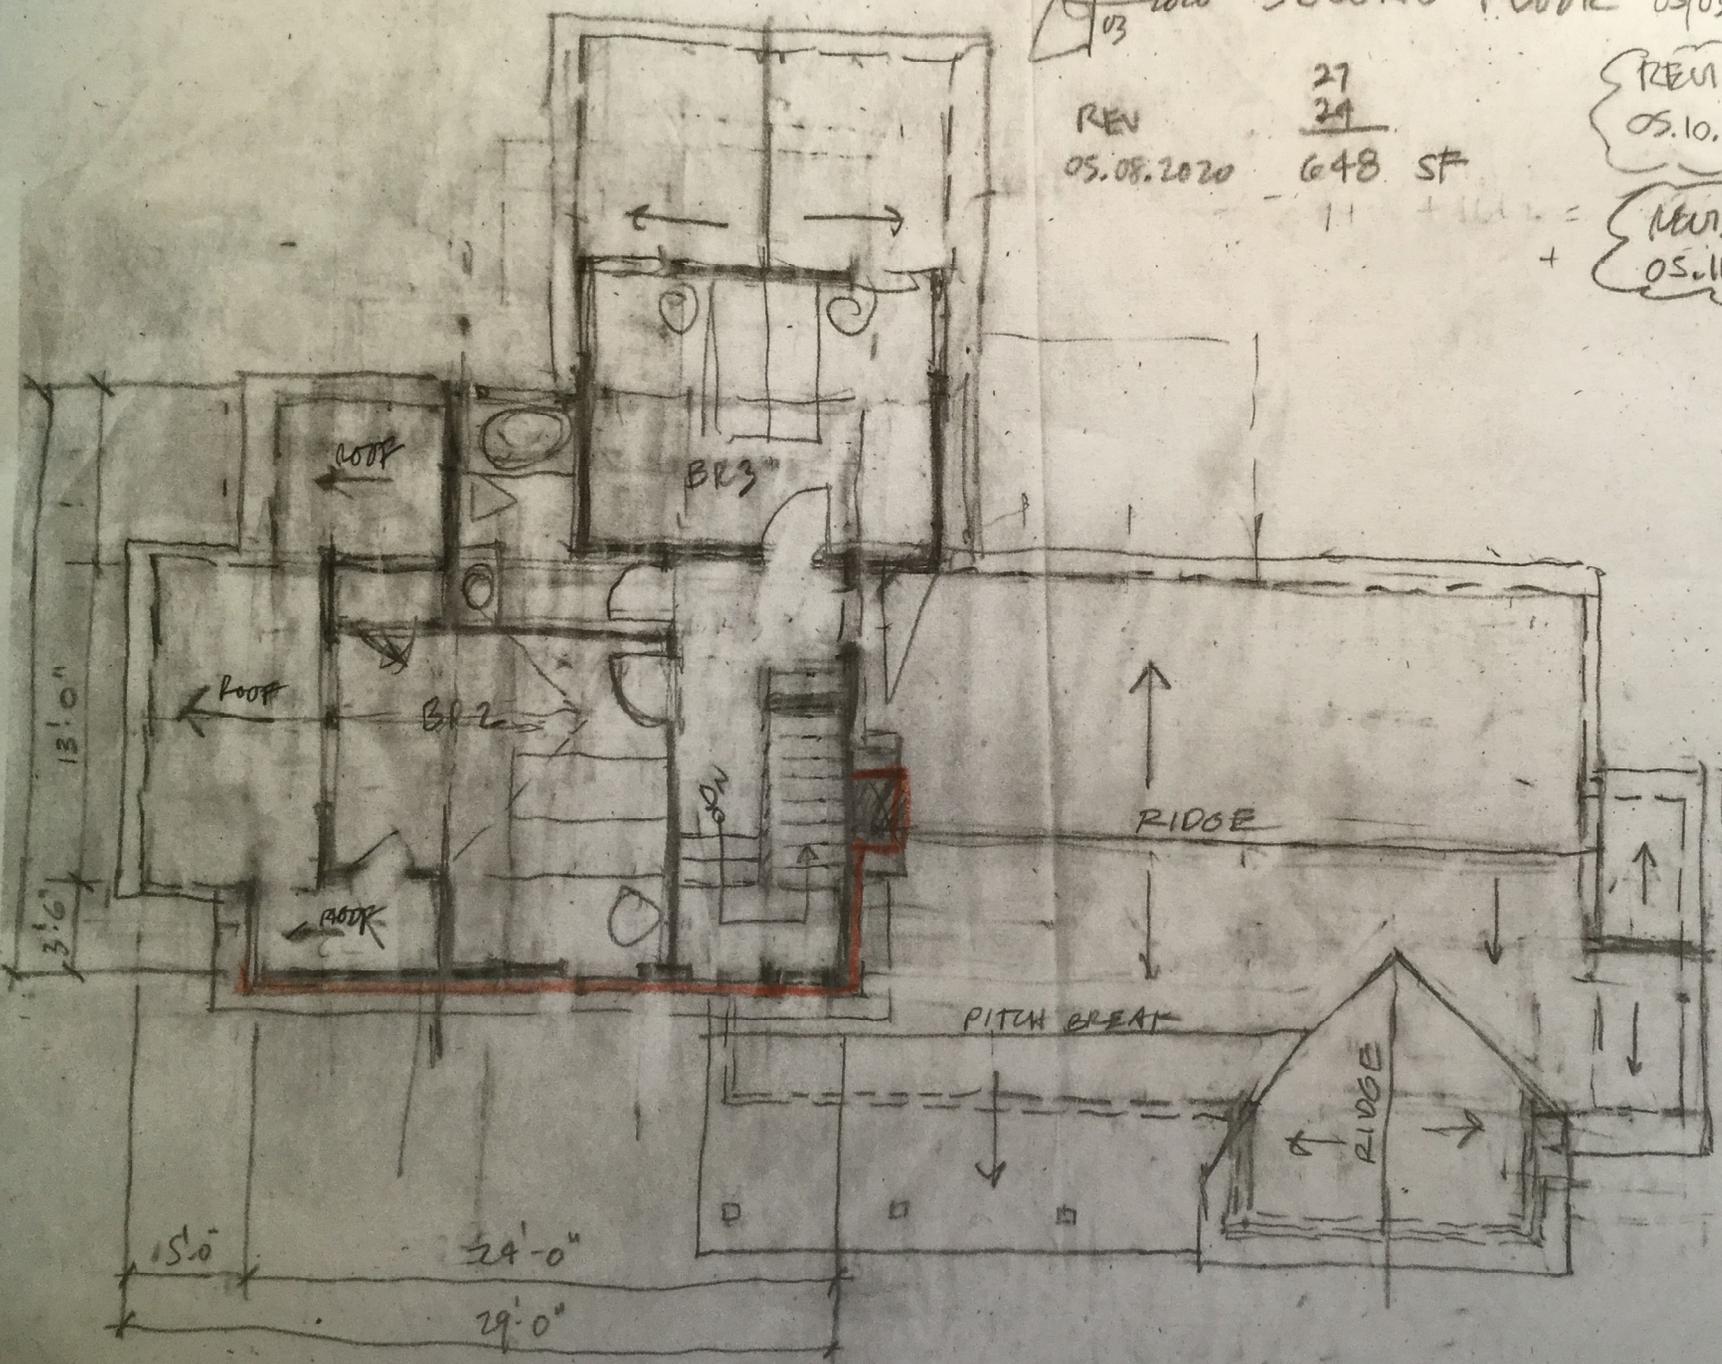
COMPO SHINGLE ROOF  
CERTAINTED 30 YEAR  
OR EQUAL

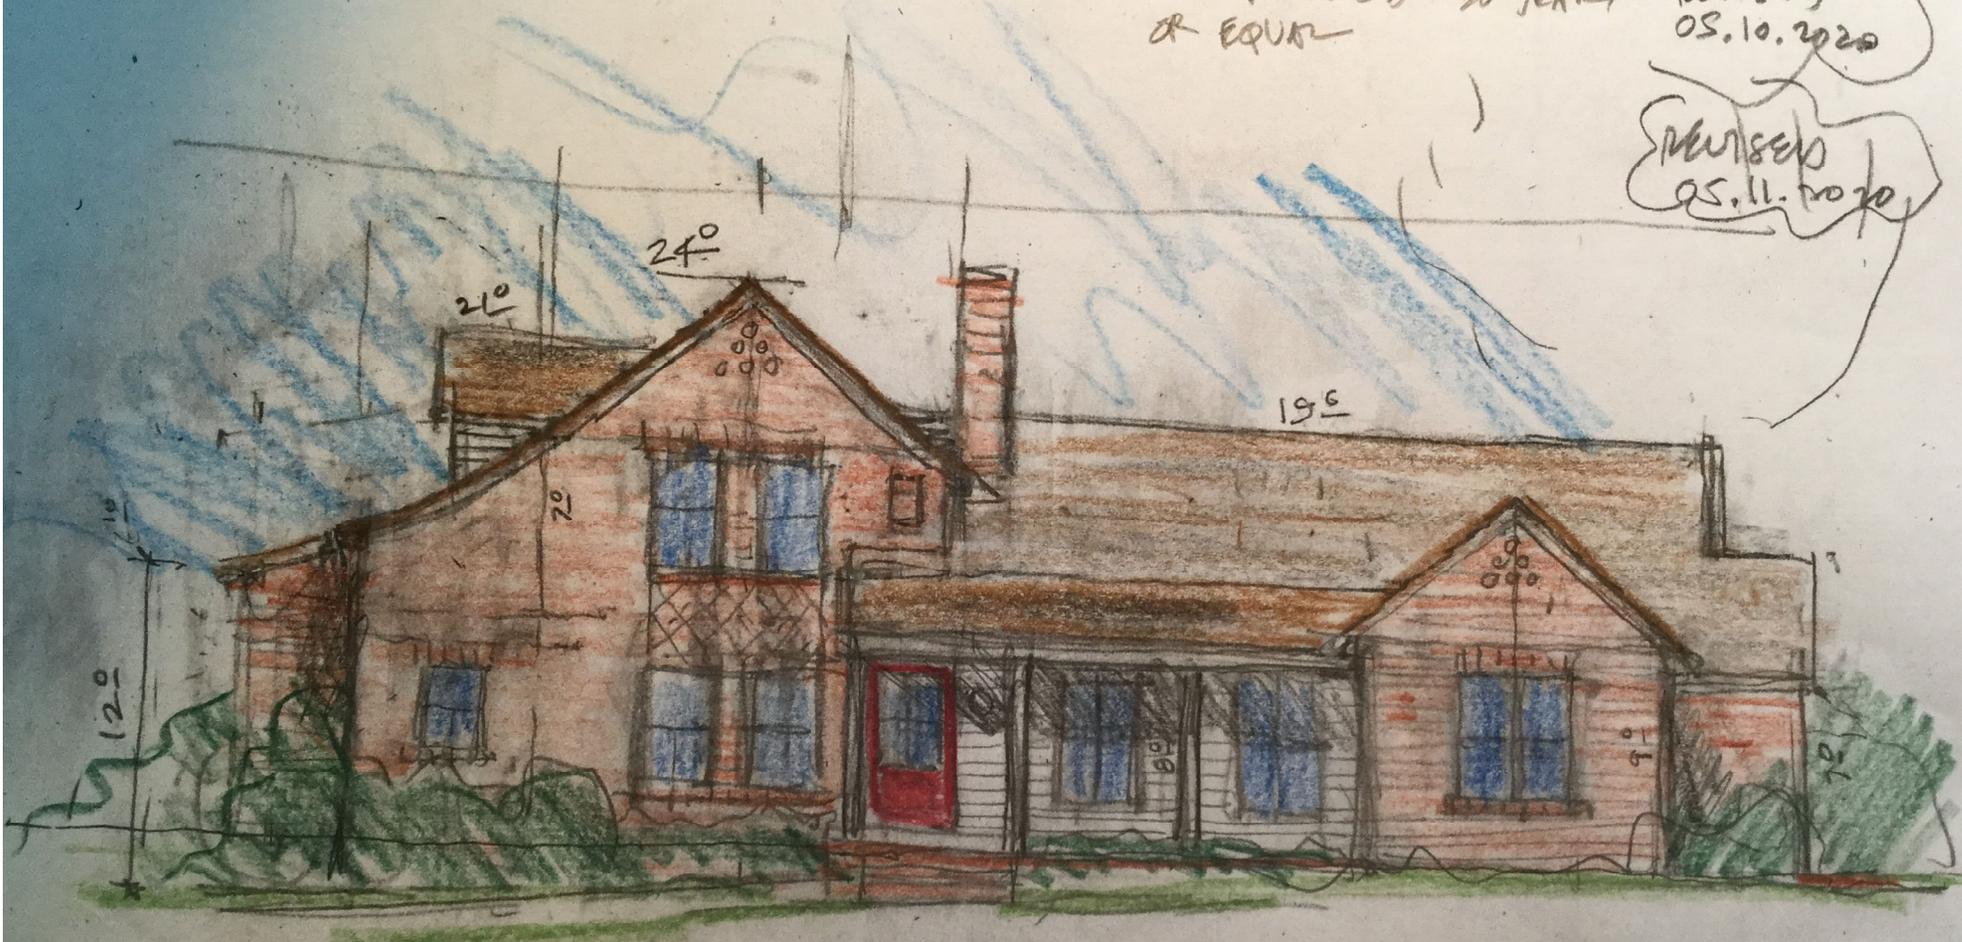
WINDOWS  
MGM "SOUTHERN ROSE"  
WHITE  
POSTS/EAVES/FASCIAS  
GUTTERS TO MATCH

UNPAINTED BRICK  
RUNNING BOND  
SOLDIER SILLS/HEADERS  
DIABOLAR INFILL

COMPOSITE SIDING  
HARDY OR EQUAL  
7" LAP
