Operations Monitoring Report

First Quarter FY22

**Thermal Engineering Group, Inc.
105 Hazel Path Court, Ste 2
Hendersonville, TN 37075**

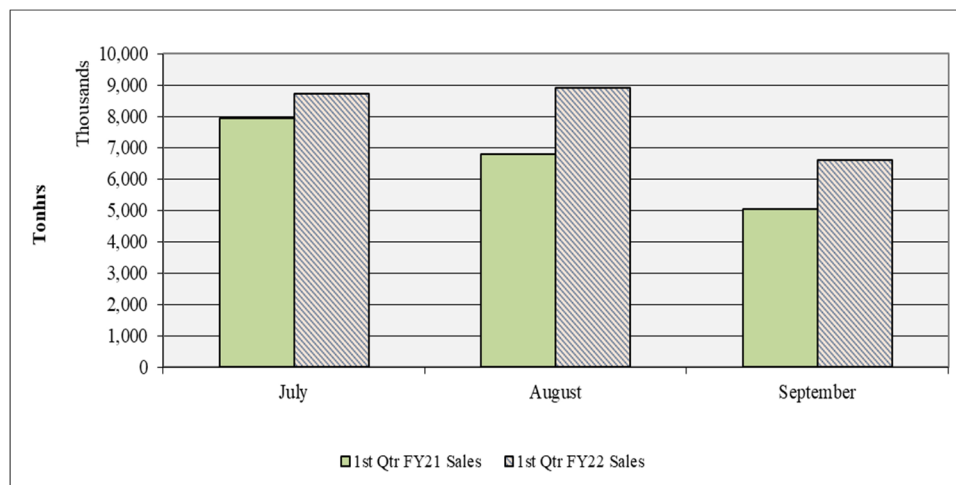
A comparison for the First Quarter chilled water sales is shown in Figure 1. This data reflects a 22.7% increase in sales for the current quarter over the same quarter of the previous fiscal year.

Figure 1. Chilled Water Sales Comparison

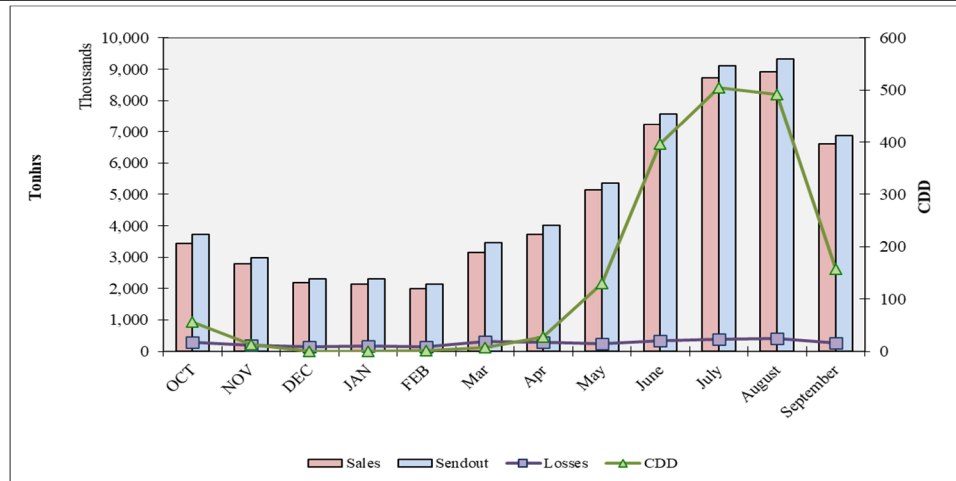
Figure 2 shows the chilled water sales, sendout and losses for the previous twelve months. The losses on this figure are defined as the difference in tonhrs per month between the recorded sendout and sales values and represent the total energy loss for chilled water in the EDS. The number of cooling degree days per month are also tracked for comparison.

Figure 2. Chilled Water Sales, Sendout, Losses and CDD for the Previous Twelve Months

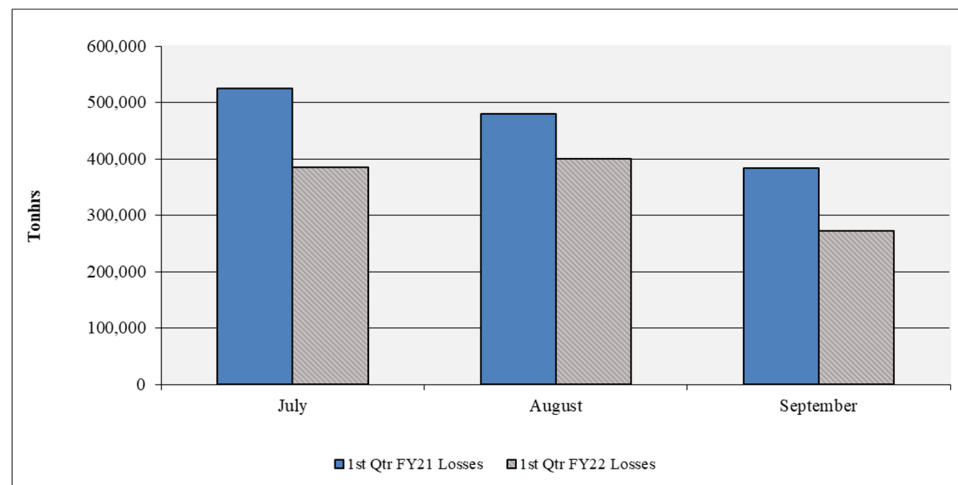
A comparison of the total, chilled water energy losses in the EDS for the First Quarter is shown in Figure 3. These losses are the difference in chilled water sendout and sales.

Figure 3. Chilled Water System Loss Comparison

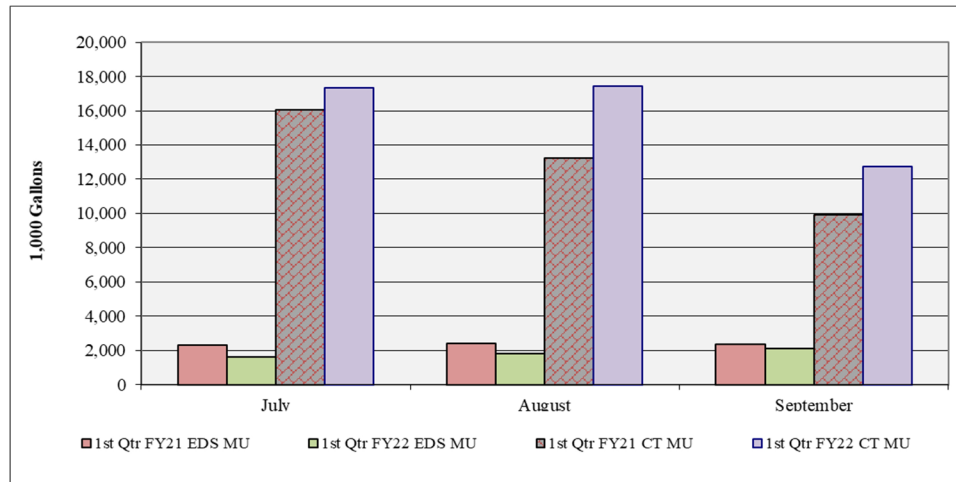
The make-up to the cooling towers increased 21.1% over the previous First Quarter. The water usage in the cooling towers is typically proportional to the consumption of chilled water and should vary with chilled water sales. The number of cycles of concentration in the condensing water circuit decreased 21.3%. The total chiller plant water use increased 14.6% over the First Quarter FY21. The overall city water make-up comparison for the chilled water system First Quarter is shown in Figure 4.

Figure 4. Chilled Water System City Water Usage Comparison

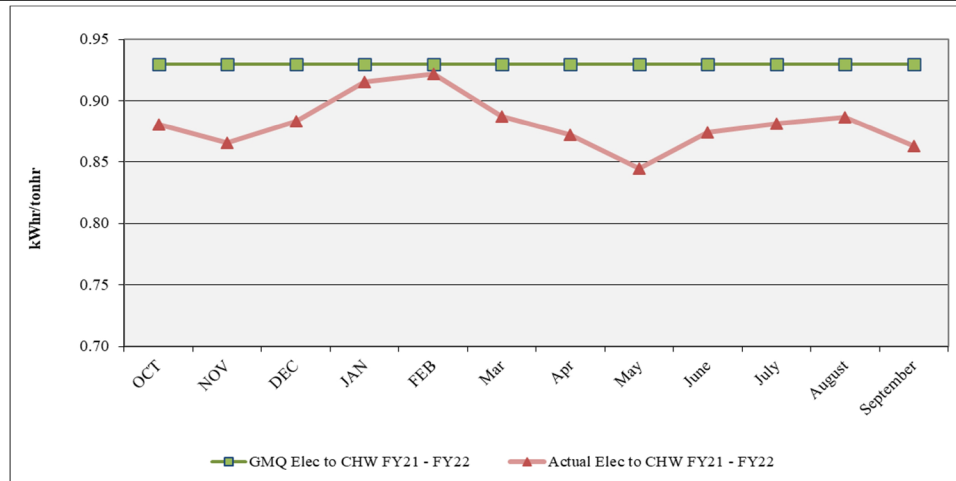
The performance of the chilled water aspect of the EGF is presented by the following two charts, Figures 5 and 6, for the previous twelve months. The System Performance Guarantee levels as described in Amendment 2 of the ARMA were not consistently achieved for the chilled water-water conversion for FY22. CNE has met the chilled water-electric guarantee each month of the fiscal year.

Figure 5. Chiller Plant Electric Performance Guarantee Comparison for the Previous Twelve Months

The chilled water allocation of the electric consumption falls under the GMQ limit of 0.93 kWhr per tonhr for the current quarter, and no excursion is reported for the current fiscal year. The electric usage per unit of sales decreased 4.1% over the previous First Quarter. These values reflect an improved chiller plant electric efficiency.

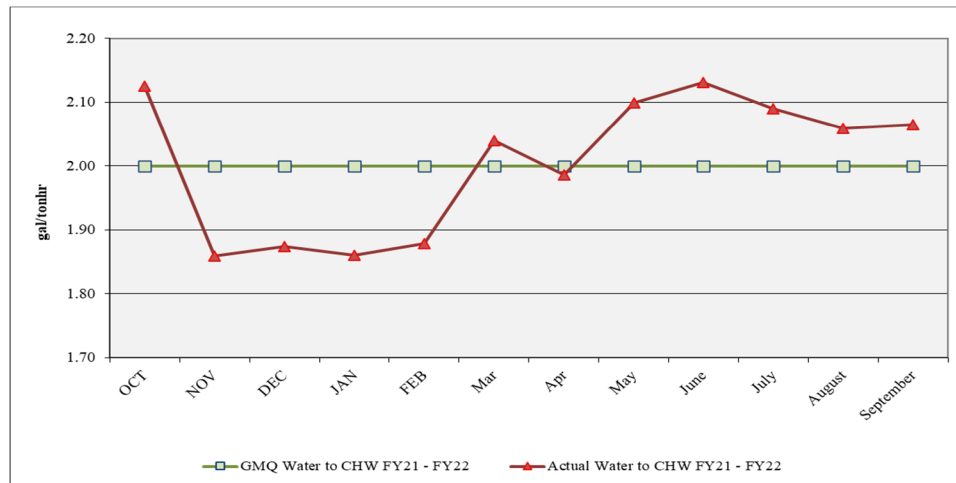
Figure 6. Chiller Plant Water Consumption Performance Guarantee Comparison for the Previous Twelve Months

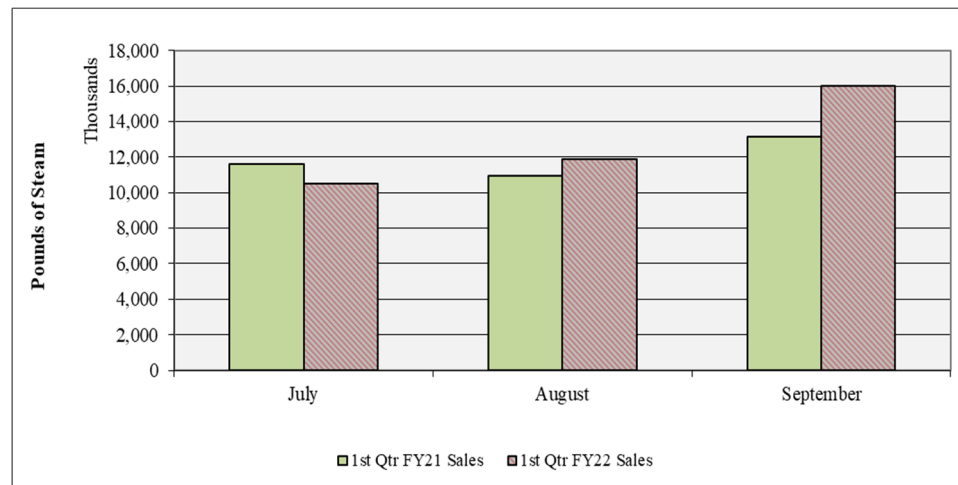
The steam sendout increased by approximately 4.8% over the previous First Quarter (FY21), and the sales also increased by approximately 7.5%. The Quarter experienced a 40.0% increase in the number of heating degree days. The steam system losses decreased marginally, and the relative amount of condensate return increased 61.0%. A comparison for the First Quarter steam sales is shown in Figure 7.

Figure 7. Steam Sales Comparison

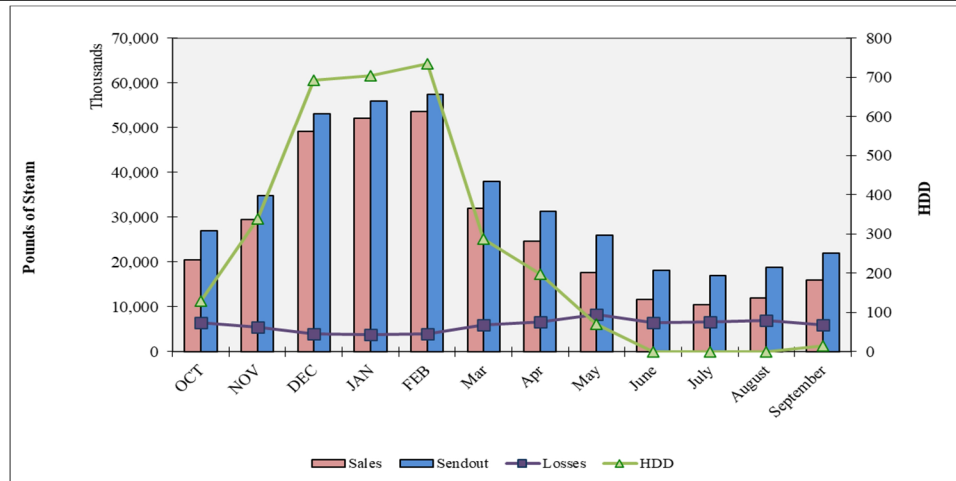
Figure 8 shows the steam sales, sendout and losses for the previous twelve months. The losses on this figure are defined as the difference in pounds per month between the recorded sendout and sales values and represent the total mass loss in the EDS between the EGF and the customer meters.

Figure 8. Steam Sales, Sendout, Losses and HDD for the Previous Twelve Months

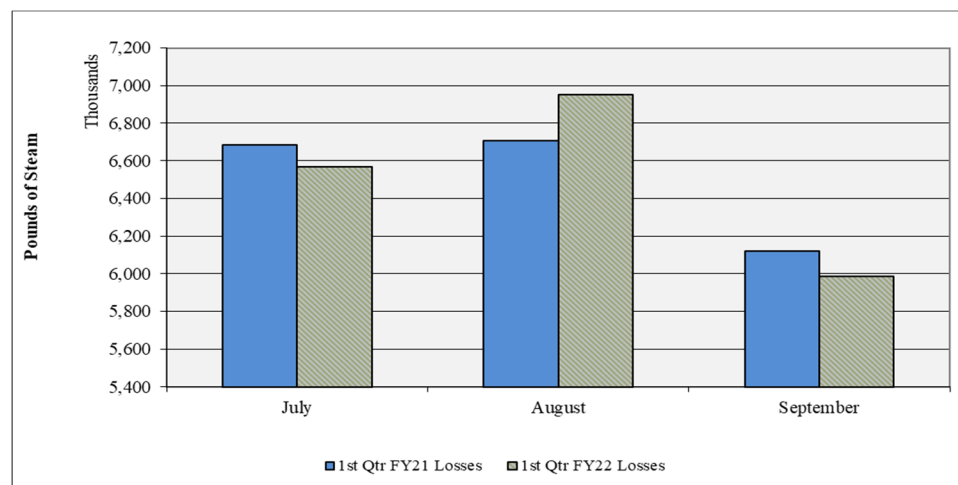
A comparison of the total steam mass losses in the EDS for the First Quarter is shown in Figure 9. The mass loss is caused by the heat loss in the EDS between the EGF and the customer meters, resulting in a mass loss at steam traps. Faulty traps, steam leaks or meter error could also be a contributing cause of these losses. Whenever steam sales decrease from the previous quarter, the percent of system losses can be expected to increase since most of these losses are based on a near constant heat loss of the system.

Figure 9. Steam System Losses

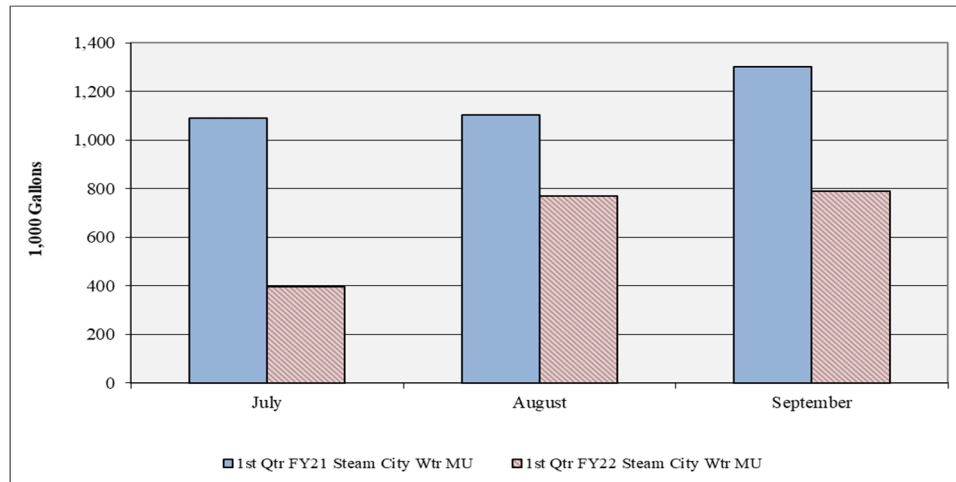
The amount of city water make-up (MU) to the steam system consists of the loss in mass between the EGF and the customers, in the condensate return from the customers to the EGF and losses at the EGF. The corresponding data for steam system make-up is shown in the comparison of First Quarter data in Figure 10.

Figure 10. Steam System City Water Make-up Comparison

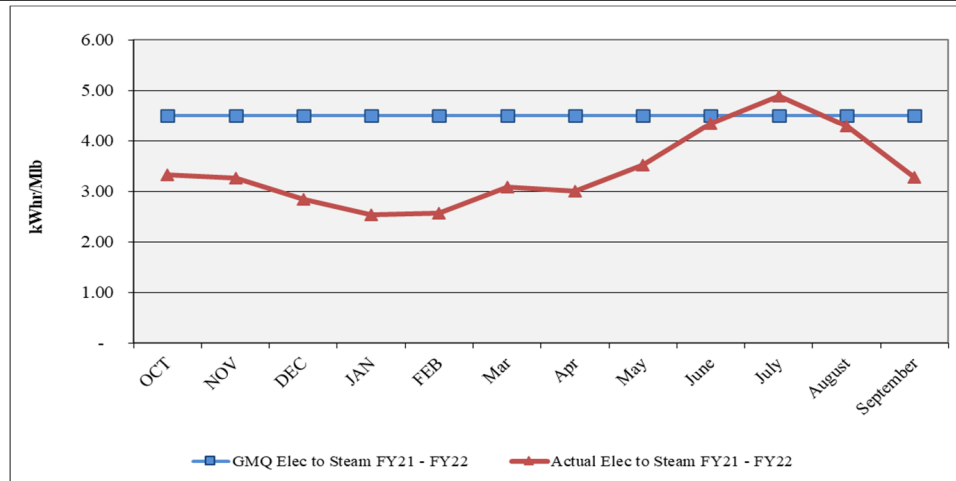
Figure 11. Steam Plant Electric Performance Guarantee for the Previous Twelve Months

The performance of the steam system of the EGF is presented by the following three charts, Figures 11, 12 and 13. The steam fuel conversion factor exceeded the guaranteed values for the month of September. The steam electric conversion factor was exceeded in July but was not exceeded in subsequent months. TEG monitors CNE performance regularly and will continue to report any non-compliance in the EGF's operation. The steam water conversion factor exceeded the guaranteed values in August and September. CNE believes these excursions may be due to a faulty meter which has been replaced.

The steam plant electric consumption for the current quarter was approximately the same as in FY21; however, the steam-to-electric conversion factor decreased 4.7% over the same period. The monthly steam-to-electric conversion factors, along with the guaranteed values, are shown in Figure 11.

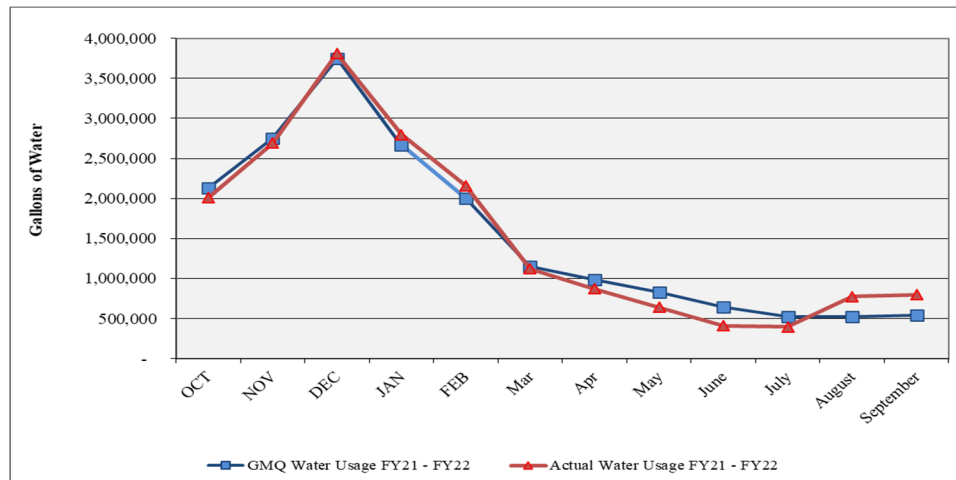
Figure 12. Steam Plant Water Performance Guarantee for the Previous Twelve Months

The water consumption for the steam plant decreased 44.2% this quarter as compared to the previous First Quarter due to a significant amount of condensate returned during the quarter. Figure 12 shows the comparison between the actual and guaranteed steam-to-water usages for each month. The excursions above the guaranteed values in August and September are believed to be caused by a faulty meter.

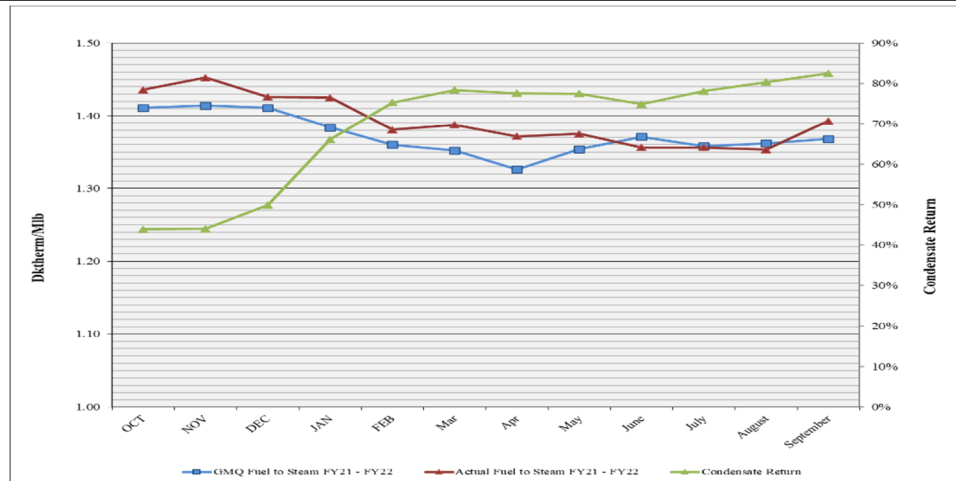
Figure 13. Steam Plant Fuel Performance Guarantee for the Previous Twelve Months

The fuel consumption per unit of steam sales decreased 1.1% over the previous First Quarter. As shown in Figure 13, the performance guarantee was met in July and August. The relative amount of condensate return is shown on this graph to reflect the influence that the increase in condensate return has on the plant efficiency.
