Operations Monitoring Report

First Quarter FY23

**Thermal Engineering Group, Inc.
105 Hazel Path Court, Ste 2
Hendersonville, TN 37075**

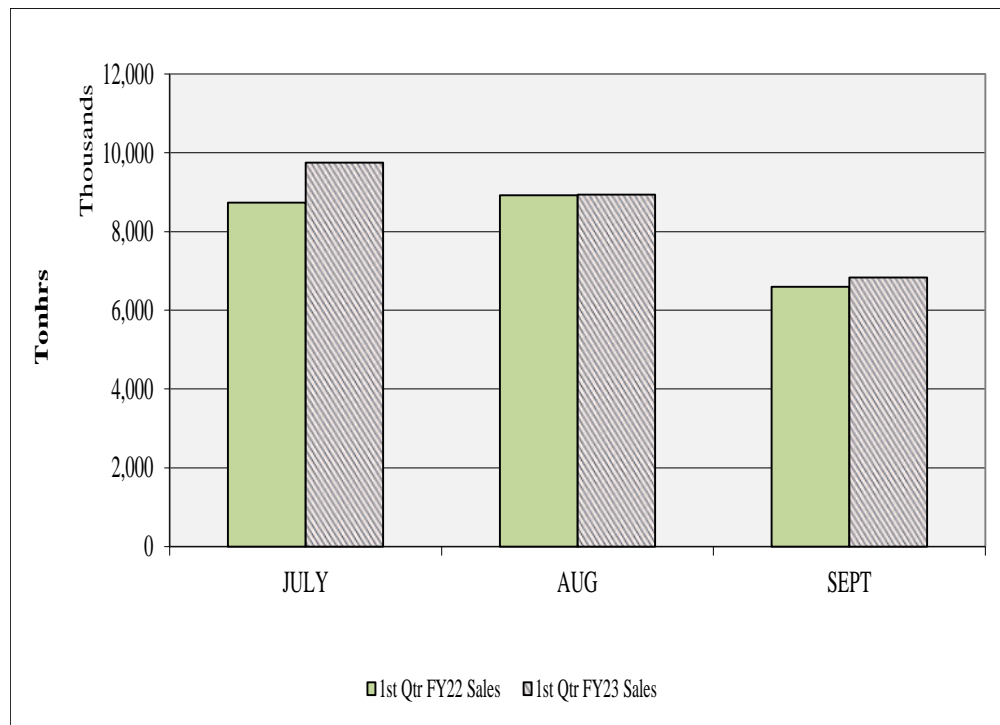
A comparison for the First Quarter chilled water sales is shown in Figure 1. This data reflects a 5.2% increase in sales for the current quarter over the same quarter of the previous fiscal year.

Figure 1. Chilled Water Sales Comparison

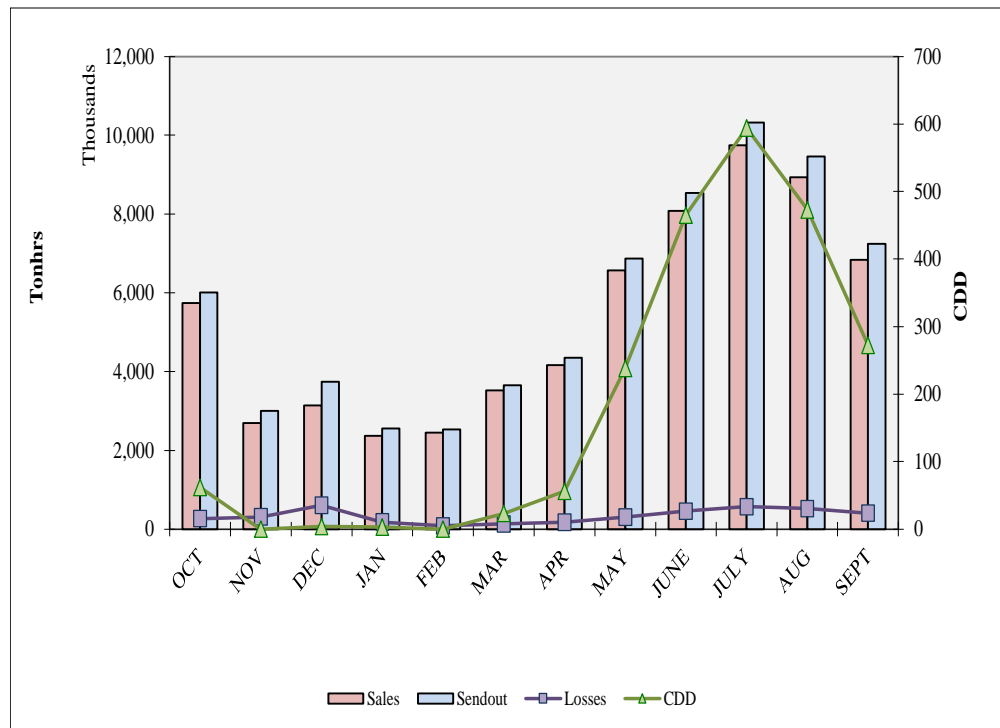
Figure 2 shows the chilled water sales, sendout and losses for the previous twelve months. The losses on this figure are defined as the difference in tonhrs per month between the recorded sendout and sales values and represent the total energy loss for chilled water in the EDS. The number of cooling degree days per month are also tracked for comparison.

Figure 2. Chilled Water Sales, Sendout, Losses and CDD for the Previous Twelve Months

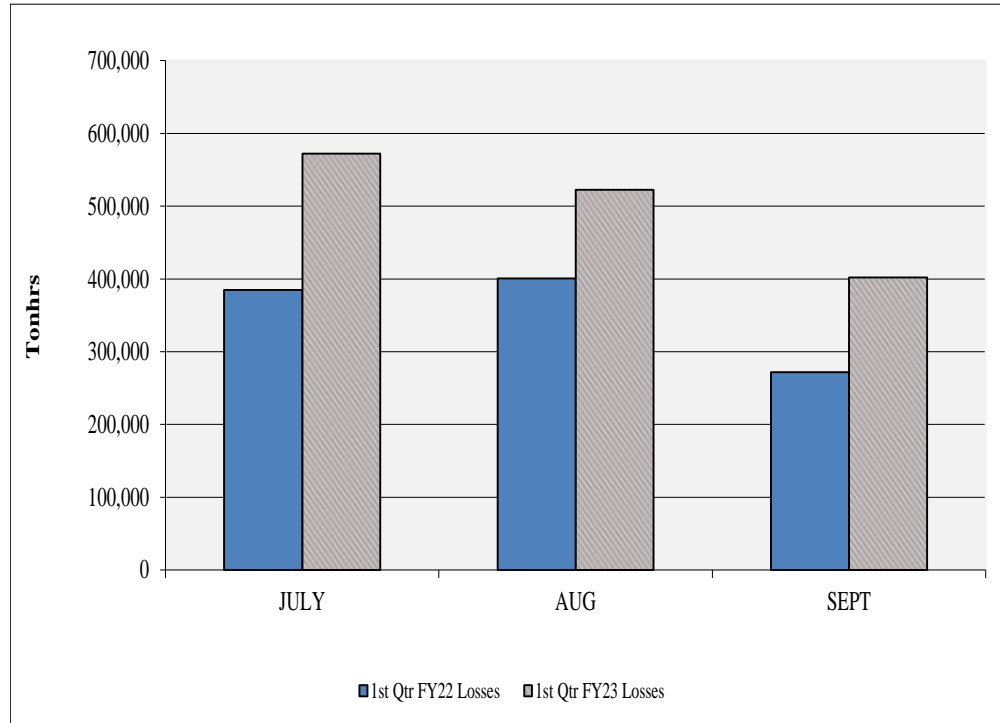
A comparison of the total chilled water energy losses in the EDS for the First Quarter is shown in Figure 3. These losses are the difference in chilled water sendout and sales.

Figure 3. Chilled Water System Loss Comparison

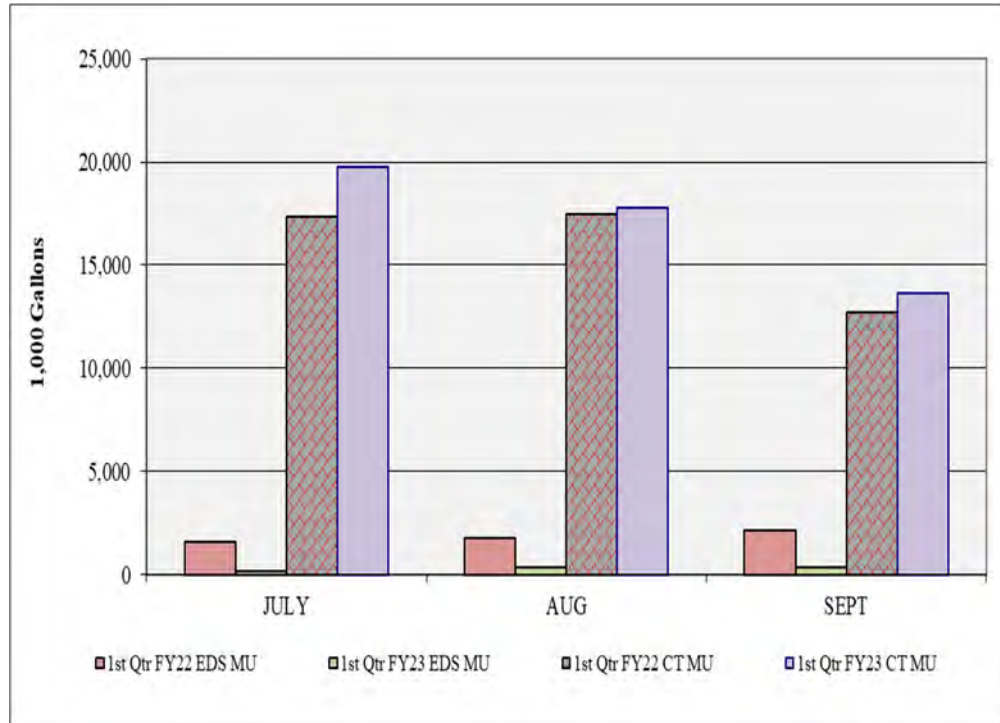
The make-up to the cooling towers increased 7.6% over the previous First Quarter. The water usage in the cooling towers is typically proportional to the consumption of chilled water and should vary with chilled water sales. The number of cycles of concentration in the condensing water circuit increased 5.5%. The total chiller plant water use decreased 2.0% over the First Quarter FY22. The overall city water make-up comparison for the chilled water system First Quarter is shown in Figure 4.

Figure 4. Chilled Water System City Water Usage Comparison

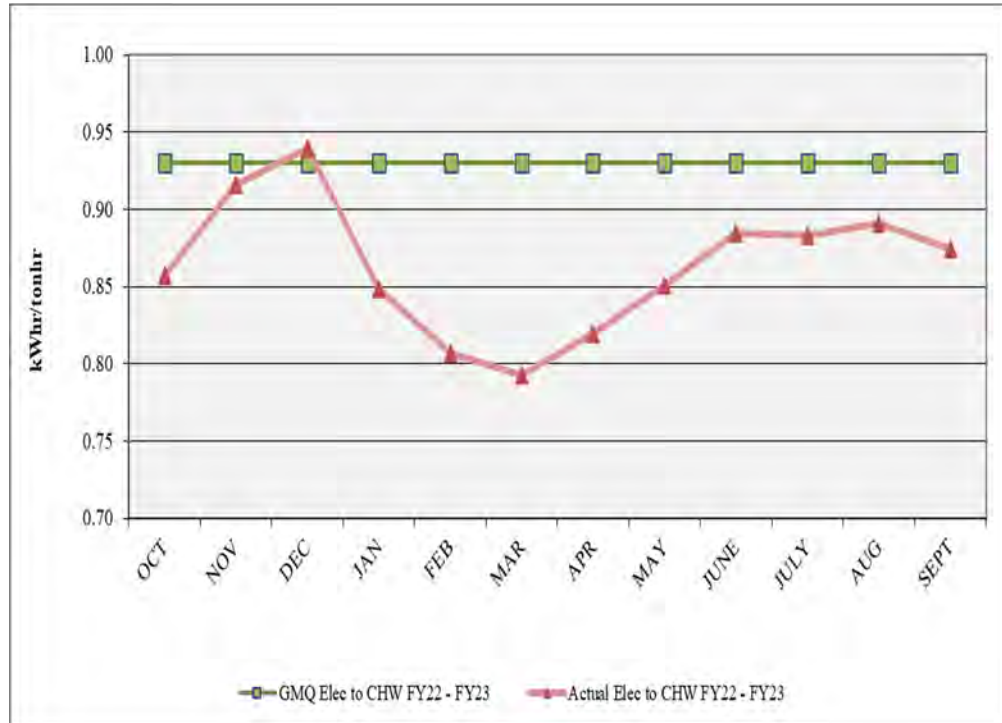
The performance of the chilled water aspect of the EGF is presented by the following two charts, Figures 5 and 6, for the previous twelve months. The System Performance Guarantee levels as described in Amendment 2 of the ARMA were not consistently achieved for the chilled water-water conversion for FY23. CES has met the chilled water-electric guarantee for each month during the First Quarter.

Figure 5. Chiller Plant Electric Performance Guarantee Comparison for the Previous Twelve Months

The chilled water allocation of the electric consumption falls under the GMQ limit of 0.93 kWhr per tonhr for the current quarter on average with only no excursions reported for the current fiscal year. The electric usage per unit of sales increased 0.5% over the previous First Quarter.

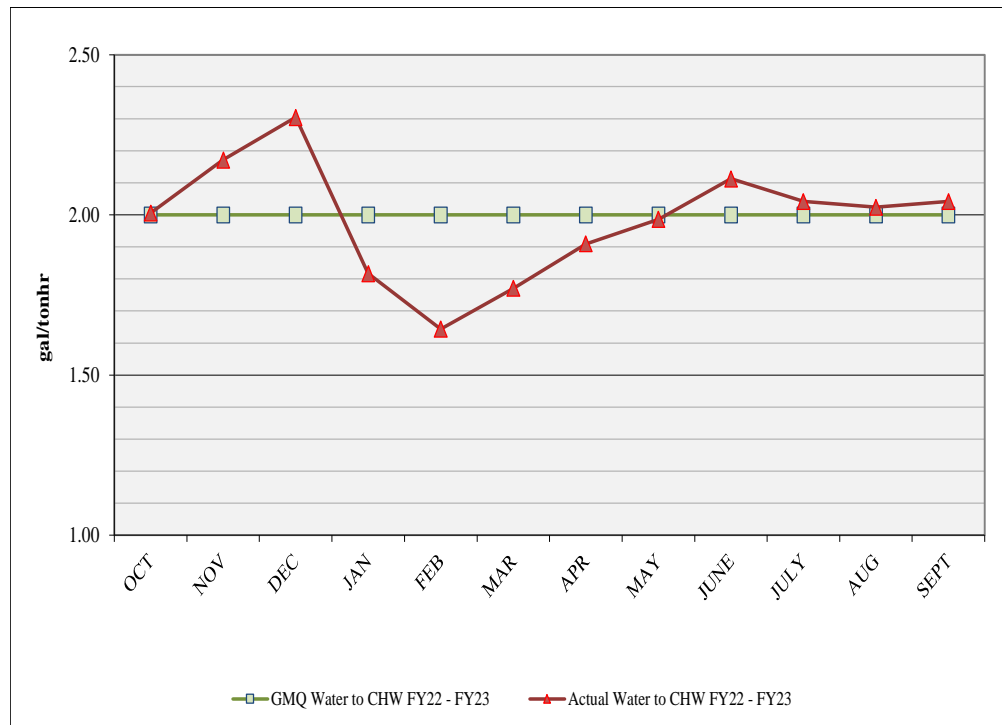
Figure 6. Chiller Plant Water Consumption Performance Guarantee Comparison for the Previous Twelve Months

The total consumption of city water for the chiller plant for the current quarter has decreased by approximately 2.0% over the previous First Quarter due largely to the repair of the chilled water leak in the EDS. The water conversion factor for the chiller plant decreased by approximately 1.7% (on average) over the First Quarter FY22. The cooling tower blowdown increased 2.9% over the previous First Quarter.

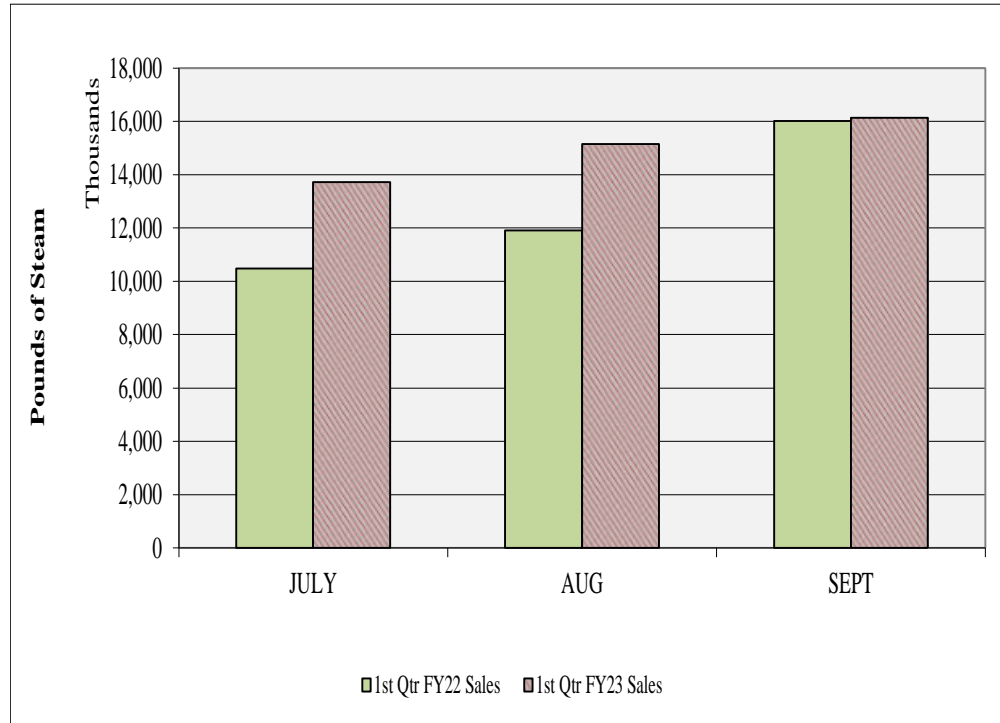
The steam sendout increased by approximately 3.7% over the previous First Quarter (FY22), and the sales increased by approximately 17.2%. The Quarter experienced a 14.3% decrease in the number of heating degree days. The steam system losses decreased 22.9%, and the relative amount of condensate return decreased 9.9% during the quarter due dumping part of the condensate due to hardness and iron at some of the customer buildings. A comparison for the First Quarter steam sales is shown in Figure 7.

Figure 7. Steam Sales Comparison

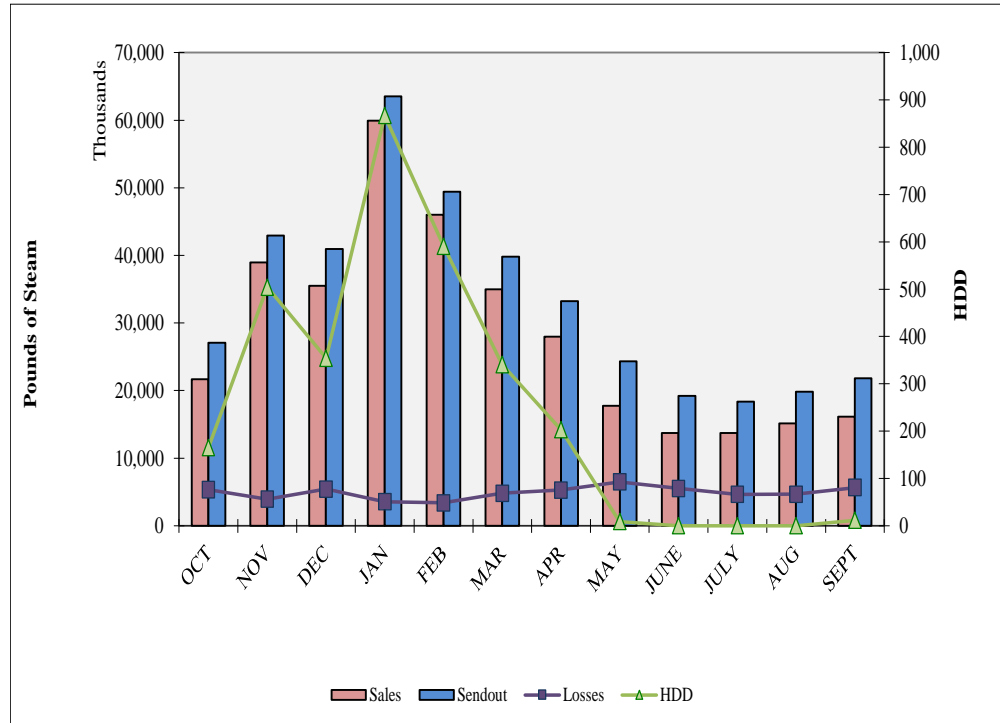
Figure 8 shows the steam sales, sendout and losses for the previous twelve months. The losses on this figure are defined as the difference in pounds per month between the recorded sendout and sales values and represent the total mass loss in the EDS between the EGF and the customer meters.

Figure 8. Steam Sales, Sendout, Losses and HDD for the Previous Twelve Months

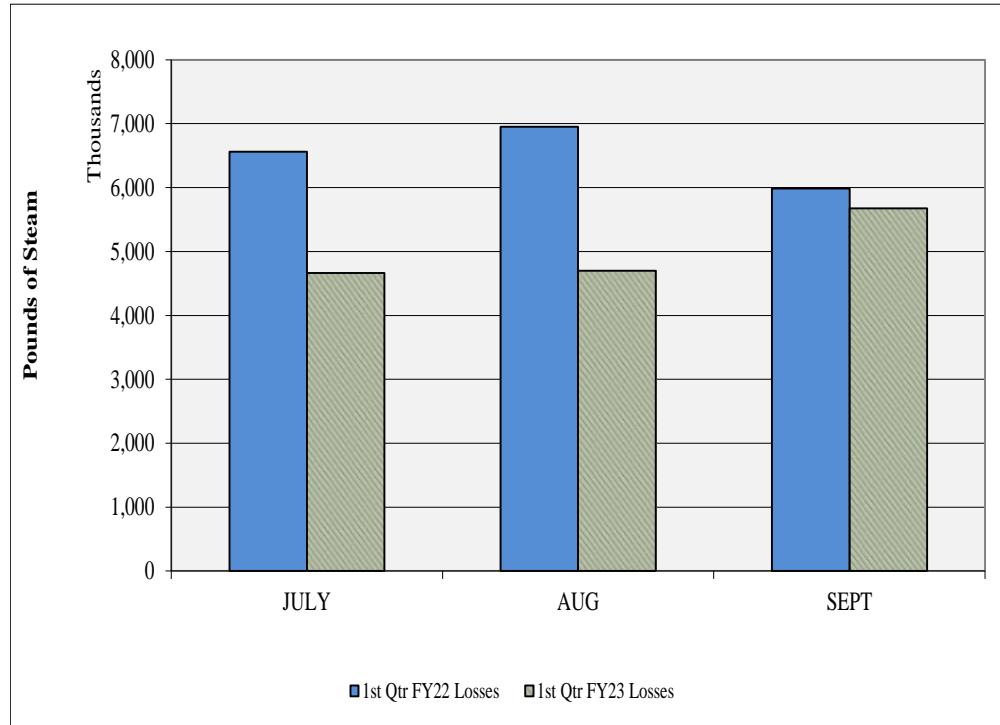
A comparison of the total steam mass losses in the EDS for the First Quarter is shown in Figure 9. The mass loss is caused by the heat loss in the EDS between the EGF and the customer meters, resulting in a mass loss at steam traps. Faulty traps, steam leaks or meter error could also be a contributing cause of these losses. Whenever steam sales decrease from the previous quarter, the percent of system losses can be expected to increase since most of these losses are based on a near constant heat loss of the system.

Figure 9. Steam System Losses

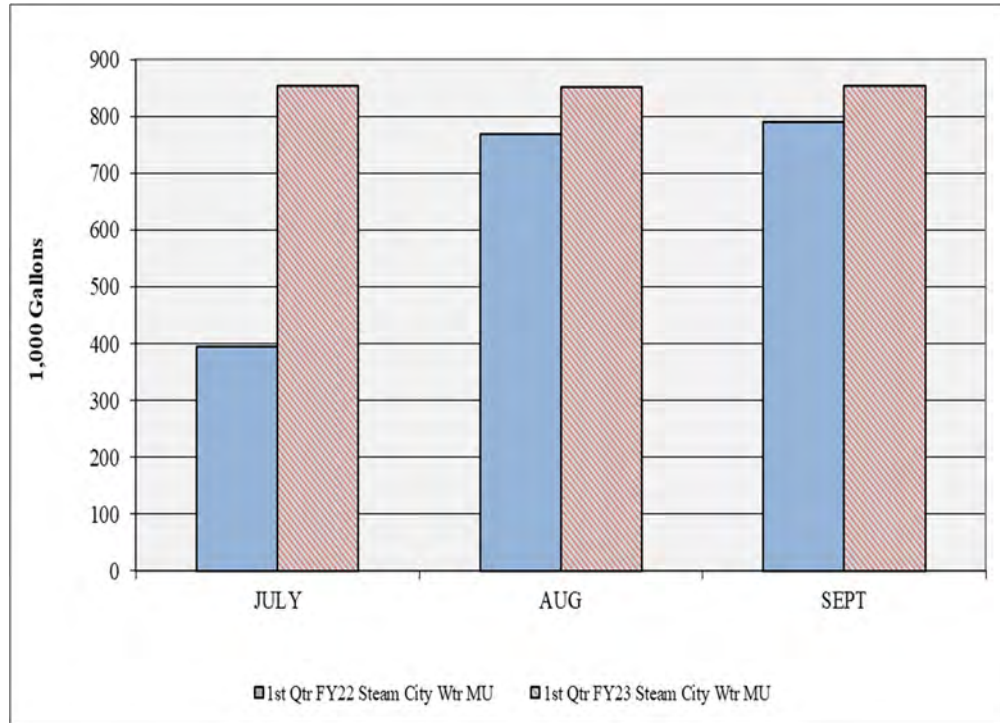
The amount of city water make-up (MU) to the steam system consists of the loss in mass between the EGF and the customers, in the condensate return from the customers to the EGF and losses at the EGF. The corresponding data for steam system make-up is shown in the comparison of First Quarter data in Figure 10.

Figure 10. Steam System City Water Make-up Comparison

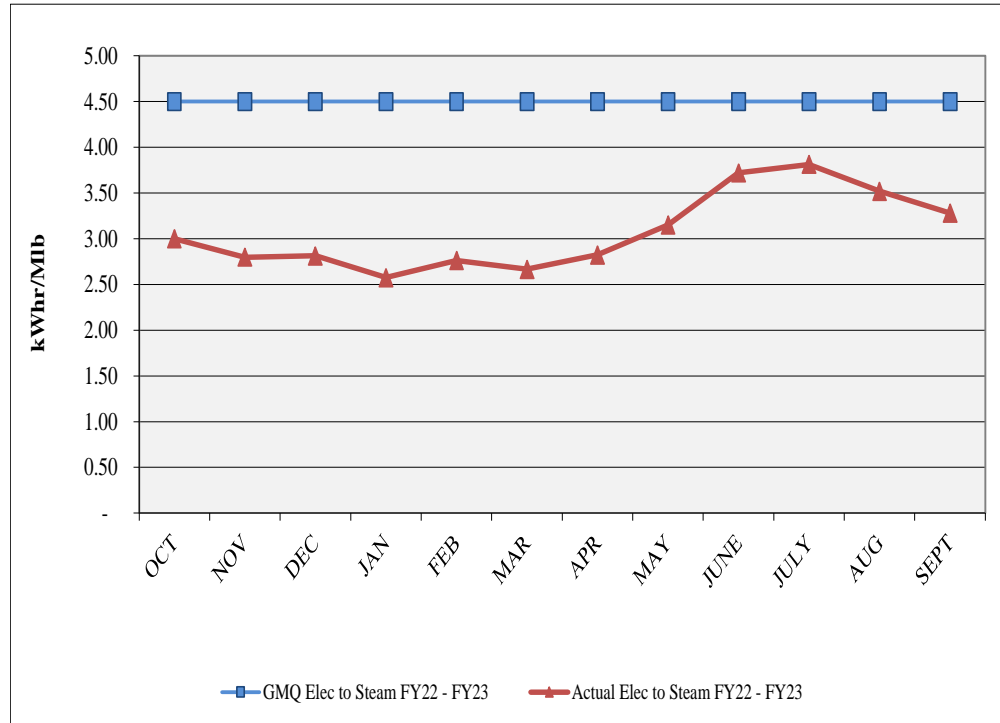
Figure 11. Steam Plant Electric Performance Guarantee for the Previous Twelve Months

The performance of the steam system of the EGF is presented by the following three charts, Figures 11, 12 and 13. The steam fuel conversion factor exceeded the guaranteed values for August and September 2022; however, the differences between the actual and guaranteed values were small. The steam electric conversion factor was met each month of the quarter. The steam water conversion factor exceeded the guaranteed values for each month in the quarter. TEG monitors CES’s performance regularly and will continue to report any non-compliance in the EGF’s operation.

The steam plant electric consumption for the current quarter was 2.4% higher in FY23 than in FY22. The steam-to-electric conversion factor decreased 14.8% over the same period. The monthly steam-to-electric conversion factors, along with the guaranteed values, are shown in Figure 11.

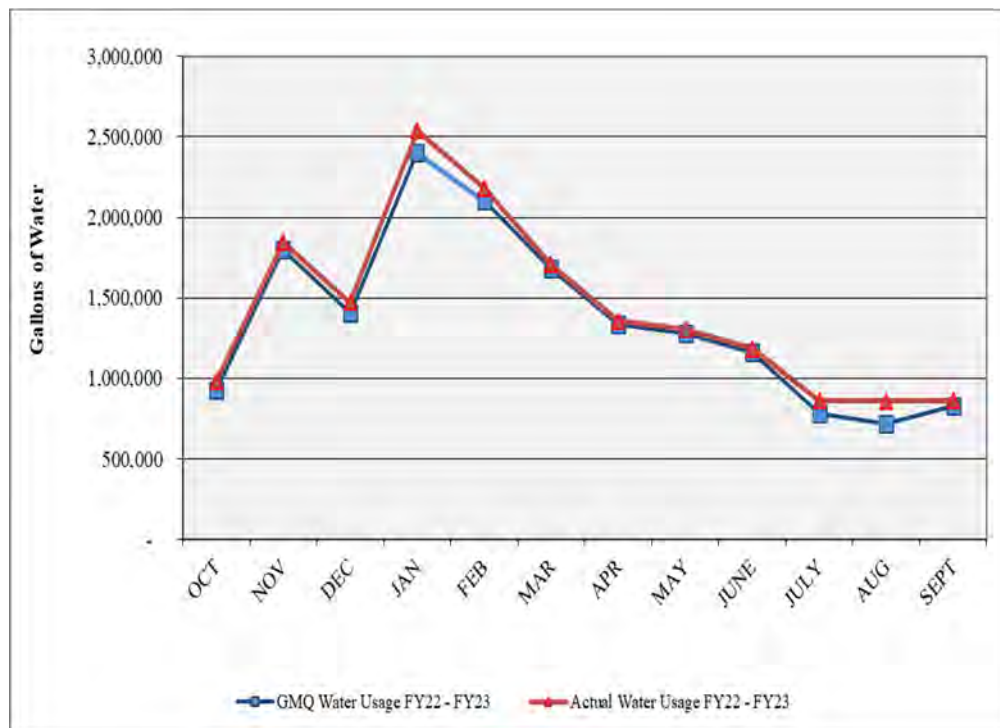
Figure 12. Steam Plant Water Performance Guarantee for the Previous Twelve Months

The water consumption for the steam plant increased 31.0% this quarter as compared to the previous First Quarter due to a decrease in the amount of condensate returned during the quarter. Figure 12 shows the comparison between the actual and guaranteed steam-to-water usages for each month.

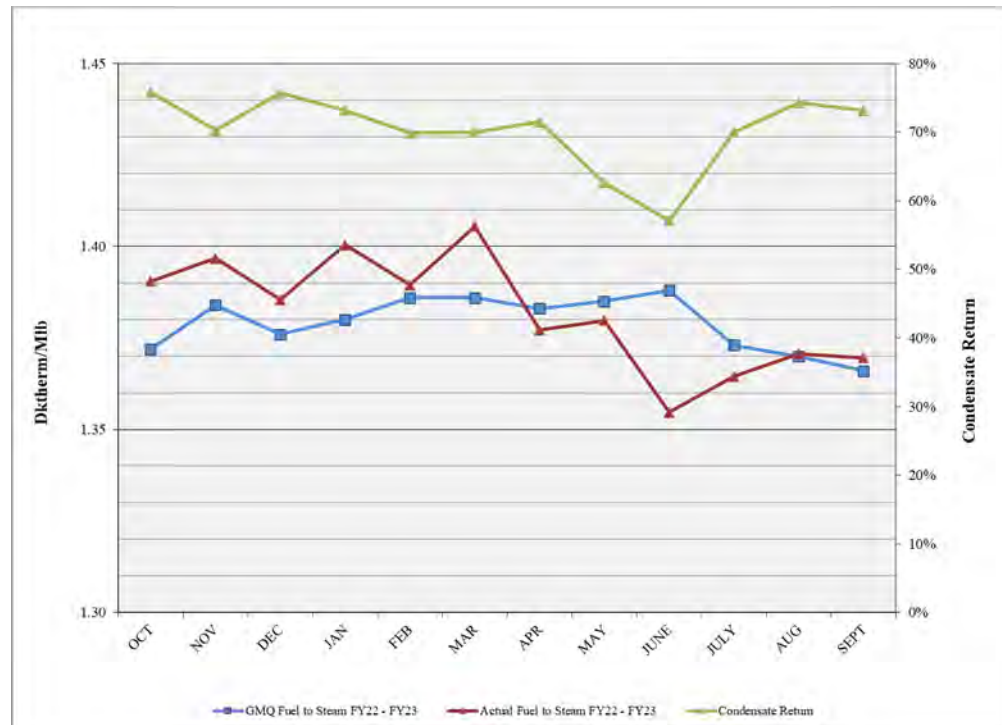
Figure 13. Steam Plant Fuel Performance Guarantee for the Previous Twelve Months

The fuel consumption per unit of steam sendout remained approximately the same as in the previous First Quarter. As shown in Figure 13, the performance guarantee was met in July but not in August or September. The relative amount of condensate return is shown on this graph to reflect the influence that the condensate return has on the plant efficiency.
