Operations Monitoring Report

Third Quarter FY23

**Thermal Engineering Group, Inc.
105 Hazel Path Court, Ste 2
Hendersonville, TN 37075**

I. Executive Summary

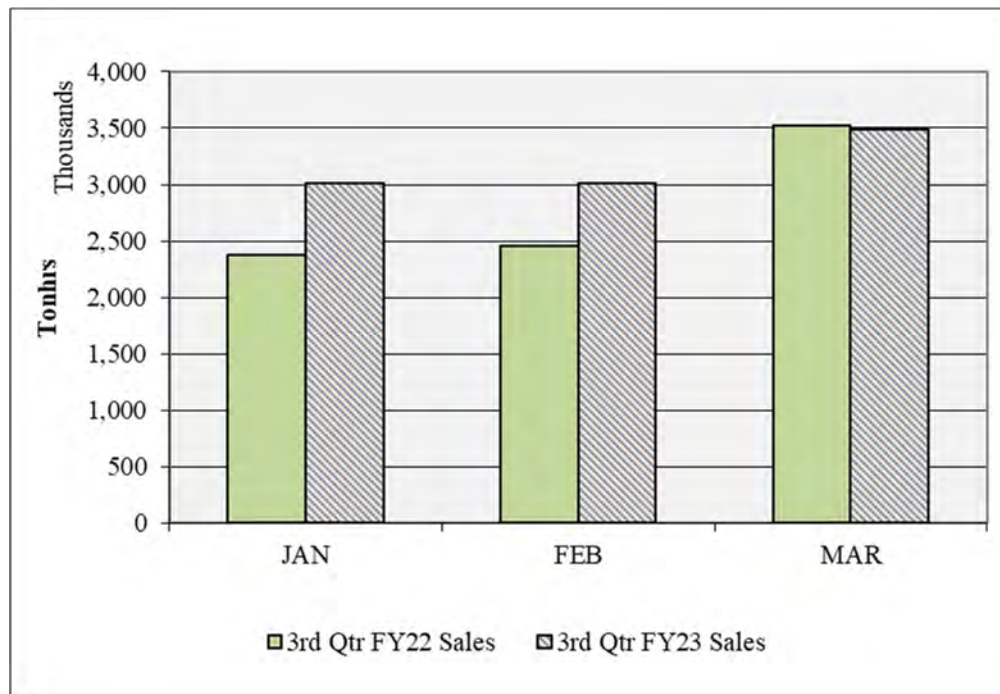
A comparison for the Third Quarter chilled water sales is shown in Figure 1. This data reflects a 14.1% increase in sales for the current quarter over the same quarter of the previous fiscal year.

Figure 1. Chilled Water Sales Comparison

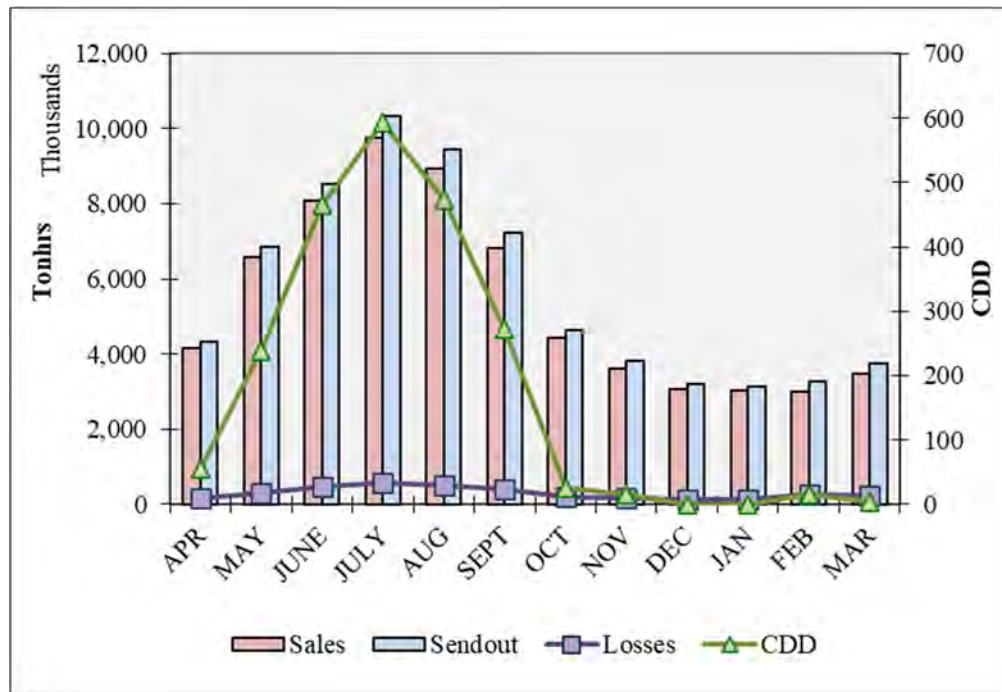
Figure 2 shows the chilled water sales, sendout and losses for the previous twelve months. The losses on this figure are defined as the difference in tonhrs per month between the recorded sendout and sales values and represent the total energy loss for chilled water in the EDS. The number of cooling degree days per month are also tracked for comparison.

Figure 2. Chilled Water Sales, Sendout, Losses and CDD for the Previous Twelve Months

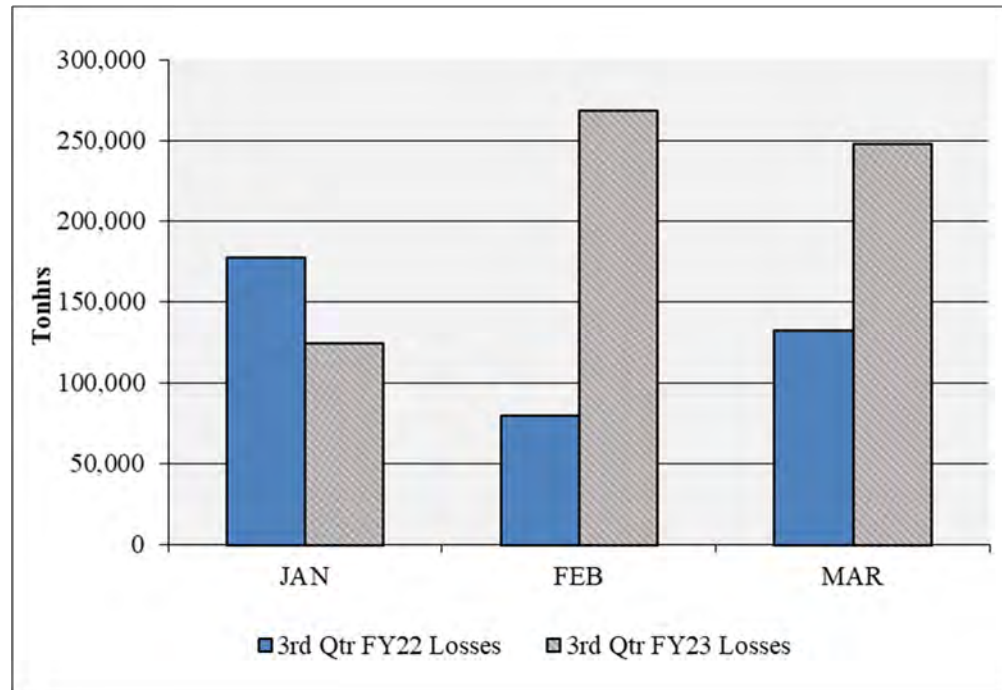
A comparison of the total chilled water energy losses in the EDS for the Third Quarter is shown in Figure 3. These losses are the difference in chilled water sendout and sales.

Figure 3. Chilled Water System Loss Comparison

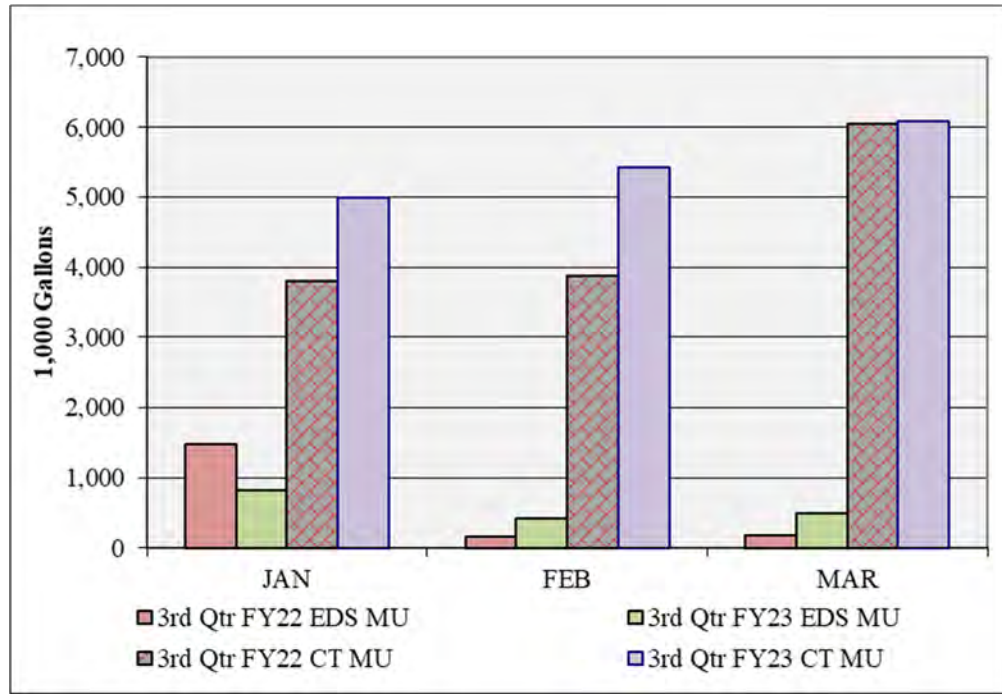
Figure 4. Chilled Water System City Water Usage Comparison

The make-up to the cooling towers increased 20.4% over the previous Third Quarter. The water usage in the cooling towers is typically proportional to the production of chilled water and should vary with chilled water sales, thus the increase in cooling tower make-up would be expected with the increase in sales over the previous Third Quarter. The total chiller plant water use increased 17.6% over the Third Quarter FY22. The overall city water make-up comparison for the chilled water system Third Quarter is shown in Figure 4.

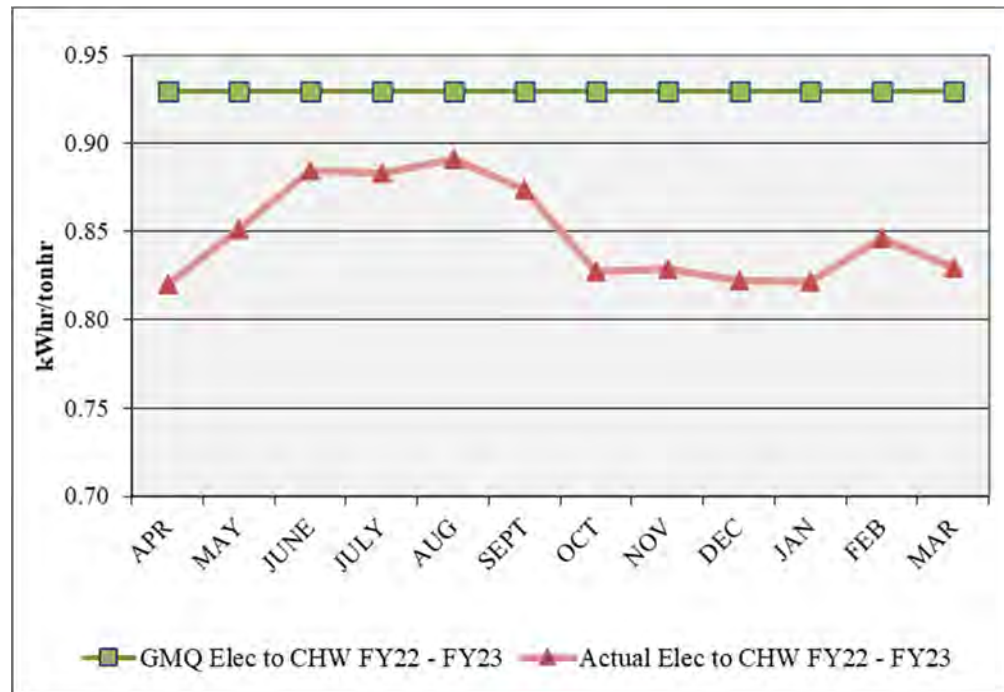
The performance of the chilled water portion of the EGF is presented in the following two charts, Figures 5 and 6, for the previous twelve months. The System Performance Guarantee levels as described in Amendment 2 of the ARMA were consistently achieved for the chilled water system for each month of the Third Quarter. The chilled water electric metric has also been met for the previous twelve months. The efforts made by CES, and the repair of the chilled water leaks have resulted in an improvement of these metrics.

Figure 5. Chiller Plant Electric Performance Guarantee Comparison for the Previous Twelve Months

The chilled water allocation of the electric consumption falls under the GMQ limit of 0.93 kWhr per tonhr for the current quarter on average with no excursions reported for the current fiscal year. The electric usage per unit of sales increased 2.4% over the previous Third Quarter. CES and TEG continue to monitor the improvements created by CES’s operational changes.

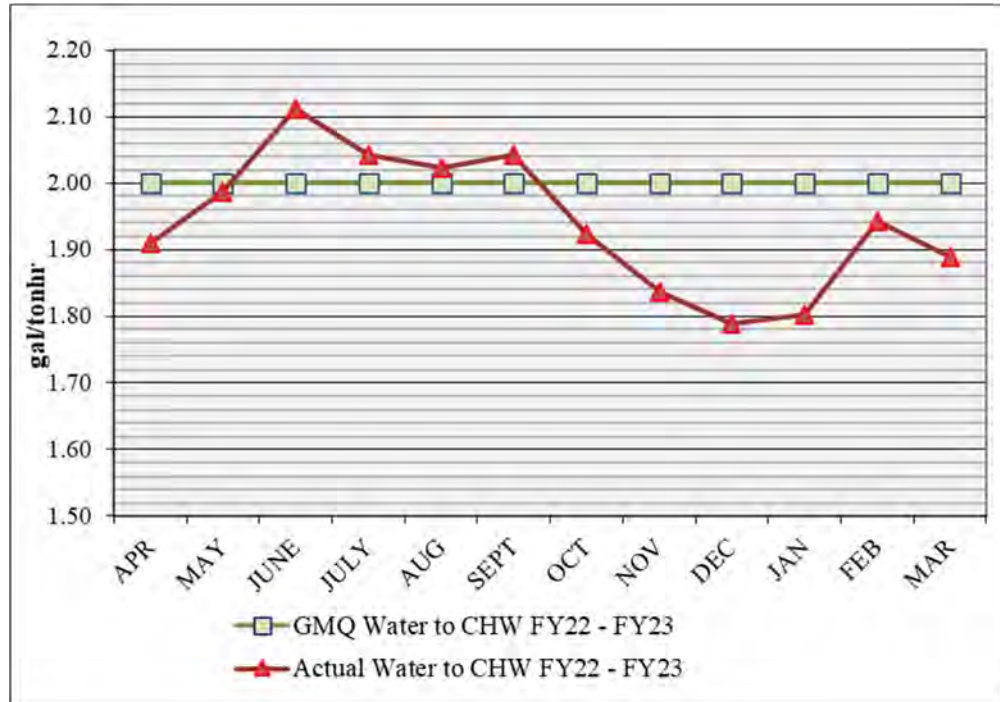
Figure 6. Chiller Plant Water Consumption Performance Guarantee Comparison for the Previous Twelve Months

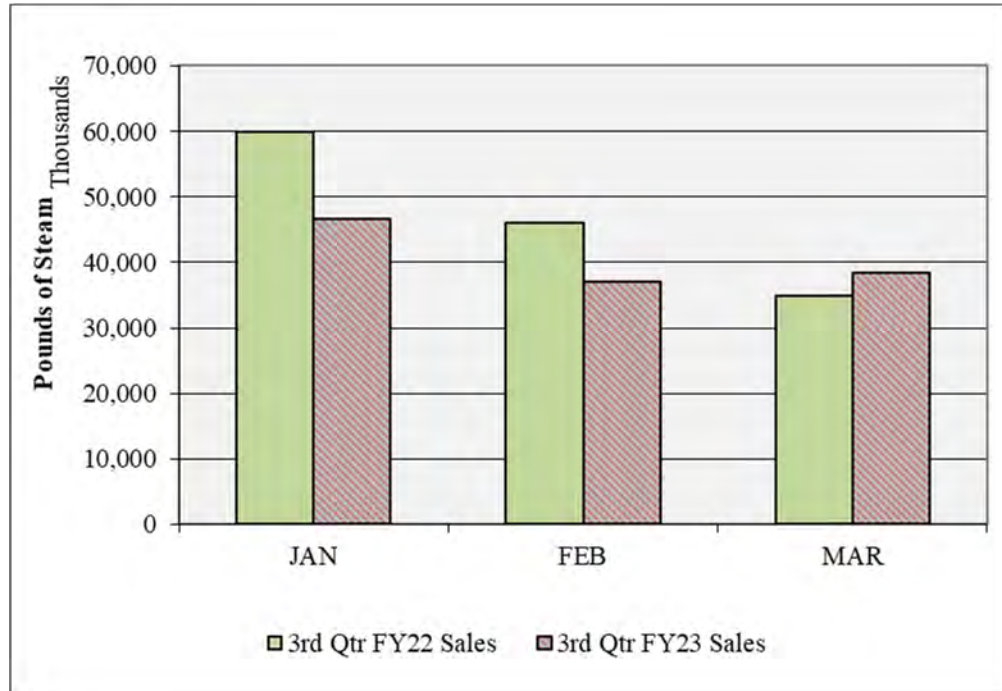
The steam sendout decreased by approximately 13.0% over the previous Third Quarter (FY22), and the sales increased by approximately 13.5%. The Quarter experienced a 26.1% decrease in the number of heating degree days. The steam system losses decreased 7.1%, and the relative amount of condensate return decreased 3.4% during the quarter due to the dumping of a portion of the condensate return from some customer buildings due to hardness and iron. A comparison for the Third Quarter steam sales is shown in Figure 7.

Figure 7. Steam Sales Comparison

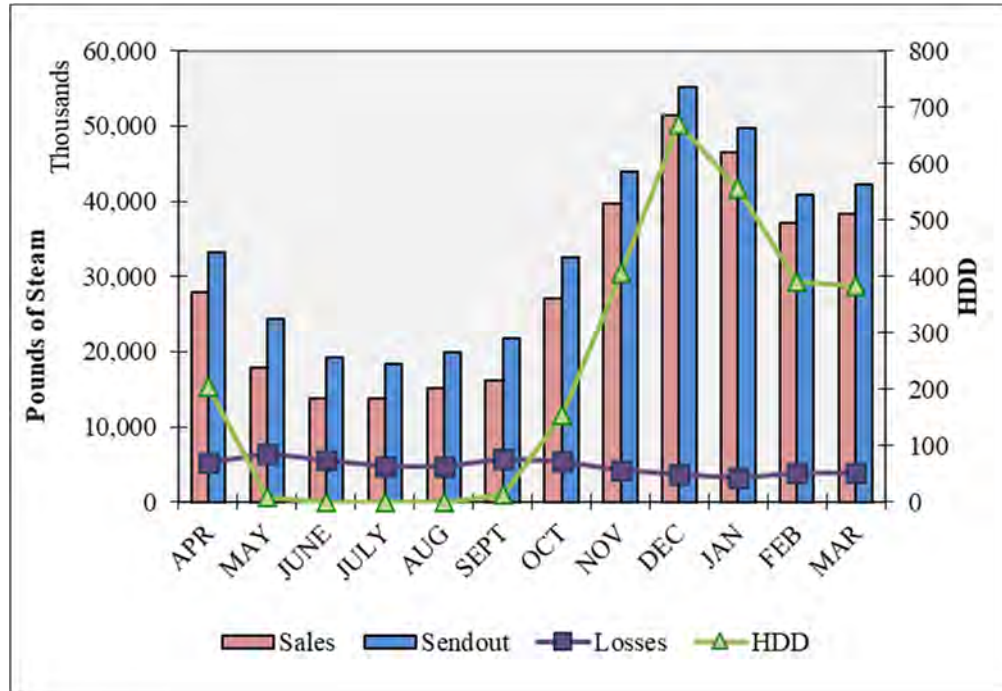
The peak steam demand for the current quarter was 135,150 pph, which reflects a 9.8% decrease in the peak steam production over the previous Third Quarter. Figure 8 shows the steam sales, sendout and losses for the previous twelve months. The losses on this figure are defined as the difference in pounds per month between the recorded sendout and sales values and represent the total mass loss in the EDS between the EGF and the customer meters.

Figure 8. Steam Sales, Sendout, Losses and HDD for the Previous Twelve Months

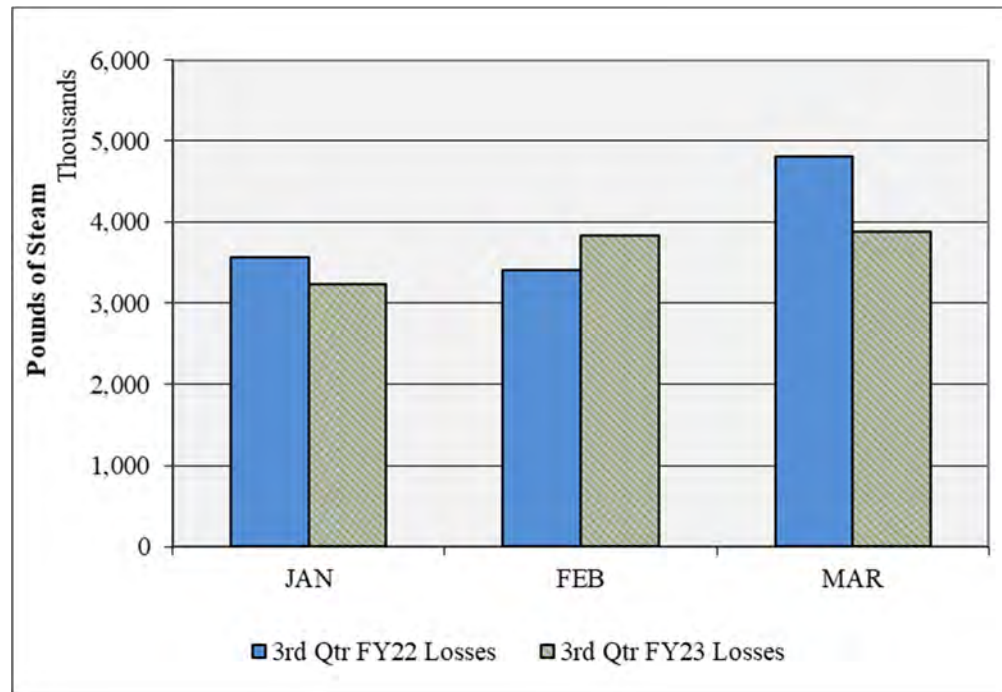
A comparison of the total steam mass losses in the EDS for the Third Quarter is shown in Figure 9. The mass loss is caused by the heat loss in the EDS between the EGF and the customer meters, resulting in a mass loss at steam traps. Faulty traps, steam leaks or meter error could also be a contributing cause of these losses. Whenever steam sales decrease from the previous quarter, the percentage of system losses can be expected to increase since most of these losses are based on a near constant heat loss of the system.

Figure 9. Steam System Losses

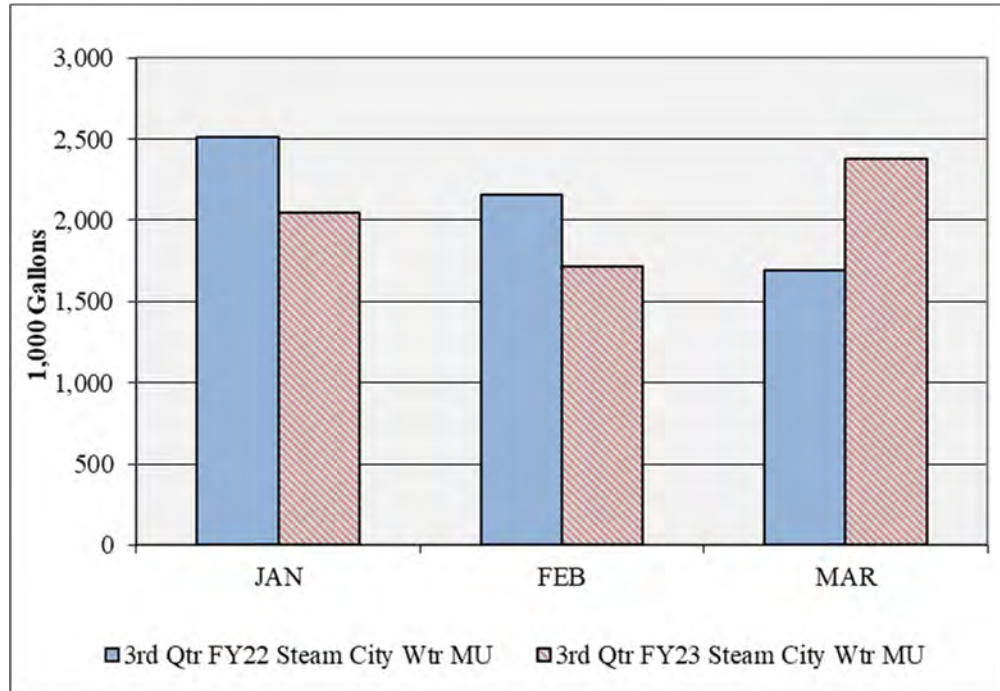
The amount of city water make-up (MU) to the steam system consists of the loss in mass between the EGF and the customers, in the condensate return from the customers to the EGF and losses at the EGF. The corresponding data for steam system make-up is shown in the comparison of Third Quarter data in Figure 10.

Figure 10. Steam System City Water Make-up Comparison

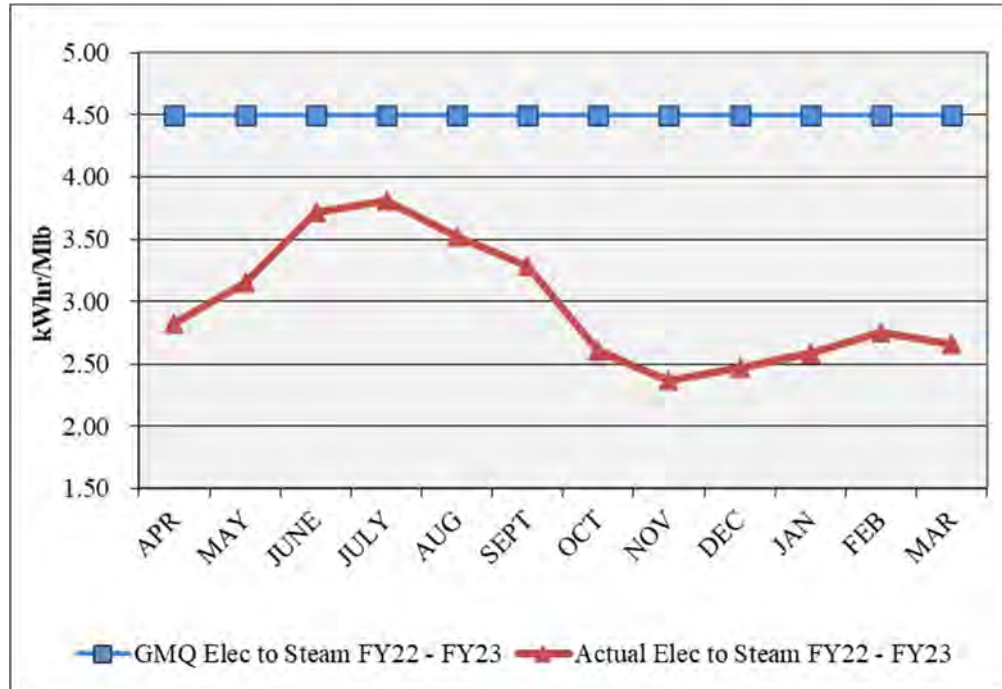
The steam plant electric consumption for the current quarter was 13.6% lower in FY23 than in FY22. The steam-electric metric decreased marginally over the same period due in part to the increased amount of sales and sendout. The monthly steam-to-electric conversion factors, along with the guaranteed values, are shown in Figure 11.

Figure 11. Steam Plant Electric Performance Guarantee for the Previous Twelve Months

The performance of the steam system of the EGF is presented in the following three charts, Figures 11, 12 and 13. The steam fuel conversion factor exceeded the guaranteed values in January 2023; however, the differences between the actual and guaranteed values were relatively small. The steam electric conversion factor was met each month of the quarter and for the previous twelve months. The steam water conversion factor exceeded the guaranteed values for each month in the quarter. TEG monitors CES’s performance regularly and will continue to report any non-compliance in the EGF’s operation.

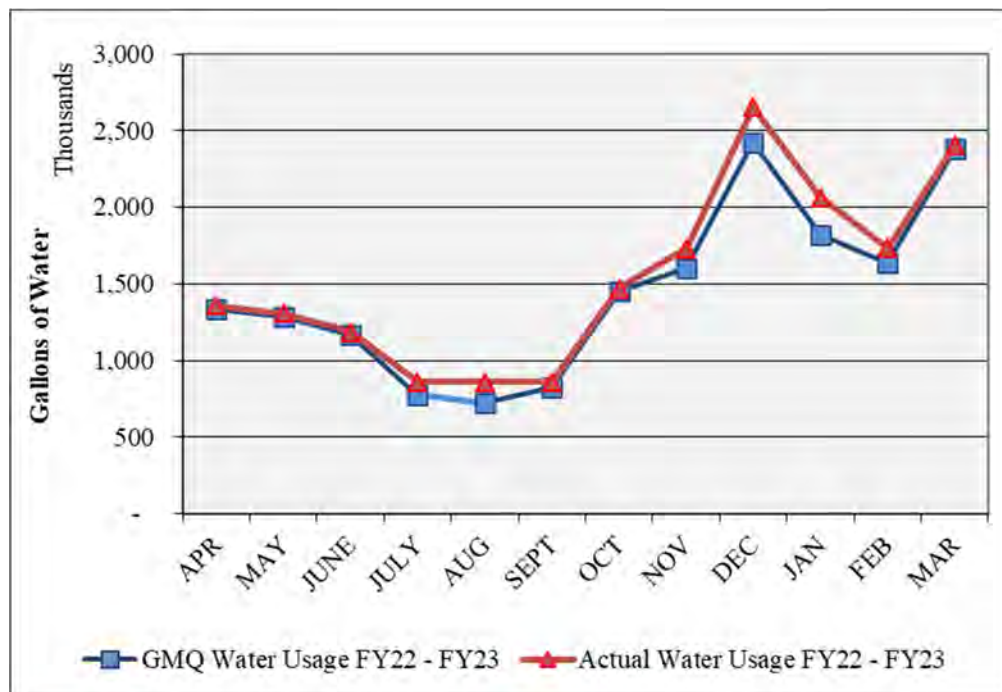
Figure 12. Steam Plant Water Performance Guarantee for the Previous Twelve Months

The water consumption for the steam plant decreased 3.5% this quarter as compared to the previous Third Quarter. Figure 12 shows the comparison between the actual and guaranteed steam-to-water usages for each month.

CES and TEG continue to monitor the performance of the EGF as CES makes efforts to improve the DES performance. However, the steam-water metric is consistently close to the guaranteed value, varying less than 7% (on average) from guarantee on average for the quarter. The guaranteed steam-water performance value is based on an equation which incorporates the amount of steam sendout and condensate return and did not change with the adoption of the new performance values in Amendment 2. CES has verified the accuracy of the meter readings and continues to review the operation.

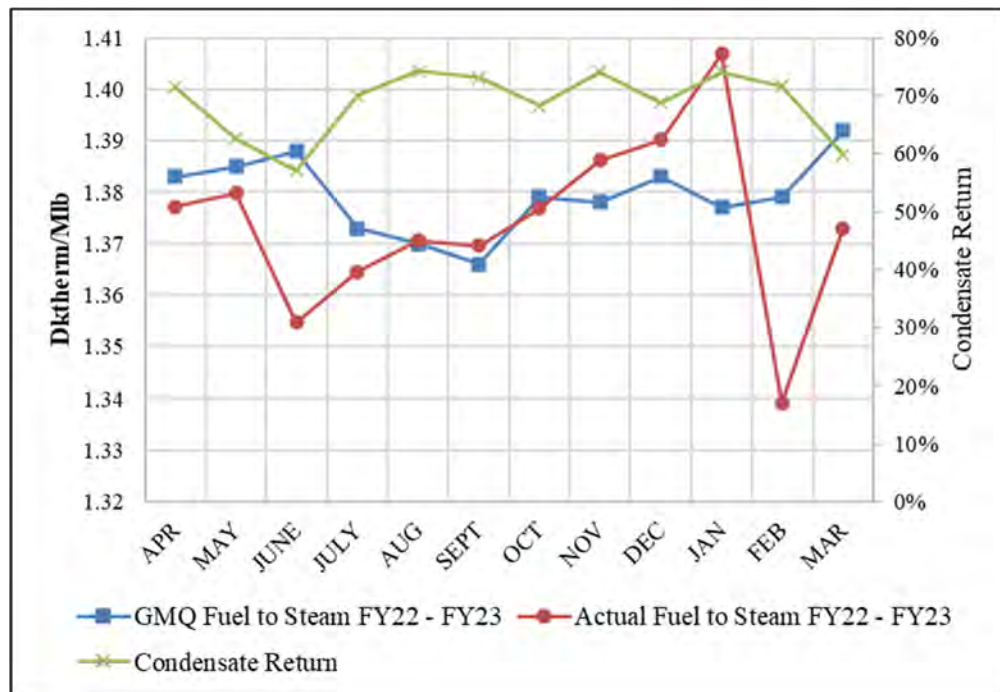
The fuel consumption per unit of steam sendout decreased 1.8% over the previous Third Quarter. As shown in Figure 13, the performance guarantee was met in February and March. The relative amount of condensate return is shown on this graph to reflect the influence that the condensate return has on the plant efficiency. Although the performance level for this metric changed with the adoption of Amendment 2, the equation used to calculate the value relies heavily on readings from the condensate return and steam sendout meters.

Figure 13. Steam Plant Fuel Performance Guarantee for the Previous Twelve Months
