Operations Monitoring Report

First Quarter FY24

**Thermal Engineering Group, Inc.
105 Hazel Path Court, Ste 2
Hendersonville, TN 37075**

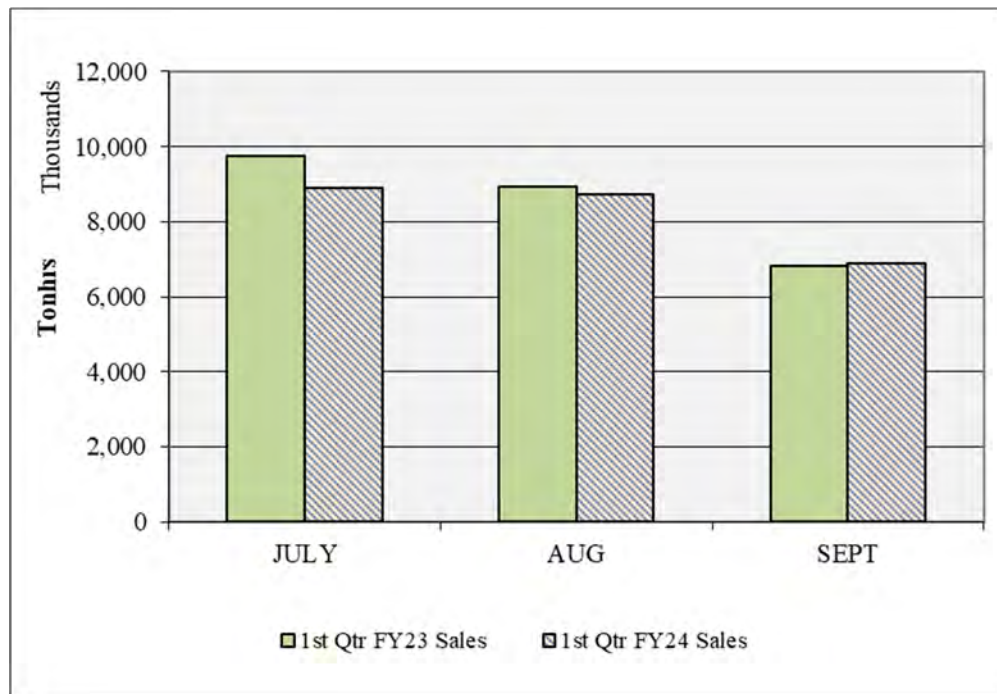
Figure 1. Chilled Water Sales Comparison

A comparison for the First Quarter chilled water sales is shown in Figure 1. This data reflects a 3.8% decrease in sales for the current quarter over the same quarter of the previous fiscal year.

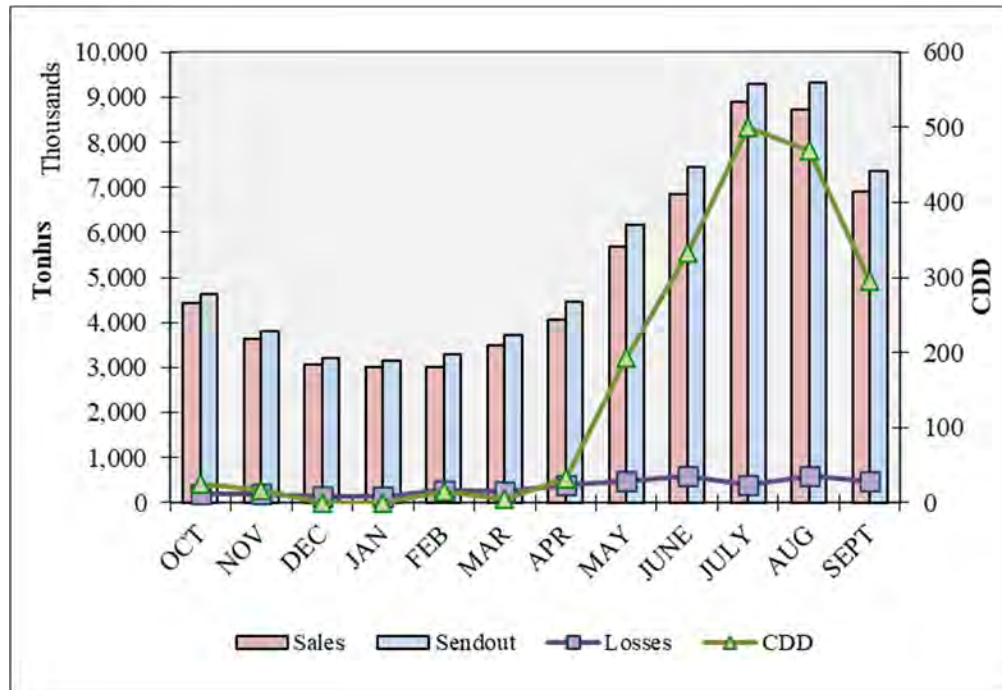
Figure 2. Chilled Water Sales, Sendout, Losses and CDD for the Previous Twelve Months

Figure 2 shows the chilled water sales, sendout and losses for the previous twelve months. The losses on this figure are defined as the difference in tonhrs per month between the recorded sendout and sales values and represent the total energy loss for chilled water in the EDS. The number of cooling degree days were 5.6% lower in FY24 than in FY23 and are tracked for comparison.

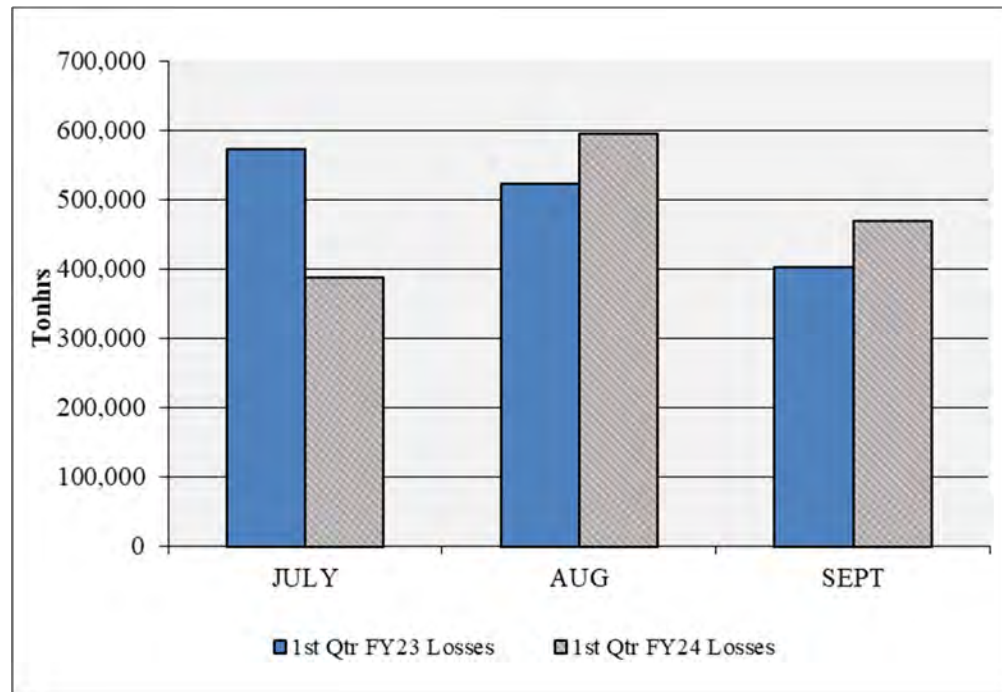
Figure 3. Chilled Water System Loss Comparison

A significant increase in the chilled water energy losses previously noted for the Fourth Quarter FY23 was determined to be related to an issue with the chilled water meter at the Bridgestone Arena. This issue was resolved prior to the First Quarter. A comparison of the total chilled water energy losses in the EDS for the First Quarter is shown in Figure 3. These losses are the difference in chilled water sendout and sales and may reflect differences in the meter accuracy between the EGF sendout meter and the customer meters.

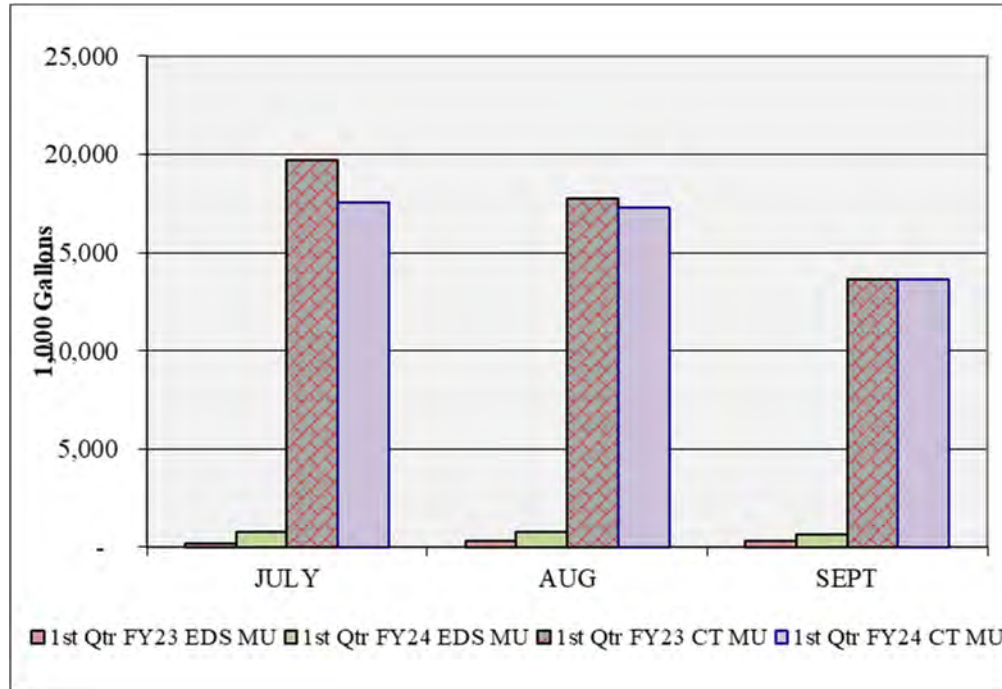
Figure 4. Chilled Water System City Water Usage Comparison

The make-up to the cooling towers decreased 5.1% over the previous First Quarter. The water usage in the cooling towers is typically proportional to the production of chilled water and should vary with chilled water sales, thus the decrease in cooling tower make-up would be expected with a decrease in sales. The total chiller plant water use decreased 2.5% over the First Quarter FY23. The overall city water make-up comparison for the chilled water system First Quarter is shown in Figure 4.

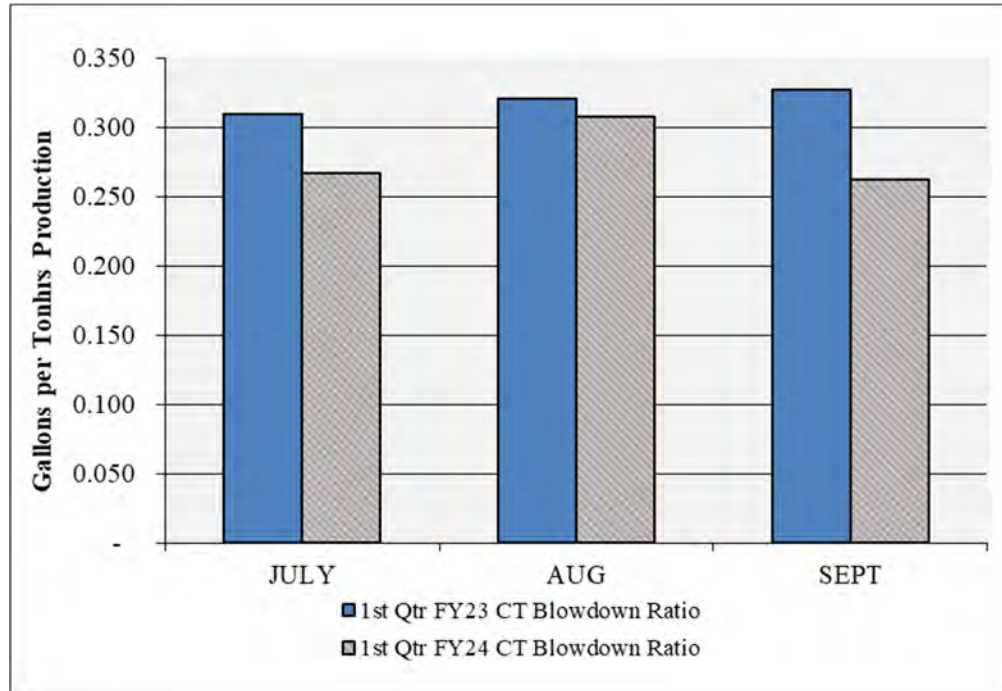
Figure 5. Cooling Tower Blowdown Ratio Comparison

Beginning in March 2023, CES and TEG began monitoring the cooling tower blowdown ratio in earnest. The relationship between the cooling tower blowdown and the chilled water production should be consistent and tracking this relationship may prove helpful in reducing the chiller plant water usage. CES has made operational changes with respect to this metric with the expectation of reducing the water usage and improving their performance relative to the chilled water-water guarantee. When a comparison is made between the First Quarter FY24 and FY23, the ratio decreased 12%. This metric will continue to be tracked and monitored to verify operational changes made by CES at the EGF have resulted in a decrease in chiller plant water usage. Figure 5 shows the comparison of this metric for the First Quarter.

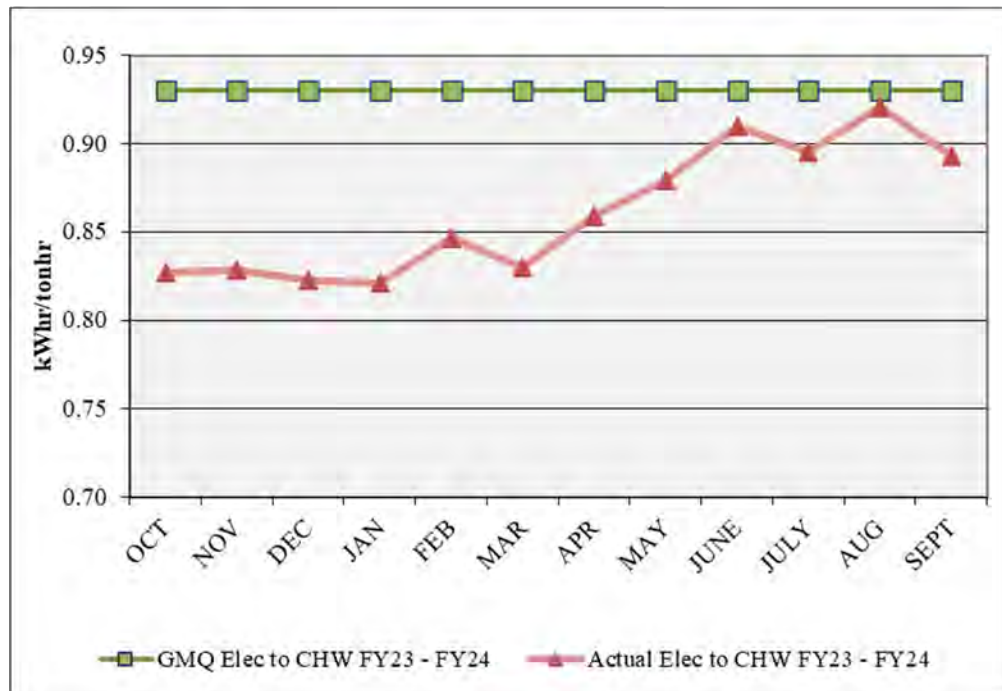
Figure 6. Chiller Plant Electric Performance Guarantee Comparison for the Previous Twelve Months

The performance of the chilled water portion of the EGF is presented in the following two charts, Figures 6 and 7, for the previous twelve months. The System Performance Guarantee levels as described in Amendment 2 of the ARMA were consistently achieved for the chilled water-electric for each month of the First Quarter. The chilled water-electric guarantee has also been met for the previous twelve months. The chilled water-water guarantee was not met during the quarter. The values represented below do not include the annual true-up adjustment which occurred in the First Quarter FY24.

The chilled water allocation of the electric consumption falls under the GMQ limit of 0.93 kWhr per tonhr for the current quarter on average with no excursions reported for the current fiscal year. The electric usage per unit of sales increased 2.2% over the previous First Quarter. The increase in the average value of the metric for this quarter may be attributable to the performance of the cooling towers and the warmer-than-usual September. CES and TEG continue to monitor the improvements created by CES’s operational changes.

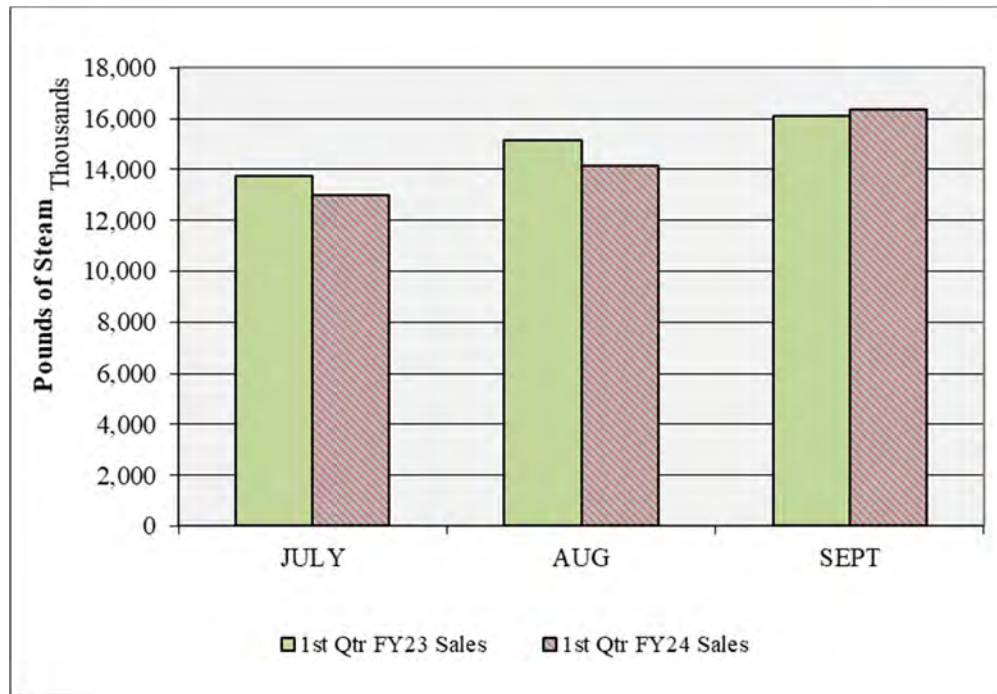
Figure 8. Steam Sales Comparison

buildings and in MH-18 for the work associated with DES198. The peak steam demand for the current quarter was 45,937 pph, which reflects a 23.9% decrease in the peak steam production over the previous First Quarter. A comparison for the First Quarter steam sales is shown in Figure 8.

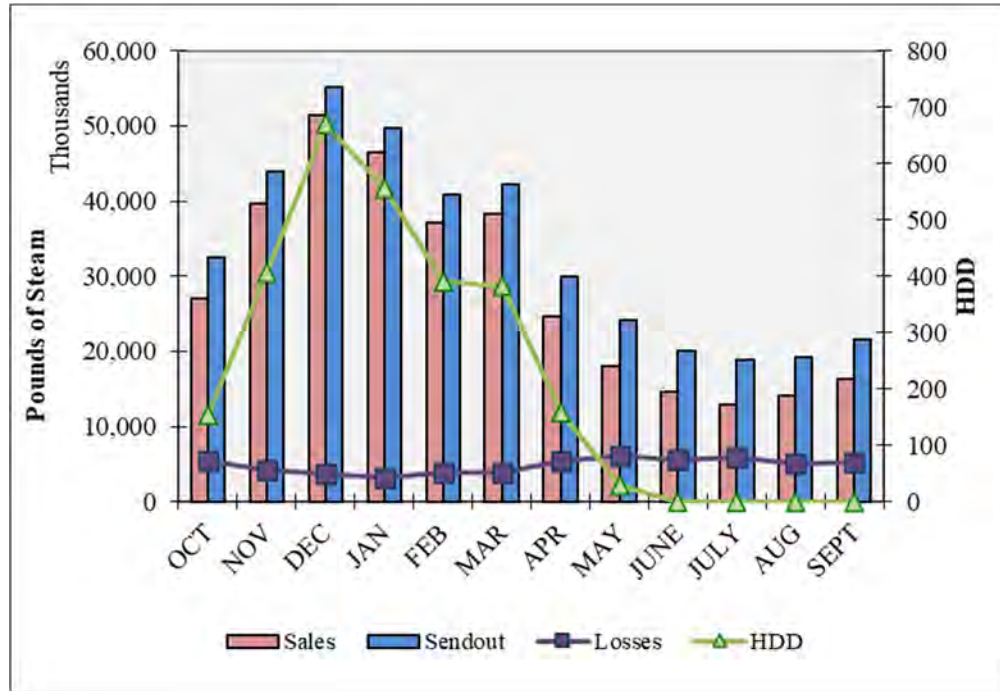
Figure 9. Steam Sales, Sendout, Losses and HDD for the Previous Twelve Months

Figure 9 shows the steam sales, sendout and losses for the previous twelve months. The losses on this figure are defined as the difference in pounds per month between the recorded sendout and sales values and represent the total mass loss in the EDS between the EGF and the customer meters.

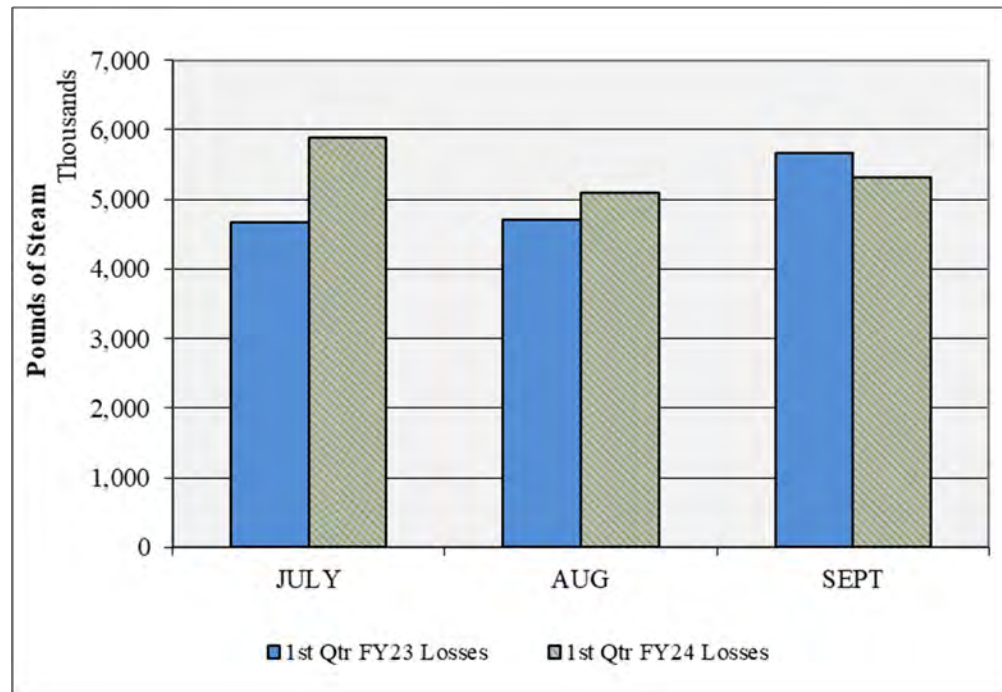
Figure 10. Steam System Losses

A comparison of the total steam mass losses in the EDS for the First Quarter is shown in Figure 10. The mass loss is caused by the heat loss in the EDS between the EGF and the customer meters, resulting in a mass loss at steam traps. Faulty traps, steam leaks or meter error could also be a contributing cause of these losses. Whenever steam sales decrease from the previous quarter, the percentage of system losses can be expected to increase since most of these losses are based on a near constant heat loss of the system.

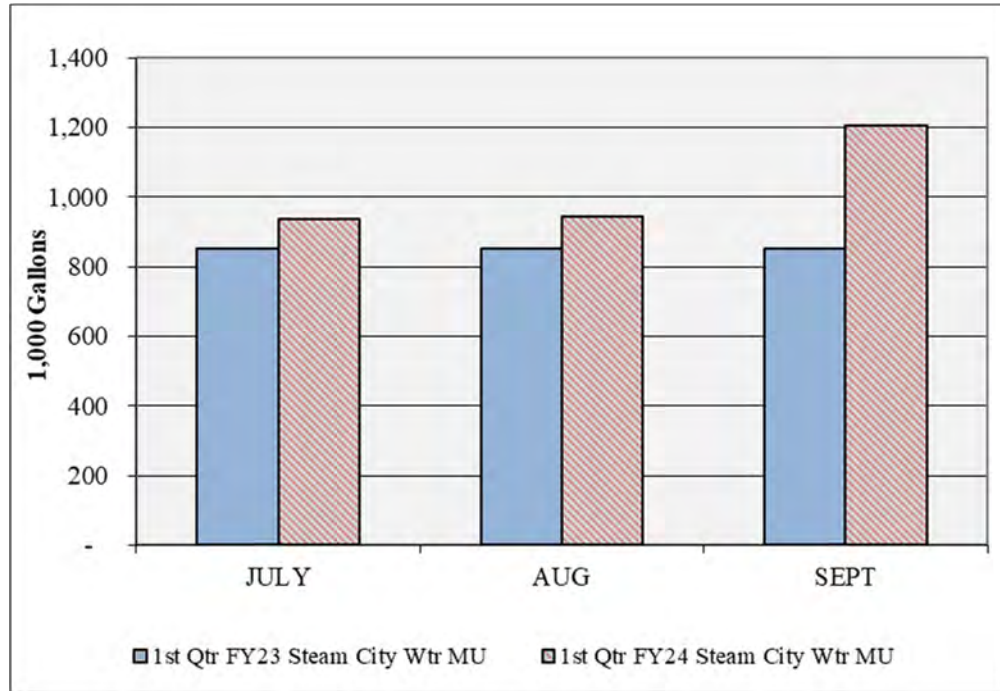
Figure 11. Steam System City Water Make-up Comparison

The amount of city water make-up (MU) to the steam system consists of the loss in mass between the EGF and the customers, in the condensate return from the customers to the EGF and losses at the EGF. The amount of make-up to the steam system increased 20.8% over the First Quarter FY23. The condensate returned from several customers had to be dumped during the quarter for higher than acceptable levels of iron or hardness. In addition, the condensate was dumped at MH-18 due to work associated with DES198. The corresponding data for steam system make-up is shown in the comparison of First Quarter data in Figure 11.

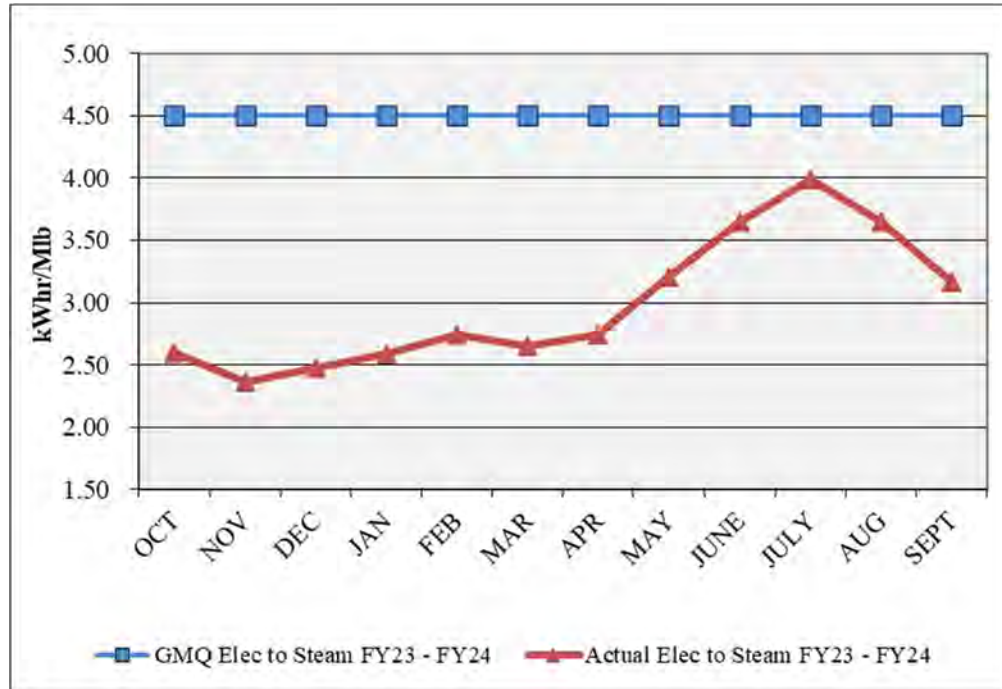
Figure 52. Steam Plant Electric Performance Guarantee for the Previous Twelve Months

The steam electric conversion factor was met each month of the quarter. The steam plant electric consumption for the current quarter was 2.2% lower in FY24 than in FY23. The steam-electric metric increased 1.8% over the previous First Quarter. The monthly steam-to-electric conversion factors, along with the guaranteed values, are shown in Figure 12.

The performance of the steam system of the EGF is presented in the following three charts, Figures 12, 13 and 14. The values represented below do not include the annual true-up adjustment which occurred in the First Quarter FY24.

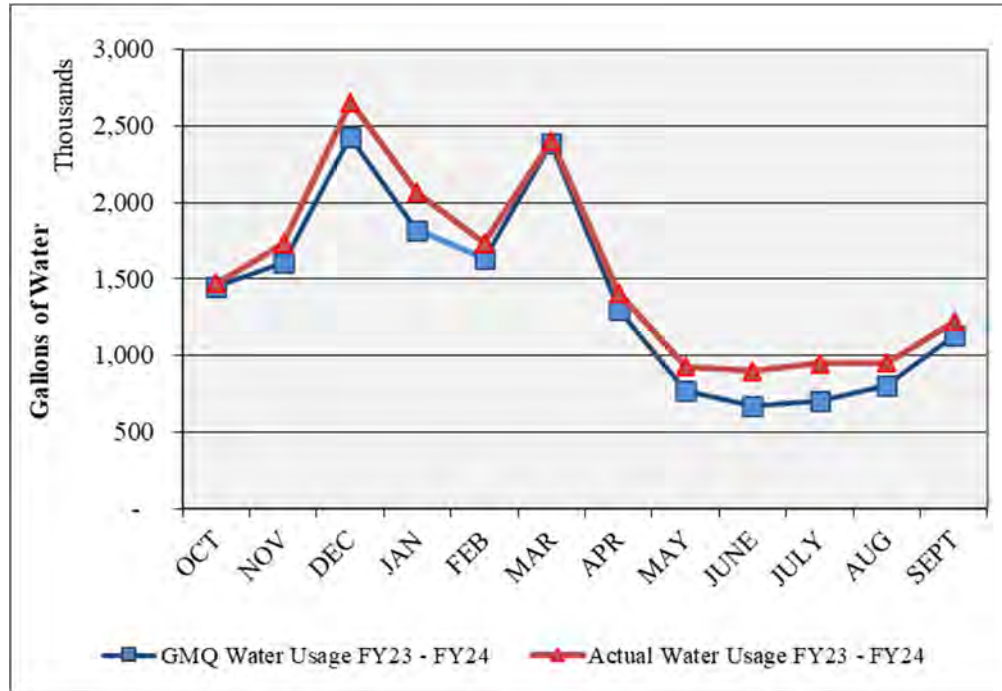
Figure 13. Steam Plant Water Performance Guarantee for the Previous Twelve Months

The steam water conversion factor exceeded the guaranteed values for each month in the quarter by magnitudes ranging from approximately 8% to 35%. TEG monitors CES’s performance regularly and will continue to report any non-compliance in the EGF’s operation. The steam water conversion factors are shown in Figure 13.

CES and TEG continue to monitor the performance of the EGF as CES makes efforts to improve the DES performance. The guaranteed steam-water performance value is based on an equation which incorporates the amount of steam sendout and condensate return and did not change with the adoption of the new performance values in Amendment 2. CES has verified the accuracy of the meter readings and continues to review the operation.

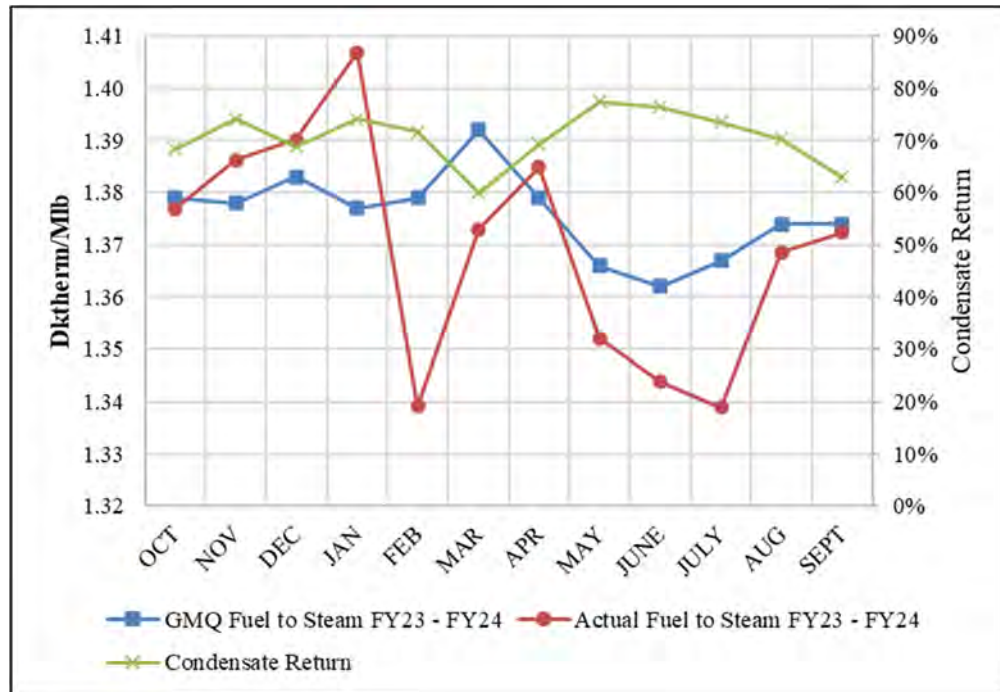
Figure 64. Steam Plant Fuel Performance Guarantee for the Previous Twelve Months

The steam fuel conversion factor met the guaranteed values for each month in the quarter. The fuel consumption per unit of steam sendout increased 0.6% over the previous First Quarter. The relative amount of condensate return is shown on this graph to reflect the influence that the condensate return has on the plant efficiency. Although the performance level for this metric changed with the adoption of Amendment 2, the equation used to calculate the value relies heavily on readings from the condensate return and steam sendout meters. Figure 14 shows the performance of the conversion factors for the previous twelve months.
