Operations Monitoring Report

Fourth Quarter FY25

Prepared by:

**Thermal Engineering Group, Inc.
105 Hazel Path Court, Ste 2
Hendersonville, TN 37075**

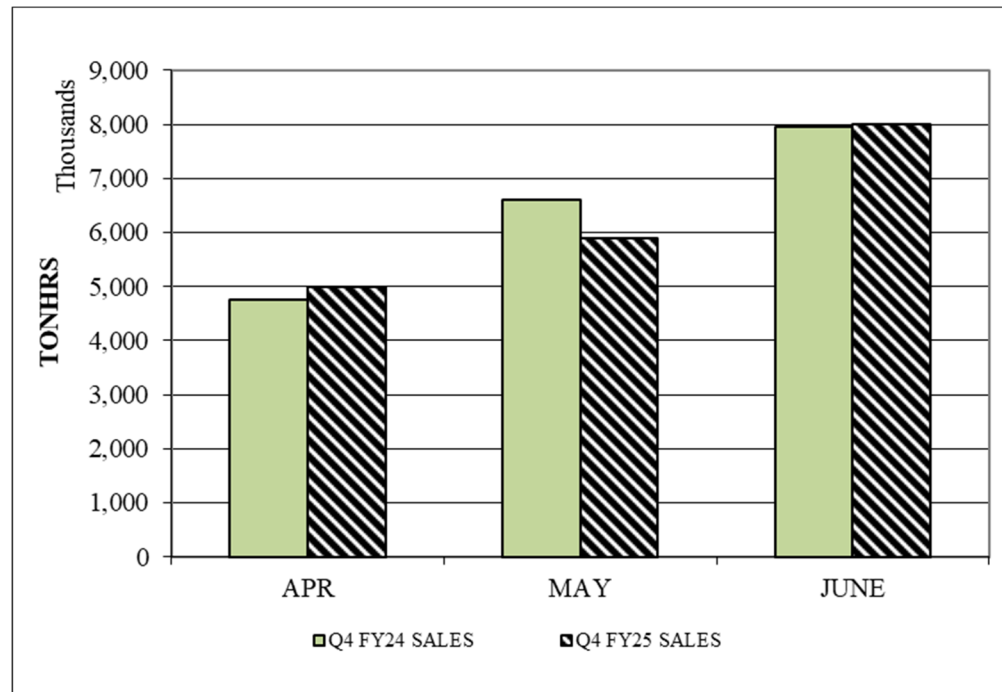
A comparison for the Fourth Quarter chilled water sales is shown in Figure 1. This data reflects 2.2% decrease in sales for the current quarter over the same quarter of the previous fiscal year. With a decrease of 2.7% in the number of cooling degree days, the change in chilled water sales may be attributable to a more temperate spring.

Figure 1. Chilled Water Sales Comparison

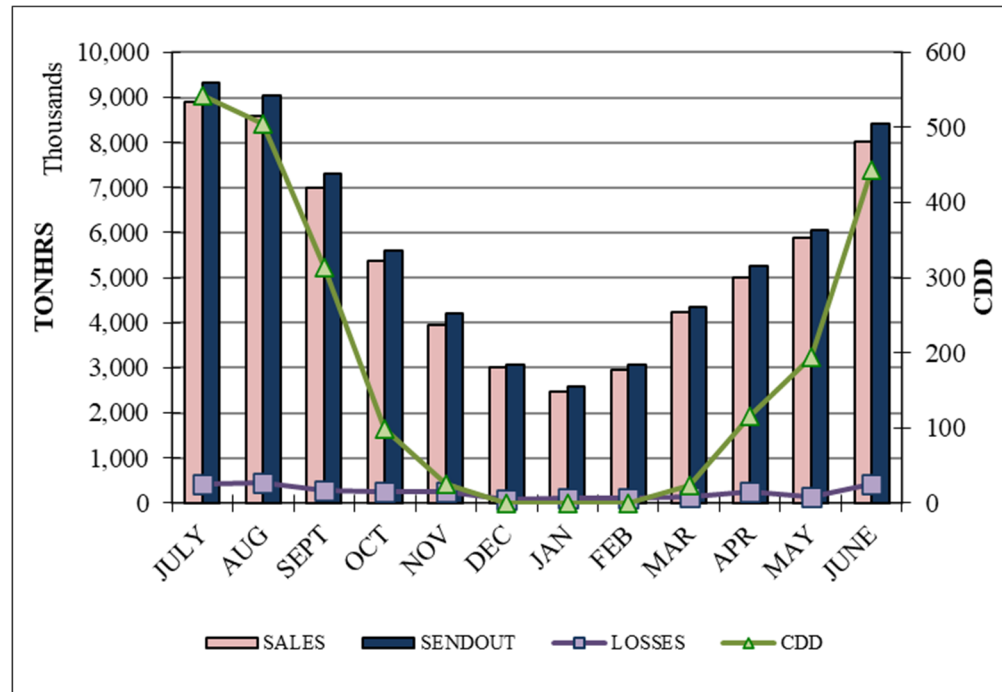
Figure 2 shows the chilled water sales, sendout and losses for the previous twelve months. For FY25, the chilled water sendout was 68,292,400 tonhrs which was approximately the same as in FY24. The annual sales were slightly higher than in FY24 with a 1.3% increase. The peak chilled water demand was 7.9% lower than in FY24 even though the total number of cooling degree days increased 4.8% in FY25. The chilled water losses decreased 22.4% over FY24. The losses in Figure 2 are defined as the difference in tonhrs per month between the recorded sendout and sales values and represent the total energy loss for chilled water in the EDS.

Figure 2. Chilled Water Sales, Sendout, Losses and CDD for the Previous Twelve Months

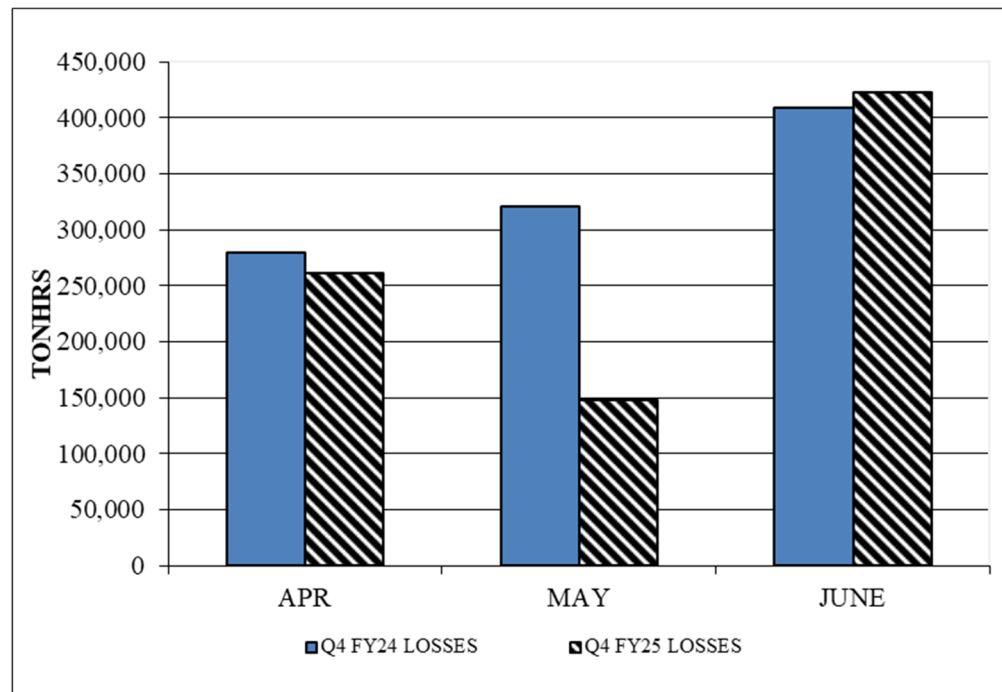
A comparison of the total chilled water energy losses in the EDS for the Fourth Quarter FY25 is shown in Figure 3. These losses are the difference in chilled water sendout and sales and may reflect differences in the meter accuracy between the EGF sendout meter, the customer meters, and the monthly usage estimated for several of the customers. The losses decreased 17.6% over the previous Fourth Quarter.

Figure 3. Chilled Water System Loss Comparison

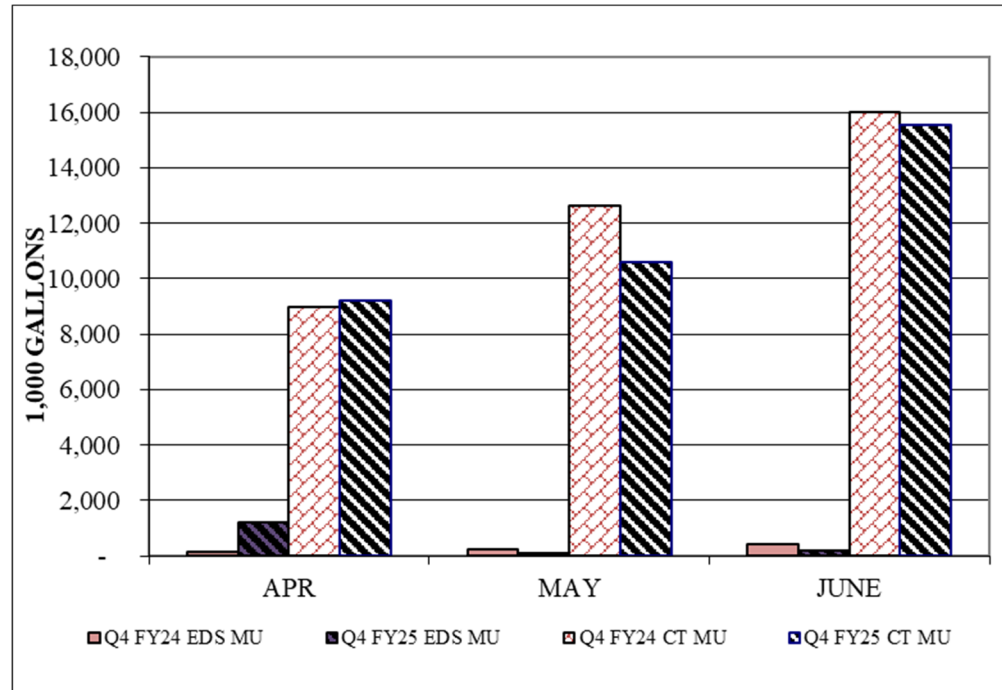
overall city water make-up comparison for the chilled water system Fourth Quarter is shown in Figure 4. (Chilled water production is the same as chilled water sendout since there are no in-plant losses for the chilled water.)

Figure 4. Chilled Water System City Water Usage Comparison

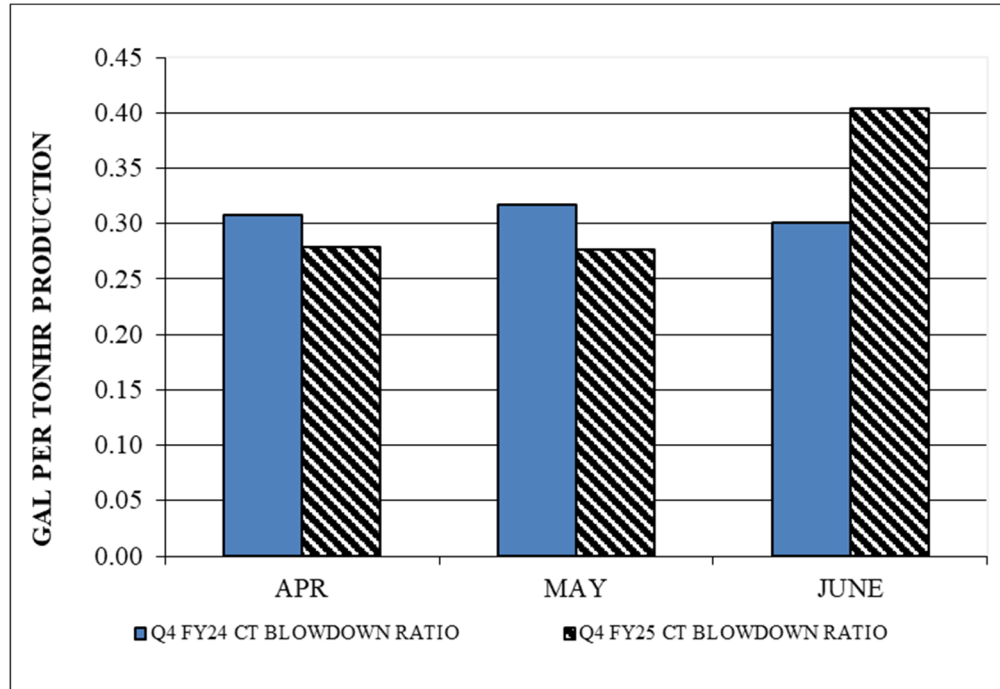
The cooling tower blowdown is monitored and controlled to maintain the conductivity of the condensing water within a range of 1,000 to 1,150 micromhos. The relationship between the cooling tower blowdown and the chilled water production should be consistent and tracking this relationship has proven helpful in reducing the chiller plant make-up water usage. DEAO has made operational changes with respect to the ratio of the cooling tower blowdown to the chilled water production over the past several years with the expectation of reducing the water usage and improving their performance relative to the chilled water-water guarantee. A comparison of the Fourth Quarter values between FY24 and FY25 are shown in Figure 5.

Figure 5. Cooling Tower Blowdown Ratio Comparison

When a comparison is made between the Fourth Quarter FY25 and FY24, the average cooling tower blowdown ratio increased 4.4%. This value corresponds to meeting the chilled water-water performance guarantee for each month during the quarter. The metric averaged 0.306 gallons per ton-hour produced for FY25 representing a 10.2% increase over FY24. Values between 0.27 and 0.30 appear to result in more favorable operation and water usage. The cooling tower blowdown ratio metric will continue to be tracked and monitored to verify the operational changes made by DEAO at the EGF continue to result in a decrease in chiller plant water usage.

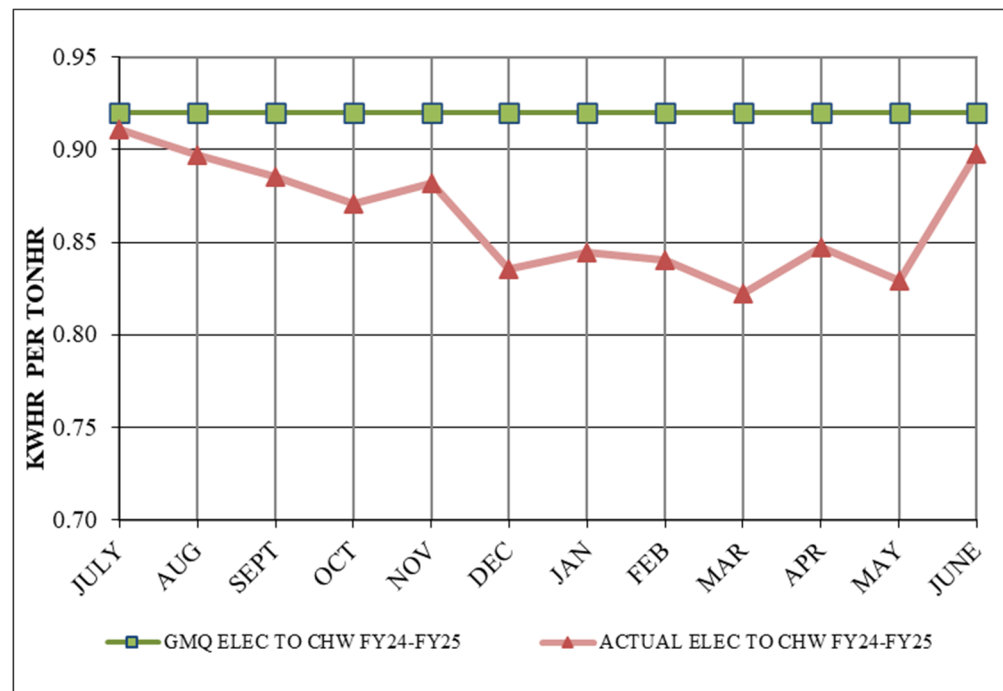
The performance of the chilled water portion of the EGF is presented in the following two charts, Figures 6 and 7, for the previous twelve months. The System Performance Guarantee for both metrics changed with Amendment 3 beginning with July 2024.

Figure 6. Chiller Plant Electric Performance Guarantee Comparison for the Previous Twelve Months

The electricity usage per unit of sales decreased 1.2% over the previous Fourth Quarter indicating a consistent efficiency. DEAO and TEG continue to monitor the improvements created by DEAO's operational changes.

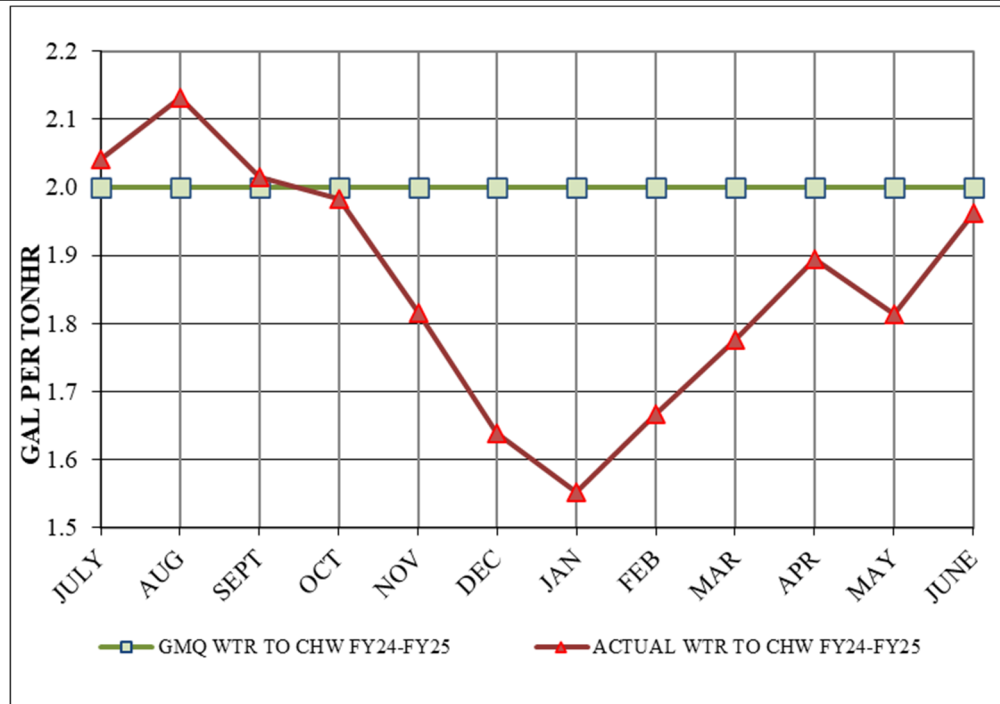
The total consumption of city water for the chiller plant for the current quarter decreased 4.2% over the previous Fourth Quarter. The EDS make-up increased significantly due to the leak discovered in April, but the cooling tower blowdown decreased 10.9%. The side stream filter backwash decreased 64.0% indicating cleaner chilled water. DEAO met the new chilled water-water performance metric each month during the quarter and only exceeded the metric in the First Quarter. Figure 7 shows the metric for the previous twelve months. TEG and DEAO continue to monitor the water usage and chiller plant performance with the goal of decreasing the energy and water usage for the system.

Figure 7. Chiller Plant Water Consumption Performance Guarantee Comparison for the Previous Twelve Months

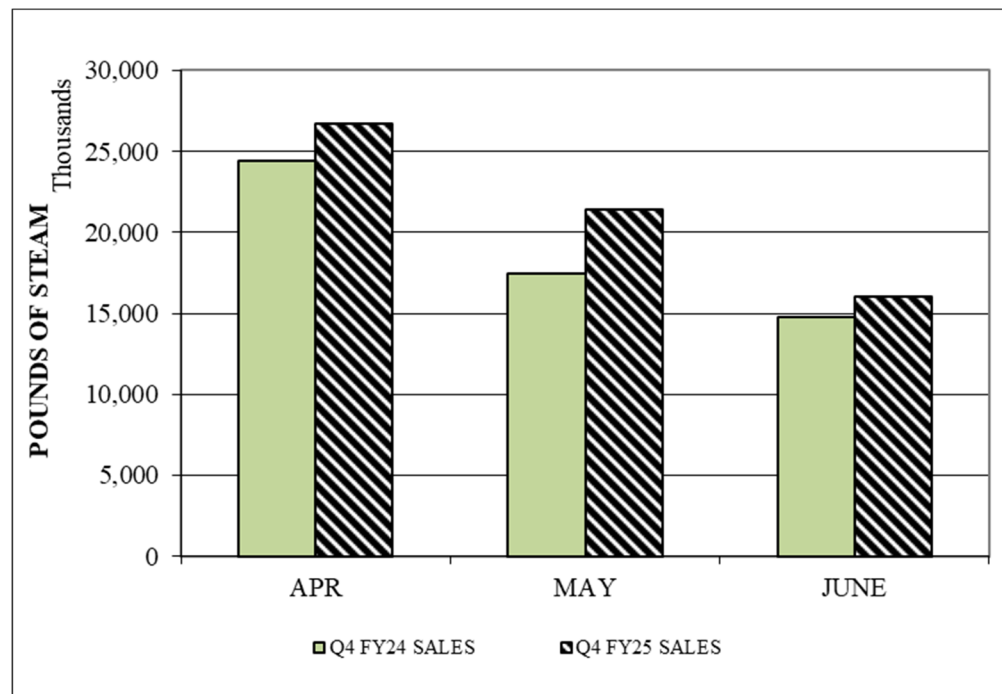
The steam sendout increased 6.7% over the previous Fourth Quarter, and the sales increased 13.2%. The number of heating degree days increased 12.7% over the previous Fourth Quarter. The steam system losses decreased 13.0%. The relative amount of condensate return remained approximately the same. The peak steam demand for the current quarter is 86,425 pph, which reflects a marginal increase in the peak steam production over the previous Fourth Quarter. The steam usage by the customers is largely driven by colder weather; however, many customer buildings use steam for domestic water heating and even reheat to manage relative humidity. These factors often contribute to higher than expected steam usage during warmer months. A comparison for the Fourth Quarter steam sales is shown in Figure 8.

Figure 8. Steam Sales Comparison

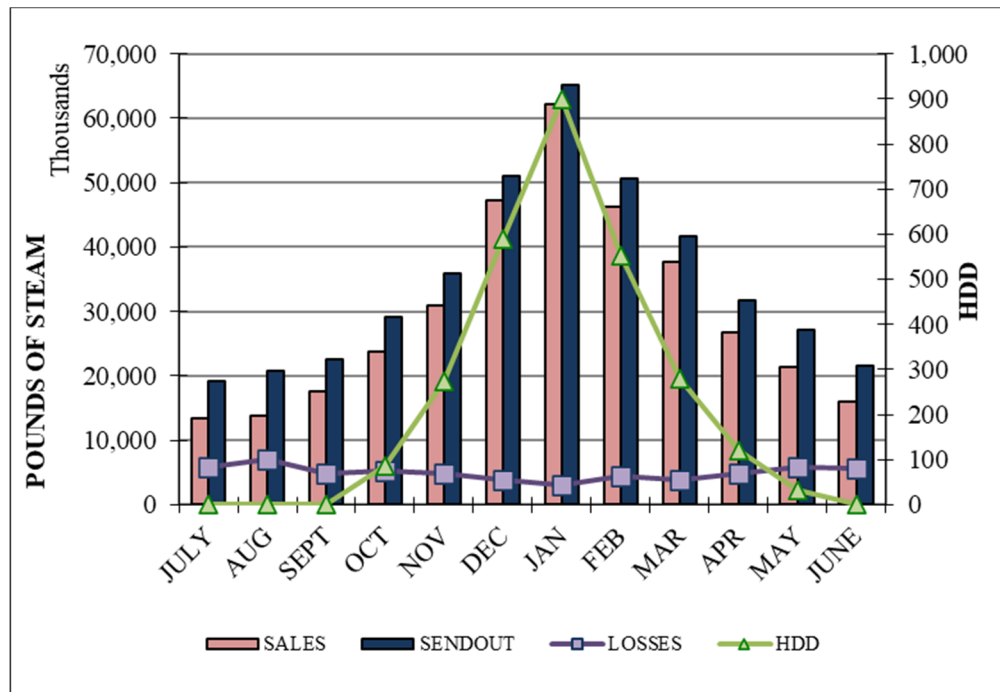
Figure 9 shows the steam sales, sendout and losses for the previous twelve months. The losses on this figure are defined as the difference in pounds per month between the recorded sendout and sales values and represent the total mass loss in the EDS between the EGF and the customer meters.

Figure 9. Steam Sales, Sendout, Losses and HDD for the Previous Twelve Months

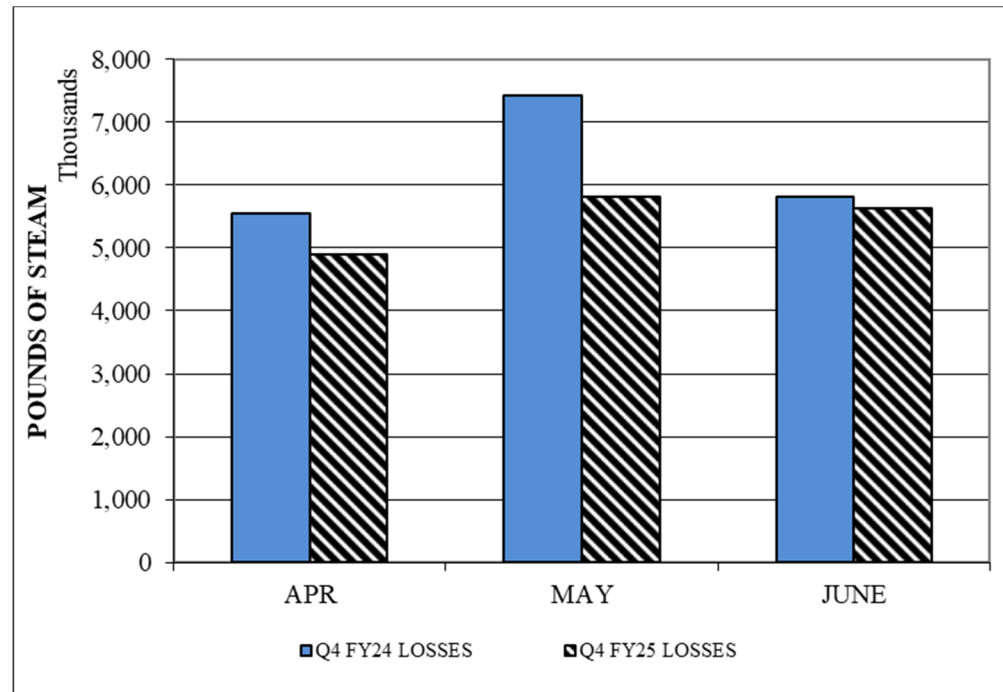
A comparison of the total steam mass losses in the EDS for the Fourth Quarter is shown in Figure 10. The mass loss is caused by the heat loss in the EDS between the EGF and the customer meters, resulting in a mass loss at steam traps. Faulty traps, steam leaks or meter error could also be a contributing cause of these losses.

Figure 10. Steam System Losses

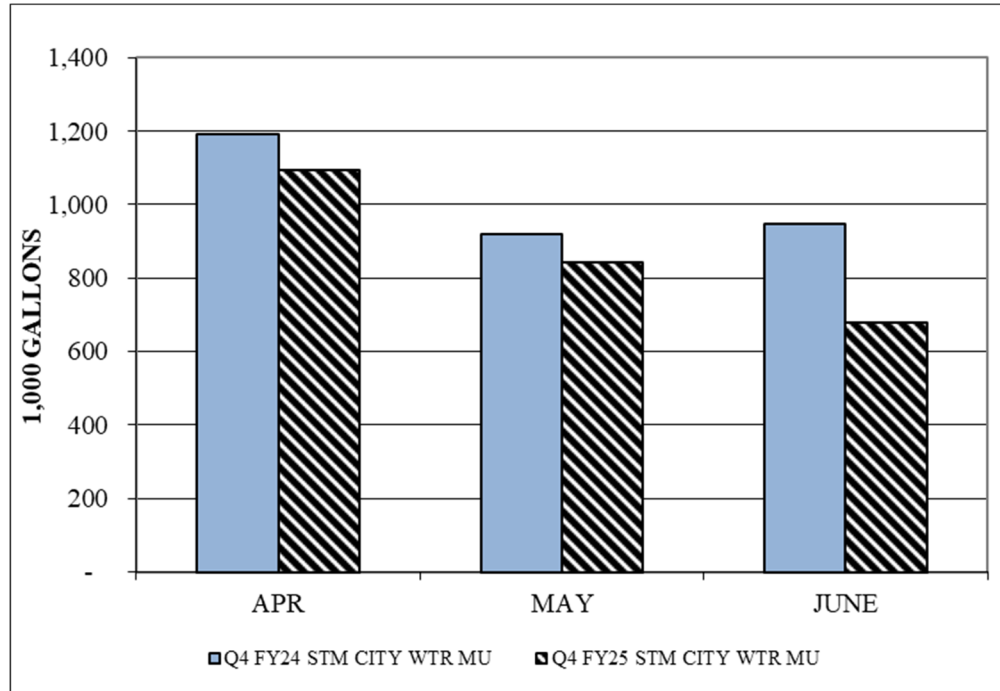
Multiple condensate leaks were found and repaired during the year resulting in a marginal increase in the relative amount of condensate return for the fiscal year. The total make-up to the steam system decreased 10.4% for the fiscal year even though condensate leaks occurred. A decrease in the total make-up to the steam system and an increase in the condensate return are anticipated in future quarters. The corresponding data for steam system make-up is shown in the comparison of Fourth Quarter data in Figure 11.

Figure 11. Steam System City Water Make-up Comparison

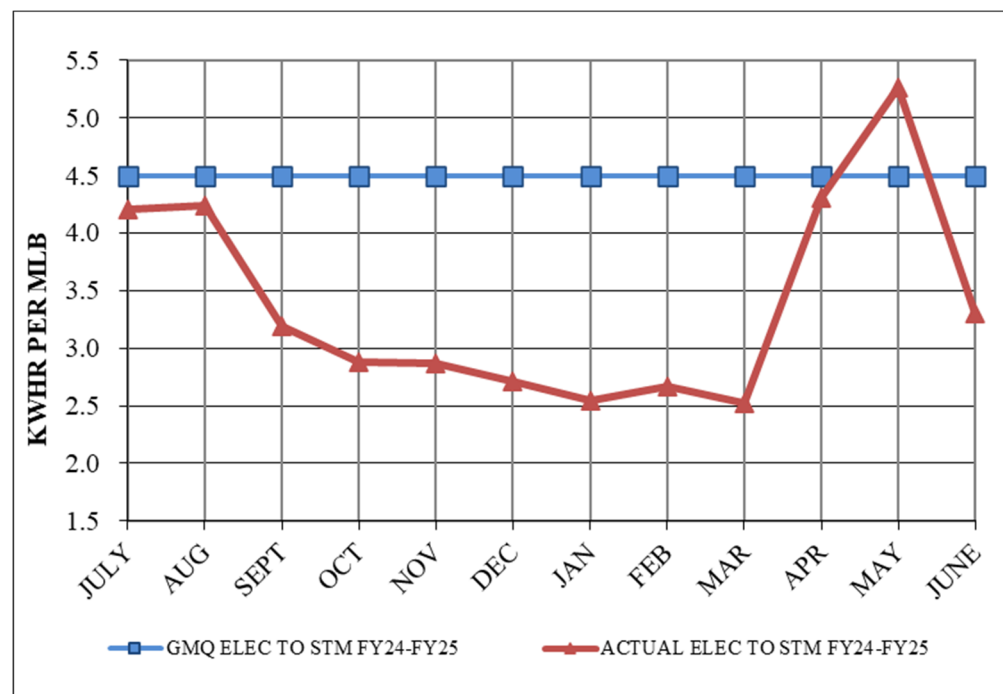
The steam electric conversion factor was not met in May, possibly due to an electric meter issue, but was met in all other months of the fiscal year. The steam plant electric consumption for the current quarter was 49.1% higher in the Fourth Quarter FY25 than in the previous Fourth Quarter and 16.1% higher in the current fiscal year. The steam-electric metric increased 27.7% over the previous Fourth Quarter and increased 10.4% over the previous fiscal year. The monthly steam-electric conversion factors, along with the guaranteed values, for the previous twelve months are shown in Figure 12.

Figure 12. Steam Plant Electric Performance Guarantee for the Previous Twelve Months

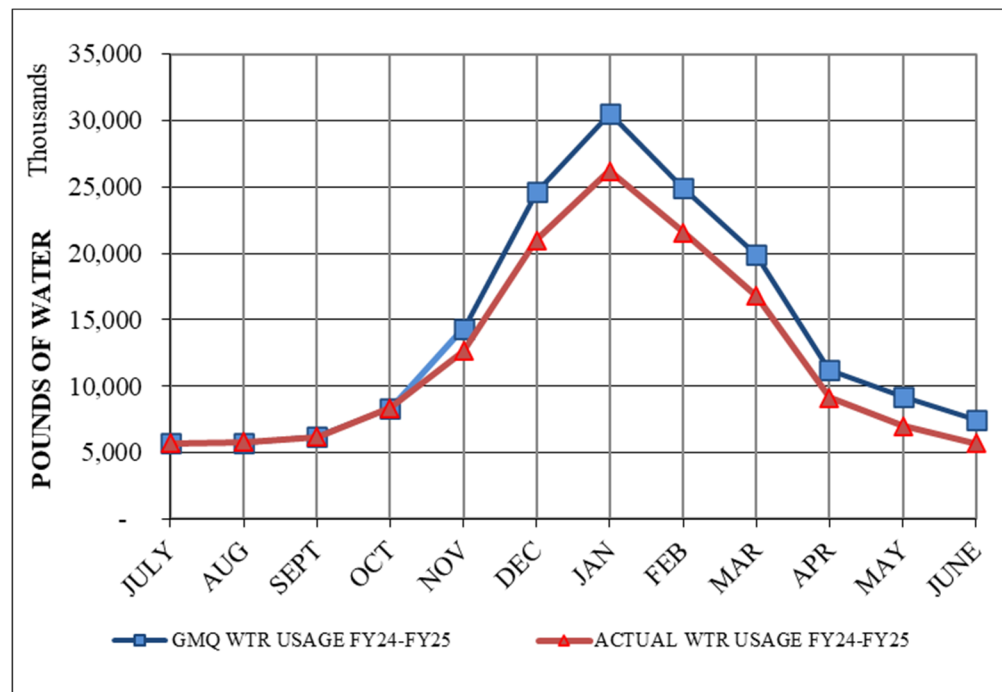
Figures 13A and 13B show the steam-water metrics using two different methodologies. Since the Amendment 3 metric is based on pounds of water and the

Figure 13A uses pounds and Figure 13B uses gallons. The guaranteed and actual volumes (gallons) prior to July 2024 use the Amendment 2 methodology. However, the GMQ volumes shown for FY25 convert the pounds values to gallons assuming a density based on the average condensate return temperature. Similarly, the mass values shown for data prior to July 2024 assume a constant density over the month based on the recorded average monthly condensate return temperature and converting the volumetric data to mass (pounds). These conversions will need to be made for FY25 and until enough historic data using the Amendment 3 methodology has been collected such that the real time density correction will be recorded.

Figure 13A. Steam Plant Water Performance Guarantee for the Previous Twelve Months Using a Mass Comparison

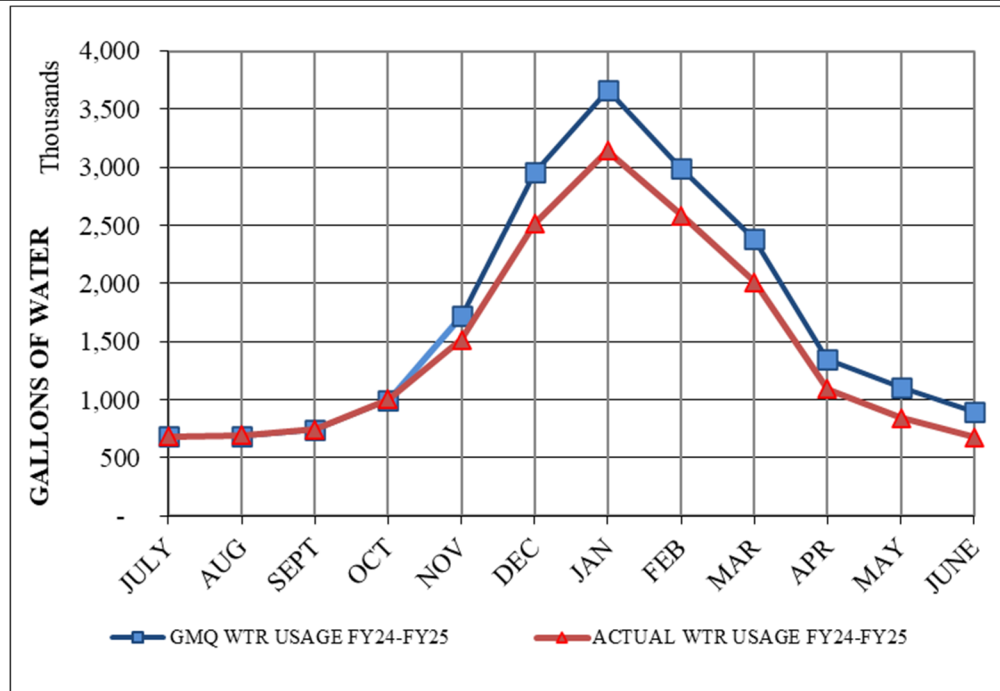
Figure 13B. Steam Plant Water Performance Guarantee for the Previous Twelve Months Using a Volumetric Comparison

For the Fourth Quarter, the boiler plant water usage decreased 14.4%. This decrease resulted in a 14.4% increase in the steam-water metric with the volumetric comparison methodology from Amendment 3. Using the Amendment 3 methodology, the metric was met each month during the quarter. For the fiscal year, the metric was met in all months except August and October with a 10.4% decrease over the fiscal year 2024.

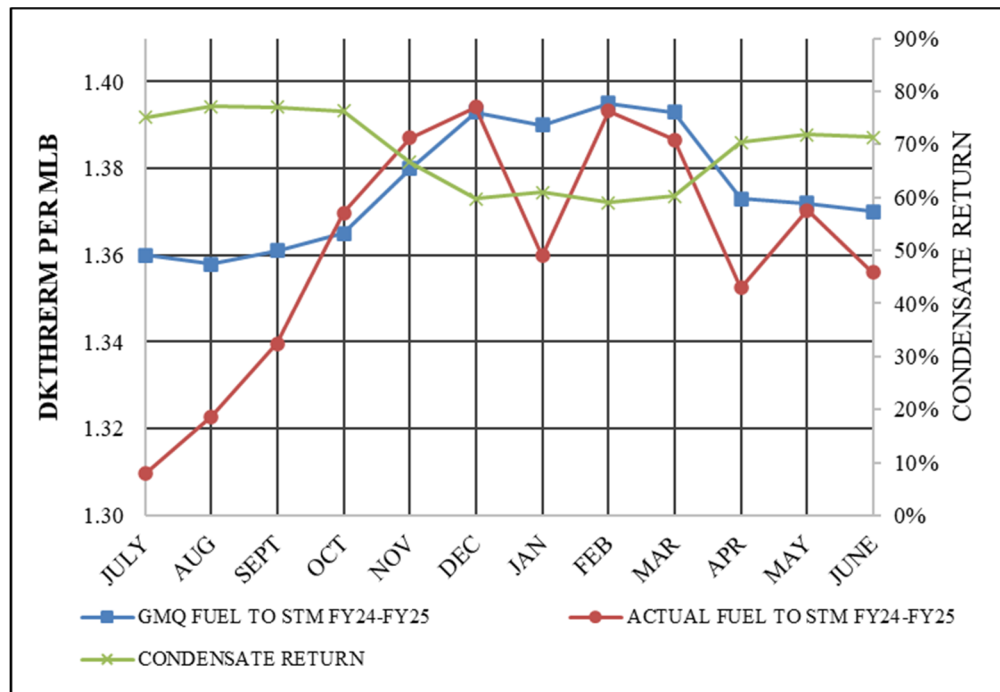
Figure 14 shows the performance of the conversion factors for the previous twelve months. The relative amount of condensate return is shown on this graph to reflect the influence the condensate return has on the plant efficiency.

Figure 14. Steam Plant Fuel Performance Guarantee for the Previous Twelve Months

The steam-fuel metric did not change in Amendment 3; however, the relative amount of condensate return is reported using the mass flow determined by the density corrected values used in the steam-water metric. The actual steam-fuel metric was met each month during the Fourth Quarter. The fuel consumption per unit of steam sendout remained approximately the same as in the previous Fourth Quarter. For the fiscal year, the metric remained approximately the same as in the previous fiscal year. However, the metric was not met in October, November, and December.

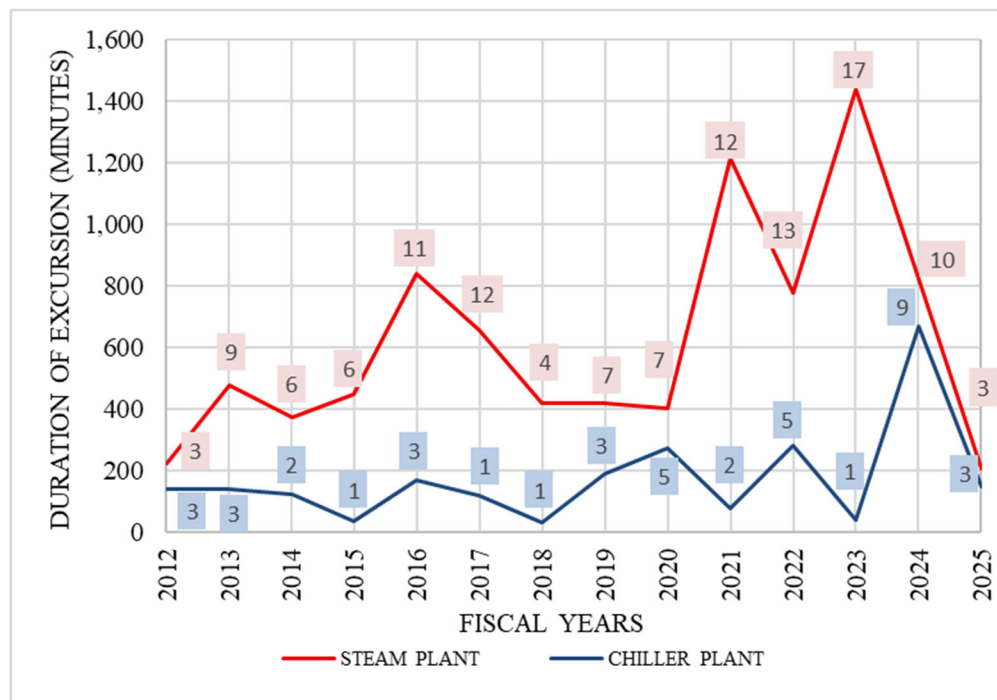
Figure 15 shows the duration of the reportable excursions for both the steam and chiller plant for the past fourteen fiscal years. The numerical values shown adjacent to the vertices of the lines on the graph represent the number of reportable excursions. This graph excludes the excursions as a result of utility interruptions, tuning and testing of equipment where excursions would be expected, planned outages, and unexpected issues at customer buildings. The data shows a general decline in reliability (greater values) until FY25 when the number and duration of the excursions reverted back to the FY12 values.

Figure 15. Steam and Chiller Plant Excursion History

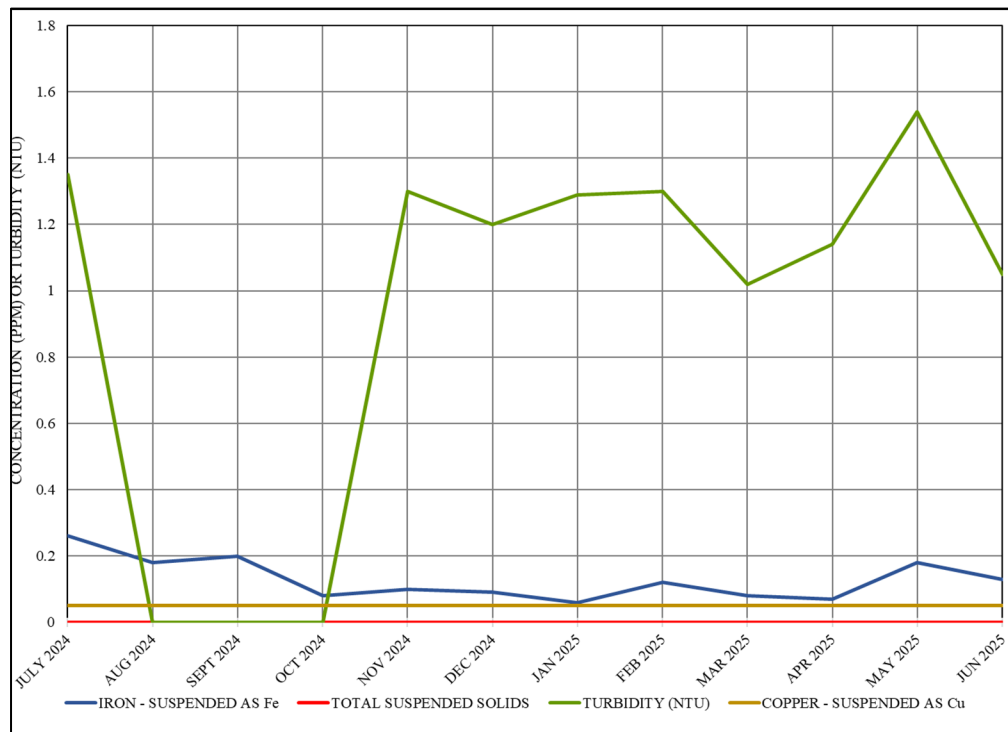
- DEAO continues to monitor and test for the presence of bacteria in the system. The biological growth in the system, as measured at the EGF and at the customer buildings, has become non-existent. Chem-Aqua's proprietary biological treatment system continues to function properly.
- The side stream filter has significantly reduced the amount of suspended solids in the chilled water and improved the turbidity of the system.
- Figure 16 shows the results of several measured metrics within the chilled water system which may be affected through the use of the side stream filter. Values shown at or near zero may be at or below the detectable limit and are represented by "zero" on the graph.

Figure 16. Chilled Water Composition Downstream of Side Stream Filter
