Operations Monitoring Report

First Quarter FY26

**Thermal Engineering Group, Inc.
105 Hazel Path Court, Ste 2
Hendersonville, TN 37075**

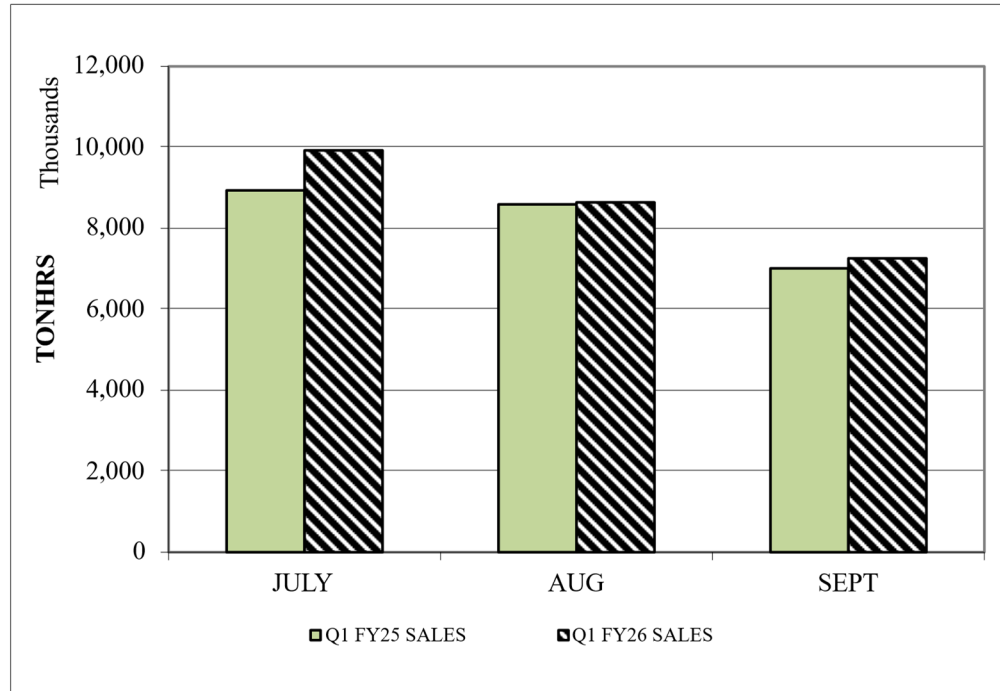
Figure 1. Chilled Water Sales Comparison

A comparison for the First Quarter chilled water sales is shown in Figure 1. This data reflects a 5.3% increase in sales for the current quarter over the same quarter of the previous fiscal year. However, the number of cooling degree days increased by only 2.3%. Several issues were experienced with several customer meter panels during the quarter resulting in a need to estimate their monthly usage. Estimating a customer's usage includes averaging the previous three-year average of usage which may not accurately reflect the actual usage for the month. DEAO and TEG have investigated this issue and determined the primary cause to be unauthorized internet access to the meter panels. Customers were notified of these issues since the internet security of the panels is the customers' responsibility. In addition, data from a number of the customer panels had to be manually retrieved due to this issue and disconnected internet connections. DEAO and TEG continue to direct the customers to resolve those issues under their control.

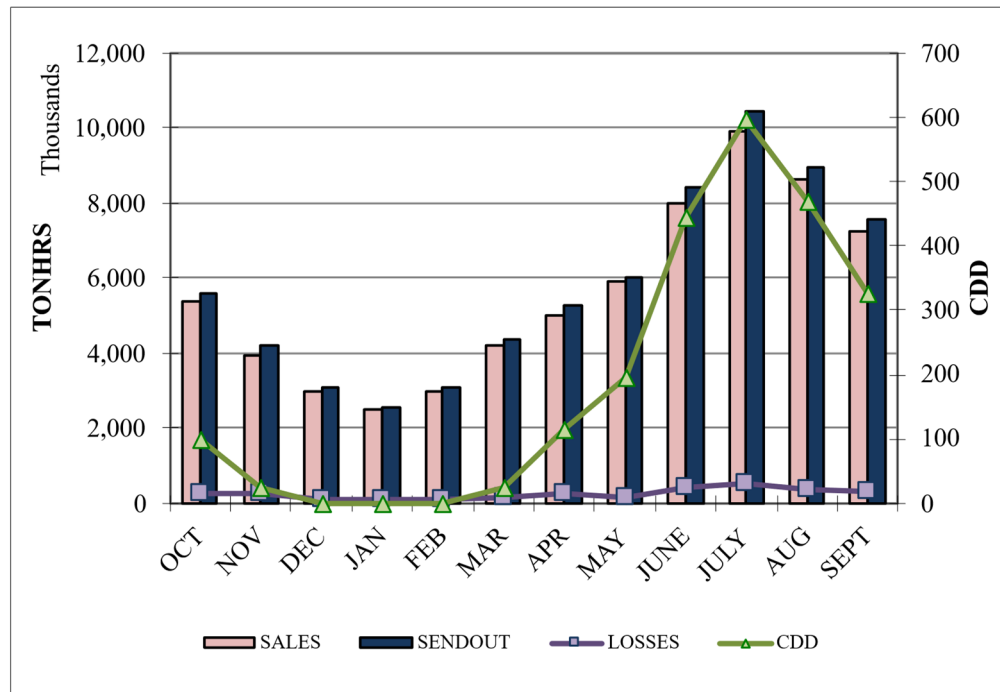
Figure 2. Chilled Water Sales, Sendout, Losses and CDD for the Previous Twelve Months

Figure 2 shows the chilled water sales, sendout and losses for the previous twelve months.

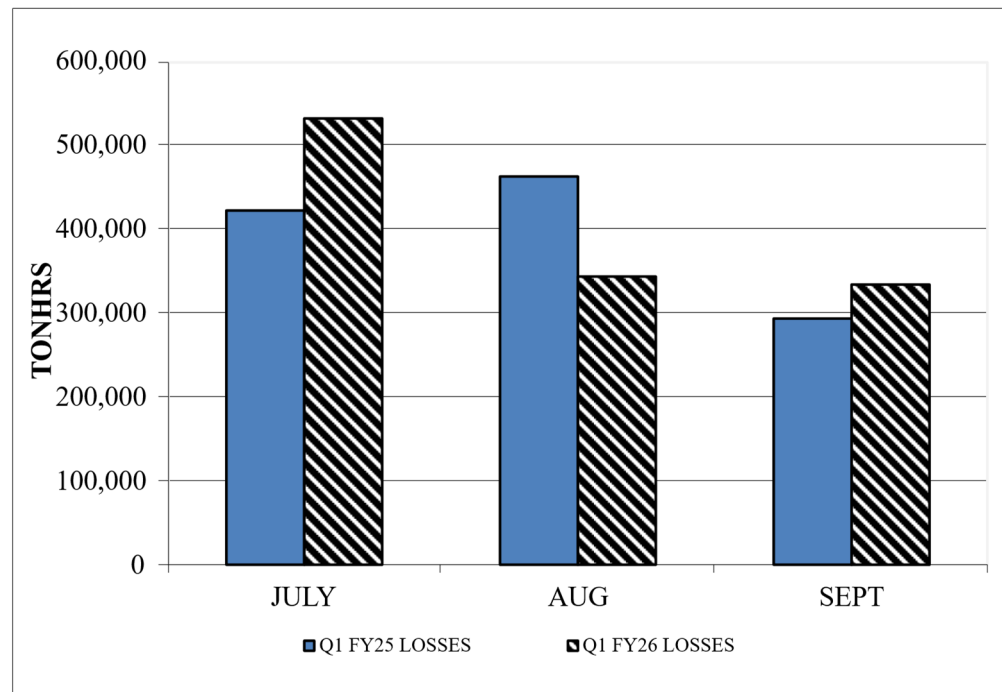
Figure 3. Chilled Water System Loss Comparison

A comparison of the total chilled water energy losses in the EDS for the First Quarter FY26 is shown in Figure 3. These losses are the difference in chilled water sendout and sales and may reflect differences in the meter accuracy between the EGF sendout meter, the customer meters, and the monthly usage estimated for several of the customers. The losses increased 2.6% over the previous First Quarter. This quarter marks the first quarter in over a year where the losses have increased over the previous quarters.

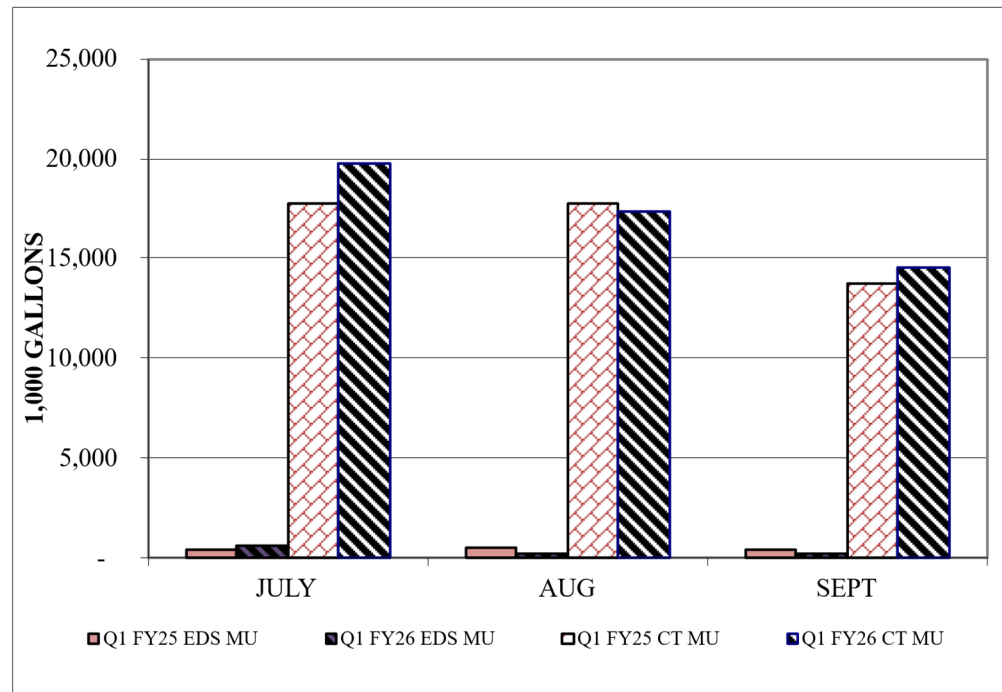
Figure 4. Chilled Water System City Water Usage Comparison

offline for a portion of July when the load was the highest. The total chiller plant water use increased 3.8% over the previous First Quarter. The overall city water make-up comparison for the chilled water system First Quarter is shown in Figure 4. (Chilled water production is the same as chilled water sendout since there are no in-plant losses for the chilled water.)

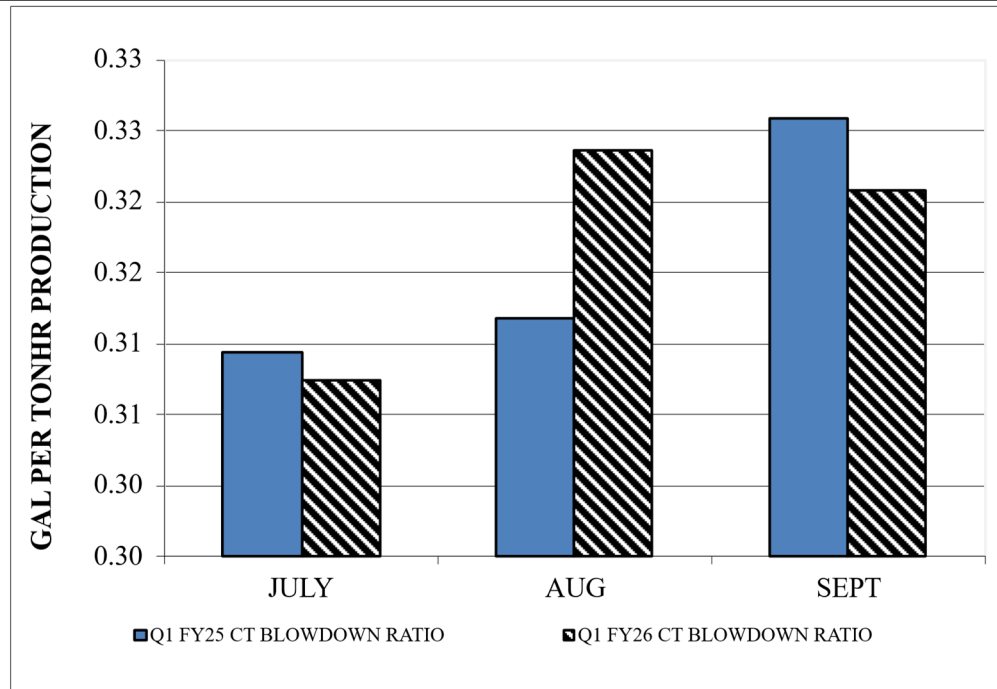
Figure 5. Cooling Tower Blowdown Ratio Comparison

The cooling tower blowdown is monitored and controlled to maintain the conductivity of the condensing water within a range of 1,000 to 1,150 micromhos. The relationship between the cooling tower blowdown and the chilled water production should be consistent and tracking this relationship has proven helpful in reducing the chiller plant make-up water usage. DEAO has made operational changes with respect to the ratio of the cooling tower blowdown to the chilled water production over the past several years with the expectation of reducing the water usage and improving their performance relative to the chilled water-water guarantee. A comparison of the First Quarter values between FY25 and FY26 are shown in Figure 5.

When a comparison is made between the First Quarter FY25 and FY26, the average cooling tower blowdown ratio increased marginally. The chilled water-water performance guarantee was not met in any month during the First Quarter FY26 or in the First Quarter FY25. During both quarters, the average cooling tower blowdown ratio was above 0.30 gallons per ton-hour. The metric averaged 0.317 gallons per ton-hour produced for the First Quarter FY26 and 0.315 in the First Quarter FY25. Values between 0.27 and 0.30 appear to result in more favorable operation and water usage and the chilled water-water performance metrics are met. The cooling tower blowdown ratio metric will continue to be tracked and monitored to verify the operational changes made by DEAO at the EGF continue to result in a decrease in chiller plant water usage.

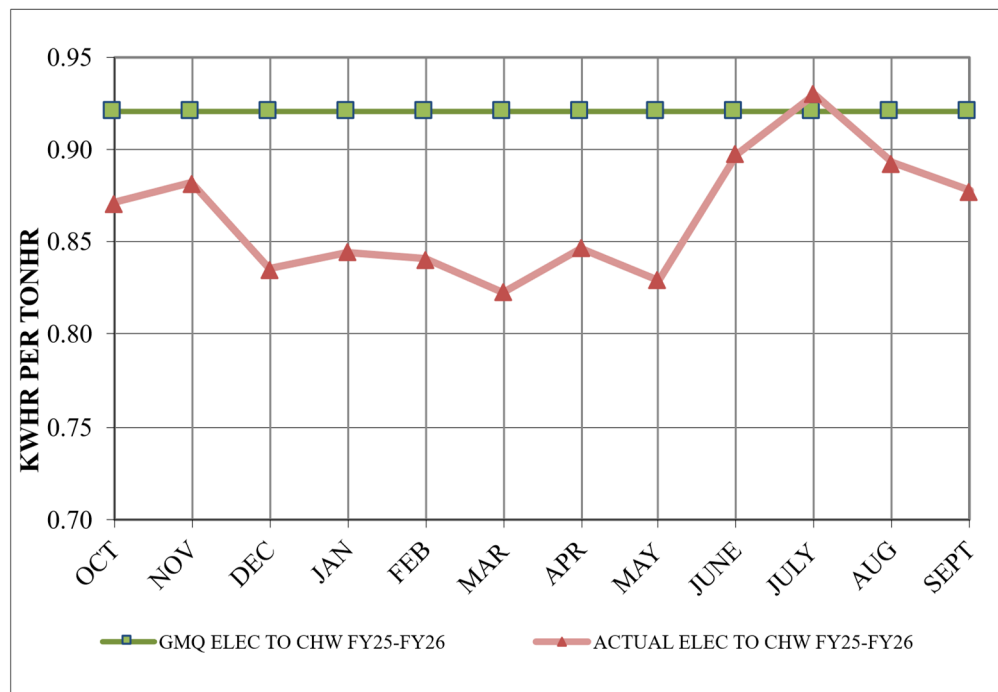
Figure 6. Chiller Plant Electric Performance Guarantee Comparison for the Previous Twelve Months

The performance of the chilled water portion of the EGF is presented in the following two charts, Figures 6 and 7, for the previous twelve months. The electricity usage per unit of sales increased 0.1% over the previous First Quarter even though the metric was not met in July. DEAO's investigation into the capture of the in-plant electric data in FY25 led to a discrepancy with the steam-electric data and how this data is used with the information provided to TEG and included in the customer invoices. The impact on the chilled water-electric remains unknown as of the end of the First Quarter, but the investigation and potential corrective factors are ongoing.

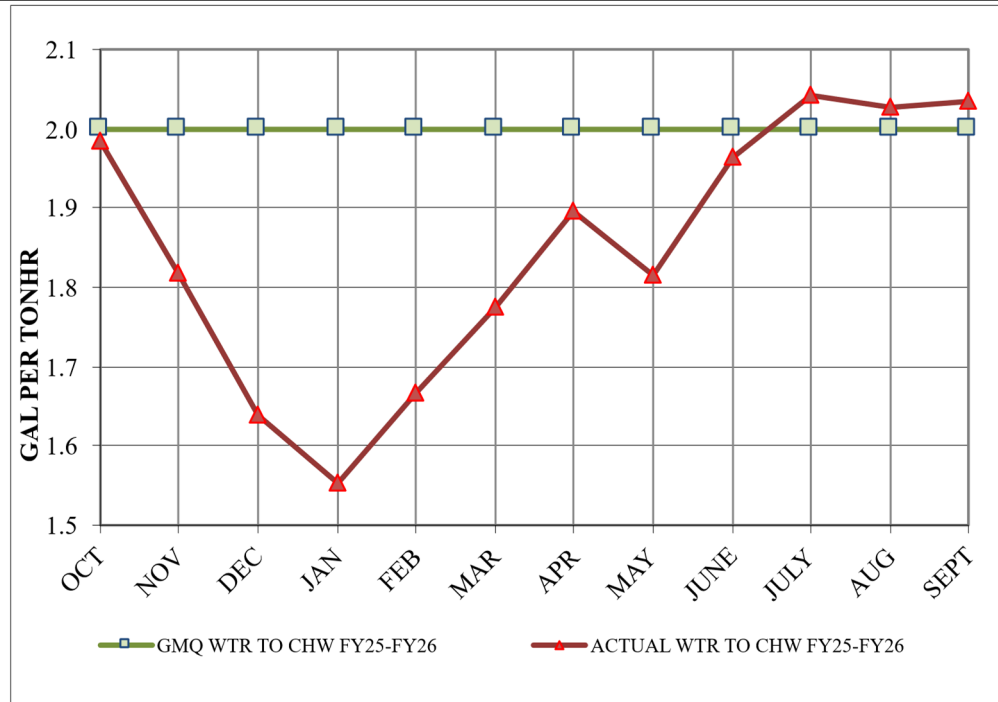
Figure 7. Chiller Plant Water Consumption Performance Guarantee Comparison for the Previous Twelve Months

The total consumption of city water for the chiller plant for the current quarter increased 3.8% over the previous First Quarter. The cooling tower blowdown increased 5.7%. The side stream filter backwash increased 10.1% possibly due to an increase in the circulation rate of the chilled water due to an increase in sales. DEAO did not meet the chilled water-water performance metric any month during the quarter. Failing to meet this metric appears to be related to operating with a cooling tower blowdown ration greater than 0.30. Figure 7 shows the metric for the previous twelve months. TEG and DEAO continue to monitor the water usage and chiller plant performance with the goal of decreasing the energy and water usage for the system.

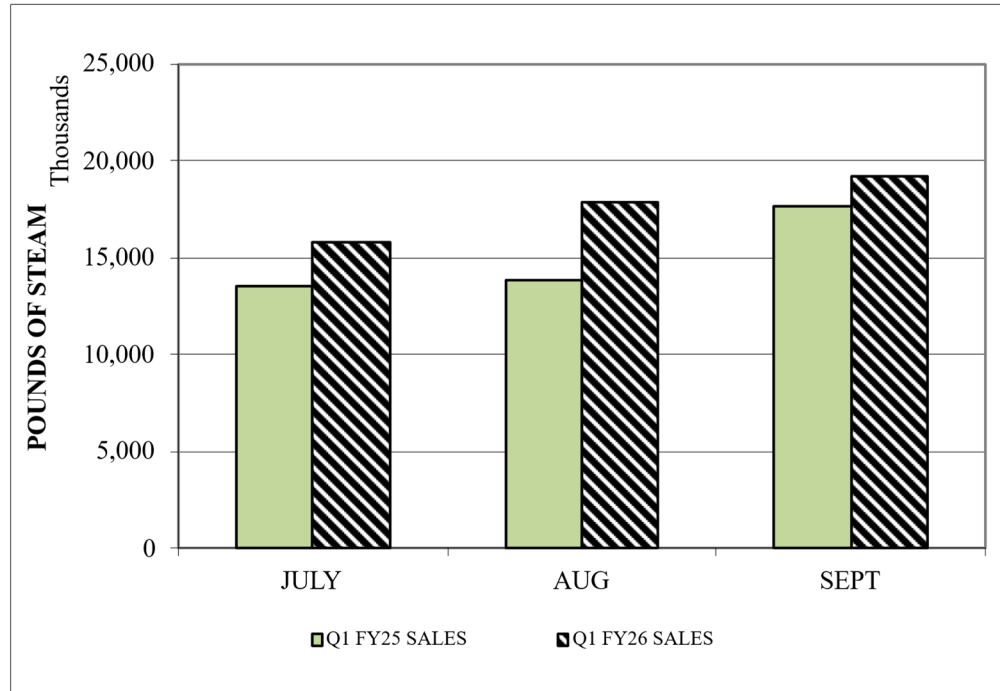
Figure 8. Steam Sales Comparison

The increase in steam usage by the customers may be driven by an increase in the domestic hot water production at the hotels and event venues and an increase in the amount of reheat required due to higher relative humidities. These factors often contribute to higher than expected steam usage during warmer months. However, several issues were experienced with several customer meter panels during the quarter resulting in a loss of metered data. As with the chilled water sales, the steam usage for several customers were estimated using the previous three-year average which may not accurately reflect the actual usage for the month. DEAO and TEG have investigated this issue and determined the primary cause to be unauthorized internet access to the meter panels. Customers were notified of these issues since the internet security of the panels is the customers' responsibility. In addition, data from a number of the customer panels had to be manually retrieved due to this issue and disconnected internet connections. DEAO and TEG continue to direct the customers to resolve those issues under their control. A comparison for the First Quarter steam sales is shown in Figure 8.

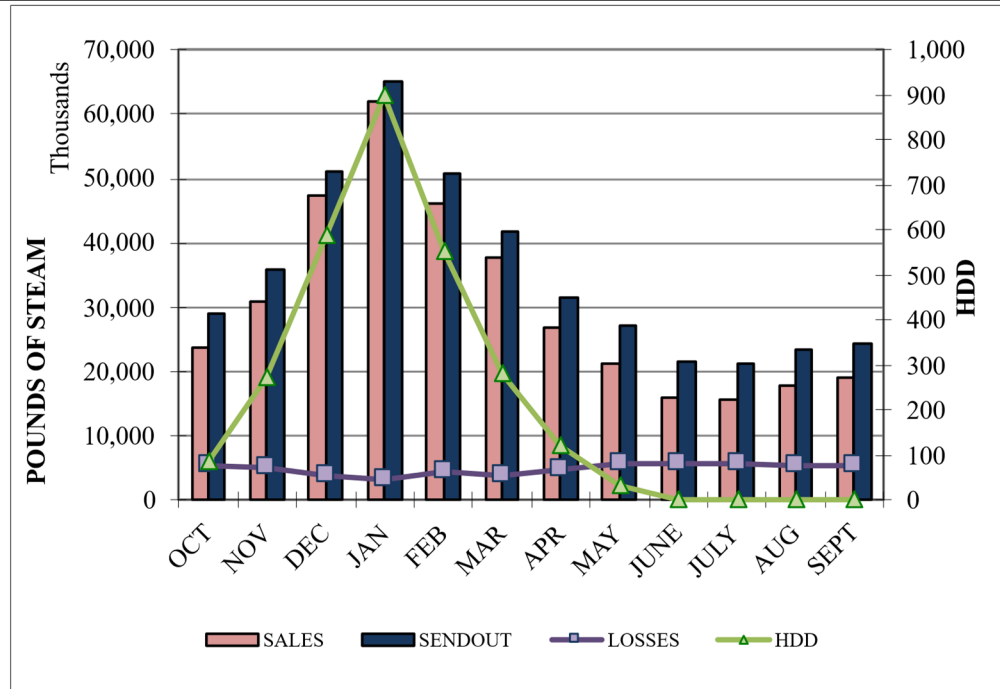
Figure 9. Steam Sales, Sendout, Losses and HDD for the Previous Twelve Months

Figure 9 shows the steam sales, sendout and losses for the previous twelve months. The losses on this figure are defined as the difference in pounds per month between the recorded sendout and sales values and represent the total mass loss in the EDS between the EGF and the customer meters.

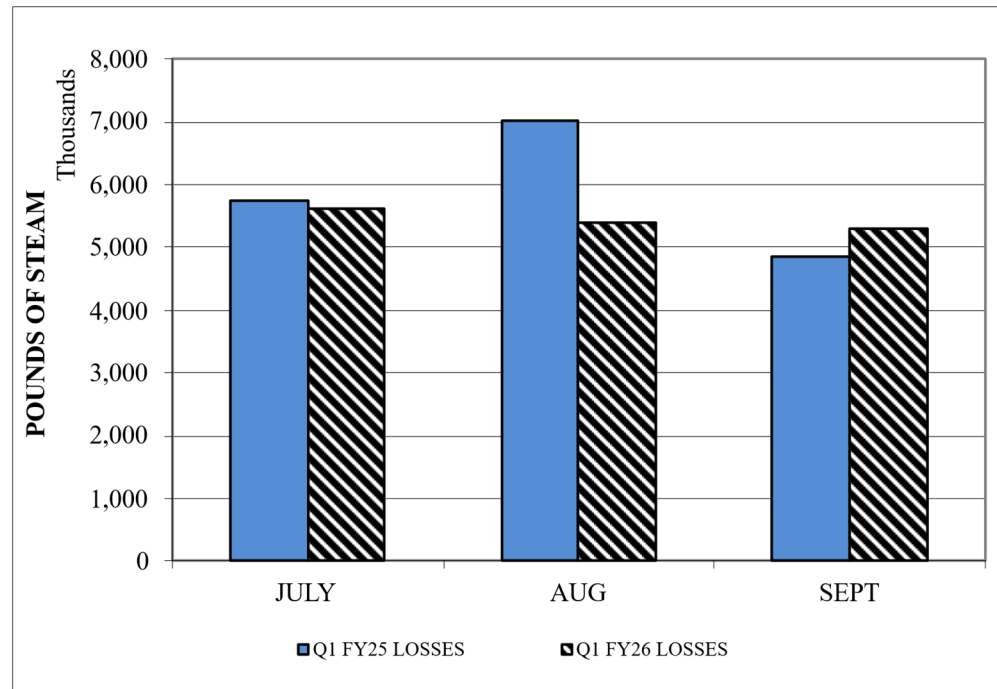
Figure 10. Steam System Losses

A comparison of the total steam mass losses in the EDS for the First Quarter is shown in Figure 10. The mass loss is caused by the heat loss in the EDS between the EGF and the customer meters, resulting in a mass loss at steam traps. Faulty traps, steam leaks, or meter error could also be a contributing cause of these losses.

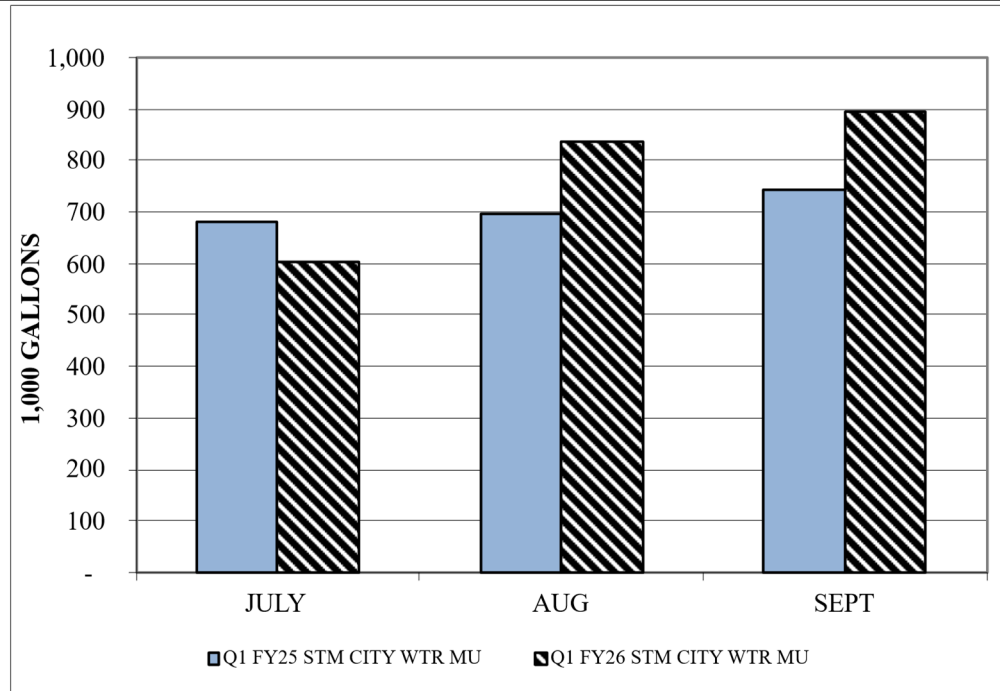
Figure 11. Steam System City Water Make-up Comparison

The amount of city water make-up (MU) to the steam system consists of the loss in mass between the EGF and the customers, in the condensate return from the customers to the EGF and losses at the EGF. The amount of make-up to the steam system increased 10.1% over the First Quarter FY25. However, the relative amount of condensate return decreased 8.1% over the previous First Quarter.

A condensate leak on Third Avenue North (in the intersection with James Robertson Parkway) was discovered during the quarter requiring several customers north of the leak to stop returning condensate to the plant. The repairs are ongoing as of the end of the First Quarter with work being performed as part of project DES236. The corresponding data for steam system make-up is shown in the comparison of First Quarter data in Figure 11.

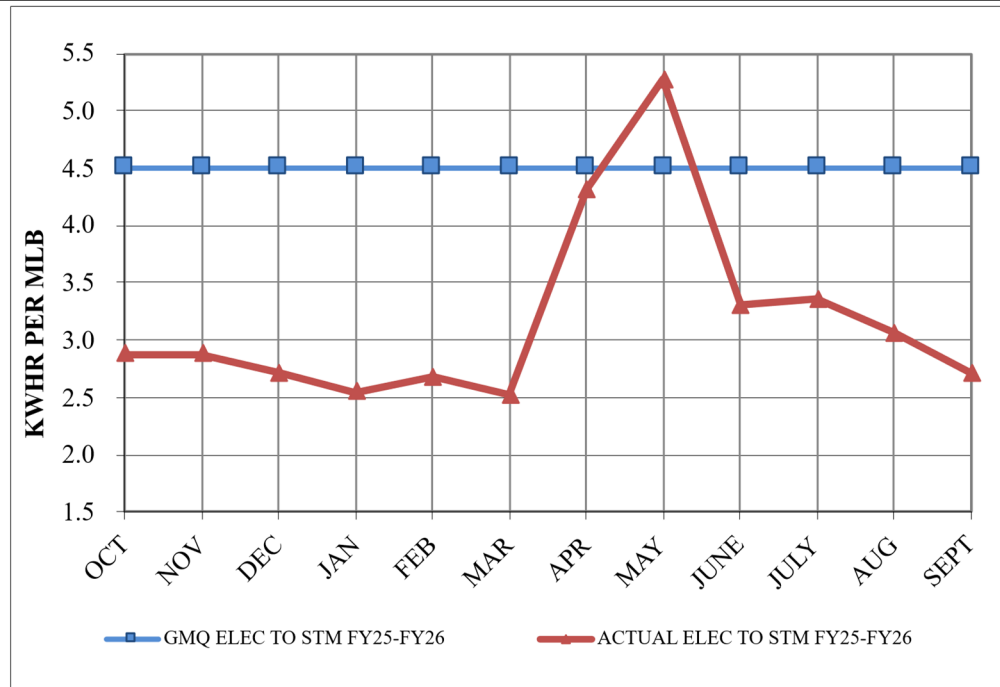
Figure 12. Steam Plant Electric Performance Guarantee for the Previous Twelve Months

The monthly steam-electric conversion factors, along with the guaranteed values, for the previous twelve months are shown in Figure 12.

DEAO's investigation into the capture of the in-plant electric data in FY25 led to a discrepancy with the steam-electric data and how this data is used with the information provided to TEG and included in the customer invoices. This issue may have influenced the inability to meet the performance goal in May. The impact on the steam-electric remains unknown as of the end of the First Quarter. However, the decrease in total plant electric usage coinciding with an increase in steam sales and an increase in the peak steam demand for the quarter may indicate an issue with both the customer meters used to determine sales and the capture of the in-plant electric usage.

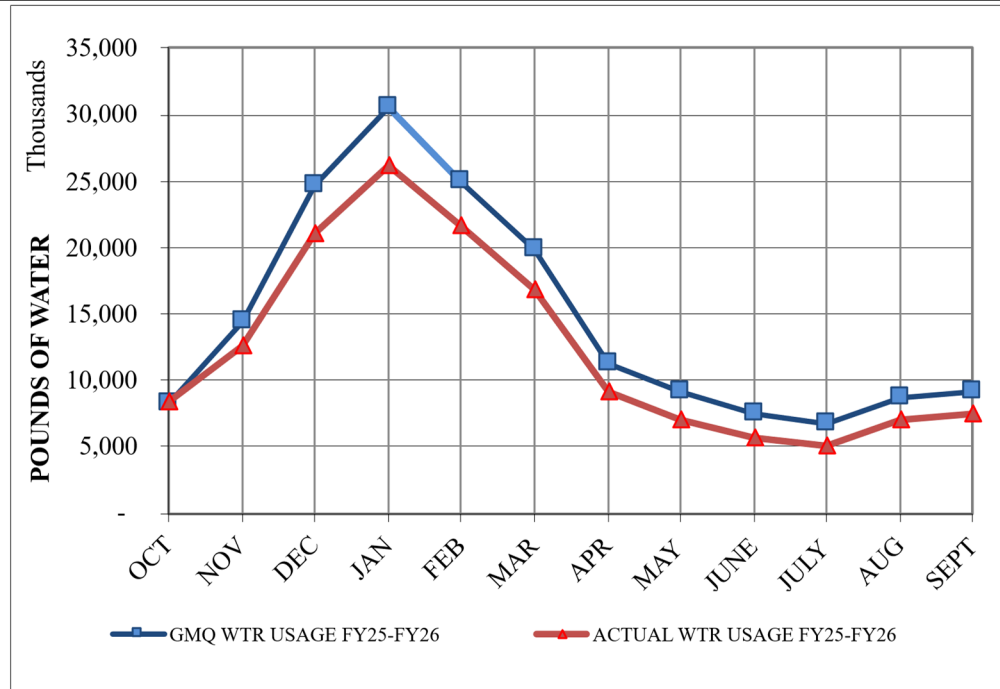
Figure 13. Steam Plant Water Performance Guarantee for the Previous Twelve Months Using a Mass Comparison

For the First Quarter, the boiler plant water usage increased 10.1%. The increase in water usage resulted in a 10.1% increase in the steam-water metric. Using the Amendment 3 methodology, the metric was met each month during the quarter. Figure 13 shows the steam-water metric using new methodology addressed in Amendment 3

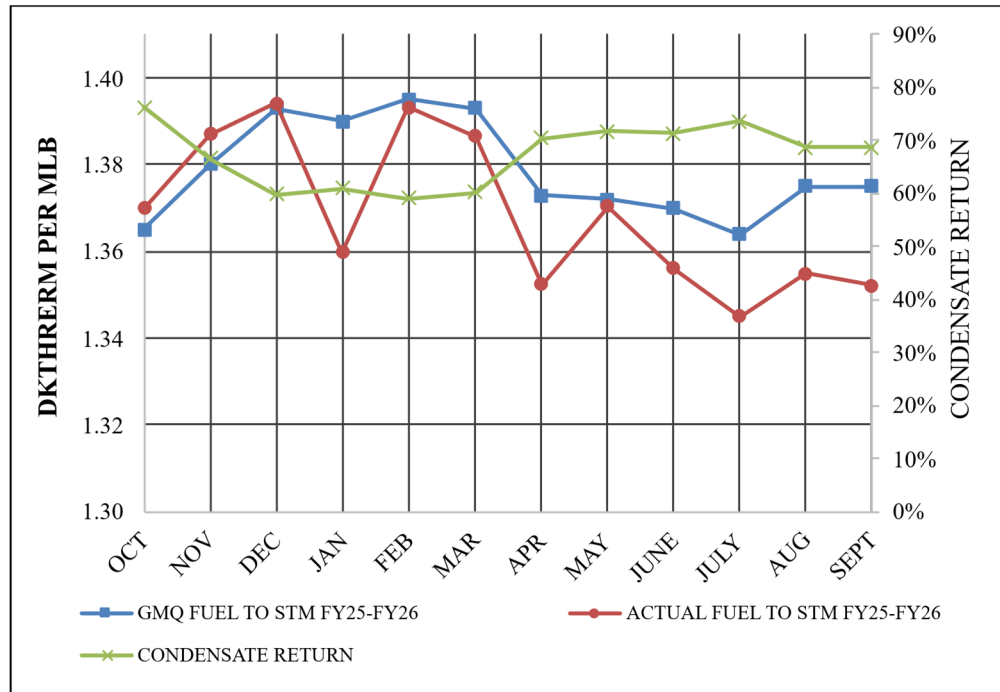
Figure 14. Steam Plant Fuel Performance Guarantee for the Previous Twelve Months

The steam-fuel metric did not change in Amendment 3; however, the relative amount of condensate return is reported using the mass flow determined by the density corrected values used in the steam-water metric. The actual steam-fuel metric was met each month during the First Quarter. The fuel consumption per unit of steam sendout increased 2.0% over the previous First Quarter indicating a decrease in efficiency.

Figure 14 shows the performance of the conversion factors for the previous twelve months. The relative amount of condensate return is shown on this graph to reflect the influence the condensate return has on the plant efficiency.

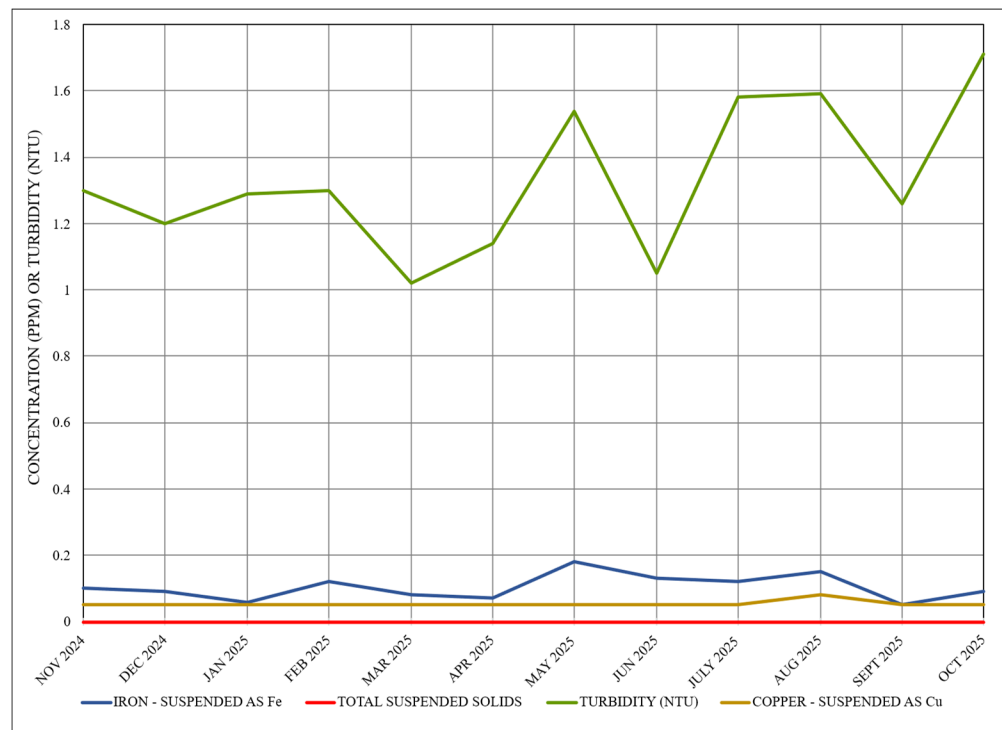
Figure 15. Chilled Water Composition Downstream of Side Stream Filter

- Figure 15 shows the results of several measured metrics within the chilled water system which may be affected through the use of the side stream filter. Values shown at or near zero may be at or below the detectable limit and are represented by “zero” on the graph.

However, the turbidity shows an increasing trend. The water treatment vendor has stated they believe the increase in turbidity may be due to one or more of the following: 1) the presence of the dye in the system used to detect leaks within the EDS, 2) degradation of the filter media, and 3) the presence of particulates entering the system from customer buildings. Additional samples and testing are anticipated in the Second Quarter to help determine the cause and potentially adjust the water treatment.
