Operations Monitoring Report

Second Quarter FY26

**Thermal Engineering Group, Inc.
105 Hazel Path Court, Ste 2
Hendersonville, TN 37075**

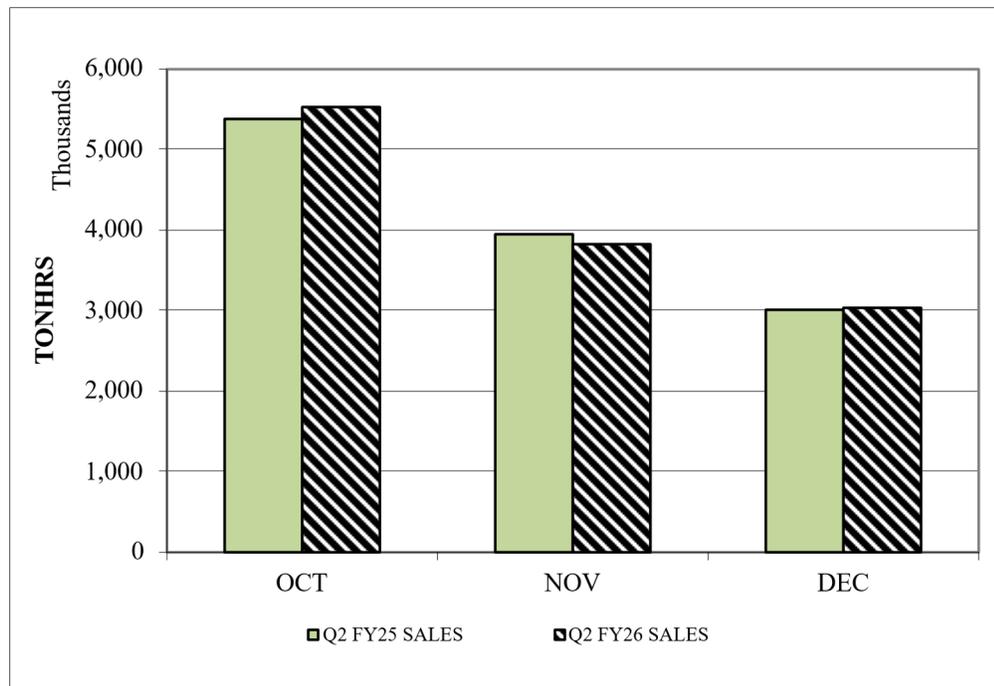
Figure 1. Chilled Water Sales Comparison

A comparison for the Second Quarter chilled water sales is shown in Figure 1. This data reflects a 0.6% increase in sales for the current quarter over the same quarter of the previous fiscal year. However, the number of cooling degree days decreased by 17.7%. Many of the issues related to the customer meter panels were resolved during the quarter and issues remain at only a few customer buildings. DEAO and TEG continue to address these problems so that customer sales values do not have to be estimated and remote access to the panels and the data they record can be maintained. DEAO and TEG continue to direct the customers to resolve those issues under their control.

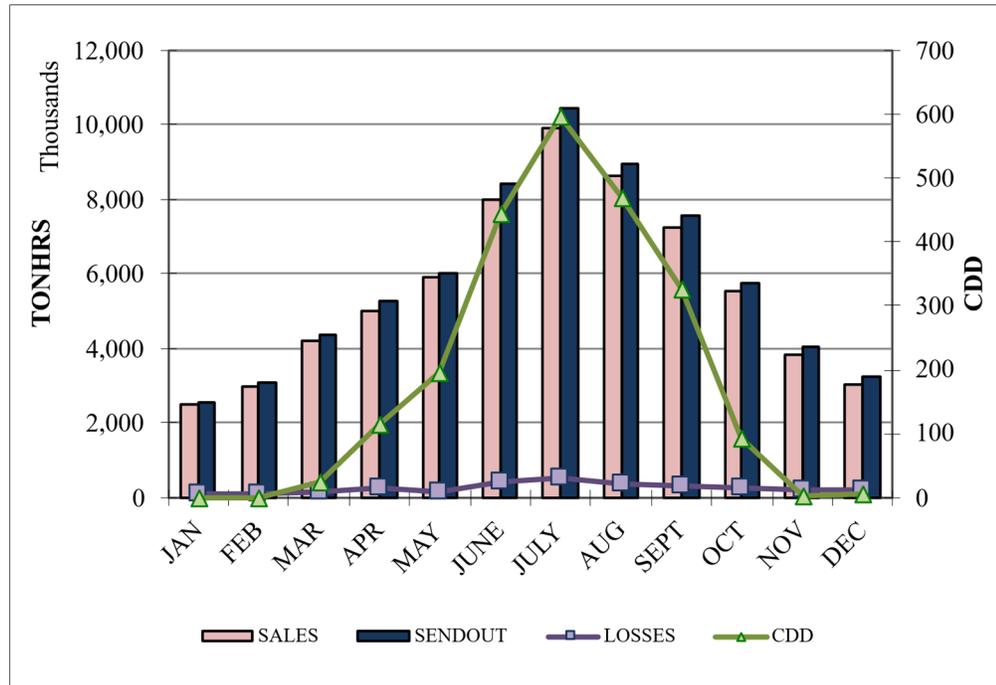
Figure 2. Chilled Water Sales, Sendout, Losses and CDD for the Previous Twelve Months

Figure 2 shows the chilled water sales, sendout and losses for the previous twelve months.

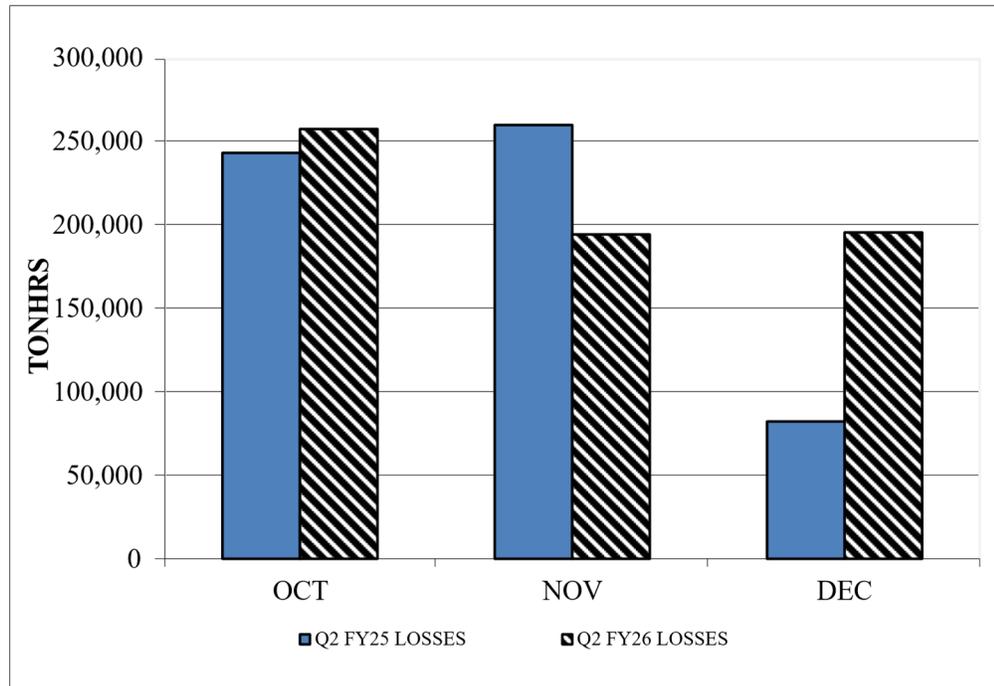
Figure 3. Chilled Water System Loss Comparison

A comparison of the total chilled water energy losses in the EDS for the Second Quarter FY26 is shown in Figure 3. These losses are the difference in chilled water sendout and sales and may reflect differences in the meter accuracy between the EGF sendout meter, the customer meters, and the monthly usage estimated for several of the customers. The losses increased 10.5% over the previous Second Quarter. The increase in losses in December may be related to an increase in the EDS make-up water to the system. The mass of the make-up would have been measured by the sendout meter at the EGF but may not have been captured by the customer meters.

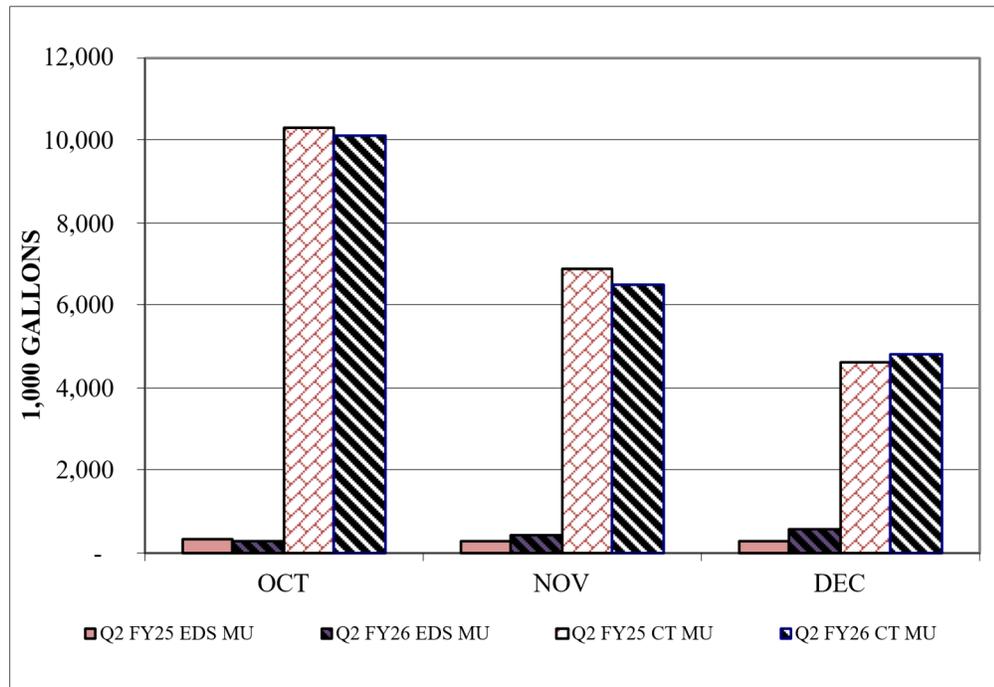
Figure 4. Chilled Water System City Water Usage Comparison

marginally over the previous Second Quarter. The overall city water make-up comparison for the chilled water system Second Quarter is shown in Figure 4. (Chilled water production is the same as chilled water sendout since there are no in-plant losses for the chilled water.)

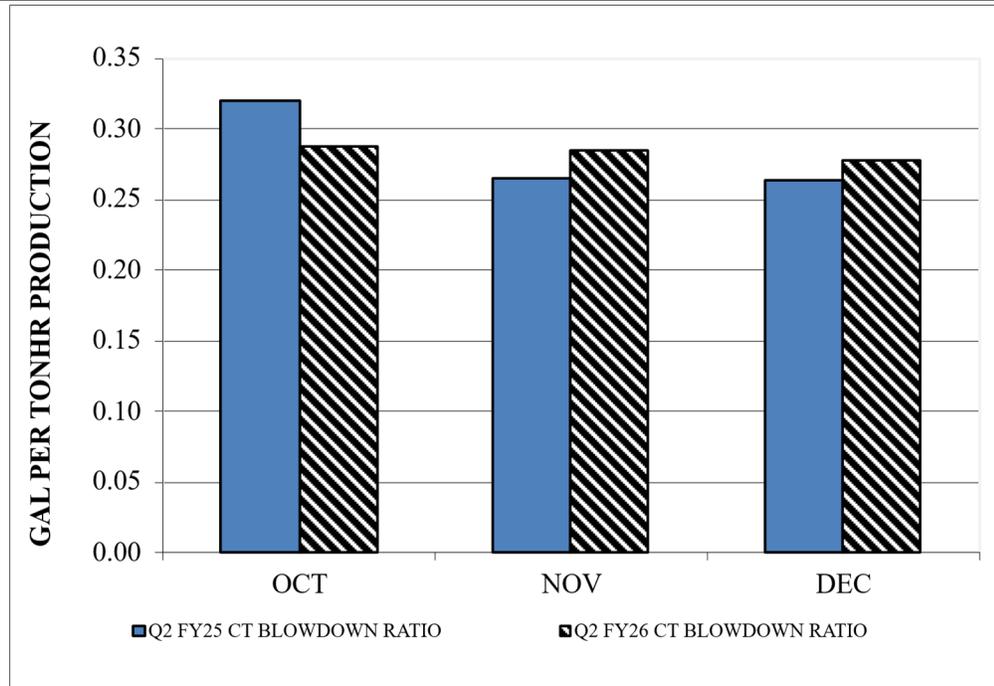
Figure 5. Cooling Tower Blowdown Ratio Comparison

The cooling tower blowdown is monitored and controlled to maintain the conductivity of the condensing water within a range of 1,000 to 1,150 micromhos. The relationship between the cooling tower blowdown and the chilled water production should be consistent and tracking this relationship has proven helpful in reducing the chiller plant make-up water usage. DEAO has made operational changes with respect to the ratio of the cooling tower blowdown to the chilled water production over the past several years with the expectation of reducing the water usage and improving their performance relative to the chilled water-water guarantee. A comparison of the Second Quarter values between FY25 and FY26 are shown in Figure 5.

When a comparison is made between the Second Quarter FY25 and FY26, the average cooling tower blowdown ratio decreased 1.2%. The chilled water-water performance guarantee was met each month during the Second Quarter FY26. During both quarters, the average cooling tower blowdown ratio was above 0.30 gallons per ton-hour. The metric averaged 0.285 gallons per ton-hour produced for the Second Quarter FY26 which validates previous assertions that values between 0.27 and 0.30 appear to result in more favorable operation and water usage and the chilled water-water performance metrics are met. The cooling tower blowdown ratio metric will continue to be tracked and monitored to verify the operational changes made by DEAO at the EGF continue to result in a decrease in chiller plant water usage.

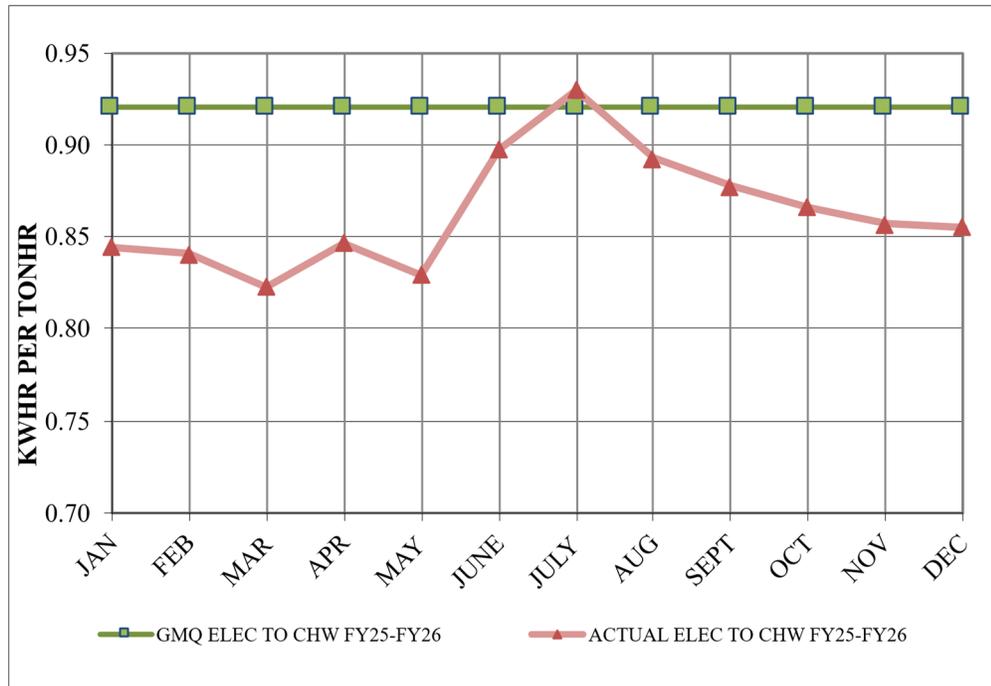
Figure 6. Chiller Plant Electric Performance Guarantee Comparison for the Previous Twelve Months

The performance of the chilled water portion of the EGF is presented in the following two charts, Figures 6 and 7, for the previous twelve months. The electricity usage per unit of sales decreased 0.1% over the previous Second Quarter and the chilled water-electric metric was met each month. DEAO’s investigation into the capture of the in-plant electric data in FY25 led to a discrepancy with the steam-electric data and how this data is used with the information provided to TEG and included in the customer invoices. The impact on the chilled water-electric remains unknown as of the end of the Second Quarter, but the investigation and potential corrective factors are ongoing.

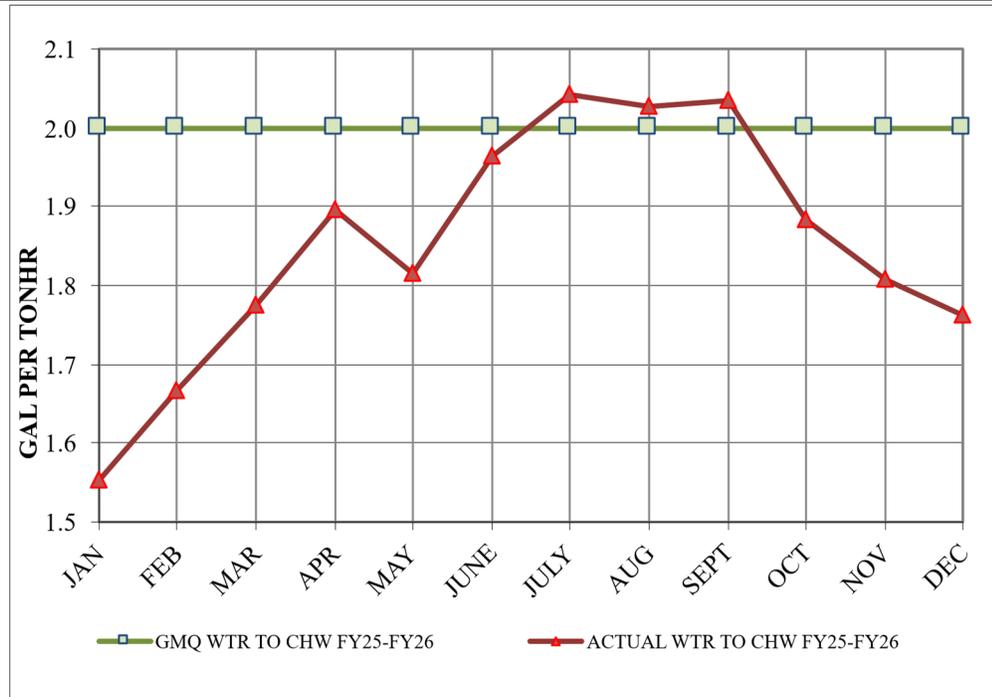
Figure 7. Chiller Plant Water Consumption Performance Guarantee Comparison for the Previous Twelve Months

The total consumption of city water for the chiller plant for the current quarter decreased marginally over the previous Second Quarter. The cooling tower blowdown decreased marginally while the side stream filter backwash decreased 25.3%. DEAO met the chilled water-water performance metric each month during the quarter and operated with a cooling tower blowdown ratio between 0.27 and 0.30 each month. Figure 7 shows the metric for the previous twelve months. TEG and DEAO continue to monitor the water usage and chiller plant performance with the goal of decreasing the energy and water usage for the system.

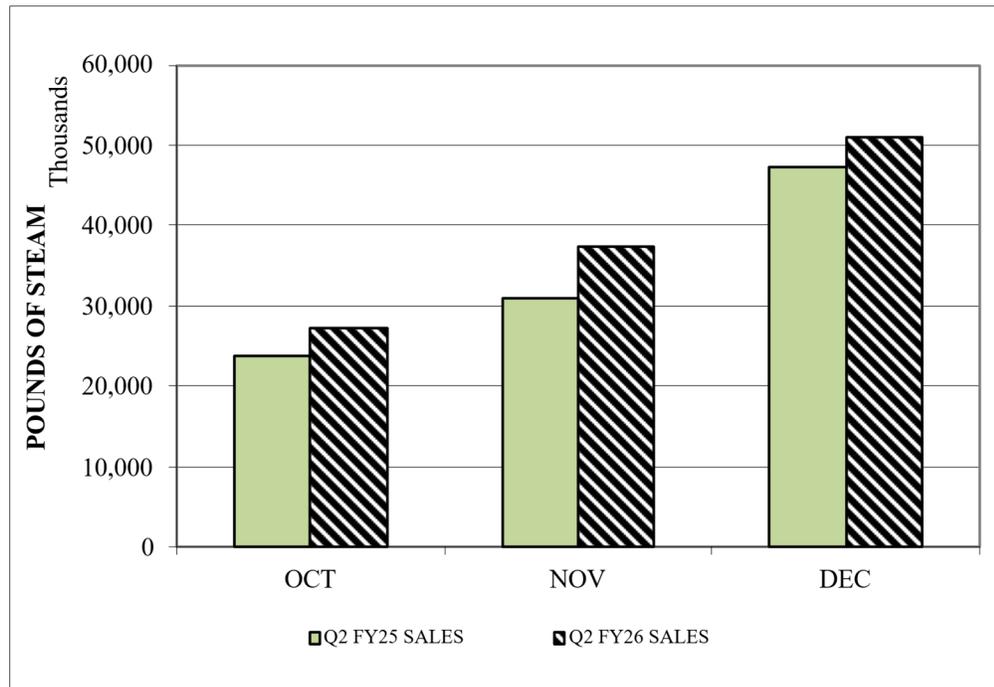
Figure 8. Steam Sales Comparison

Many of the issues related to the customer meter panels were resolved during the quarter and issues remain at only a few customer buildings. DEAO and TEG continue to address these problems so that customer sales values do not have to be estimated and remote access to the panels and the data they record can be maintained. In addition, data from a number of the customer panels had to be manually retrieved due to this issue and disconnected internet connections. DEAO and TEG continue to direct and coordinate with the customers to resolve those issues under their control. A comparison for the Second Quarter steam sales is shown in Figure 8.

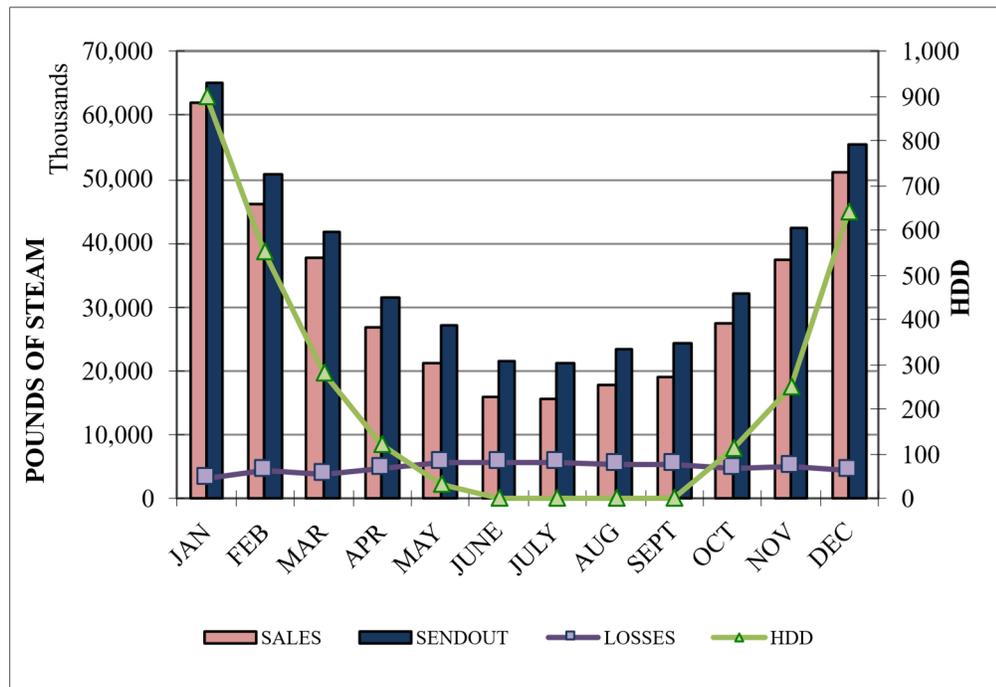
Figure 9. Steam Sales, Sendout, Losses and HDD for the Previous Twelve Months

Figure 9 shows the steam sales, sendout and losses for the previous twelve months. The losses on this figure are defined as the difference in pounds per month between the recorded sendout and sales values and represent the total mass loss in the EDS between the EGF and the customer meters.

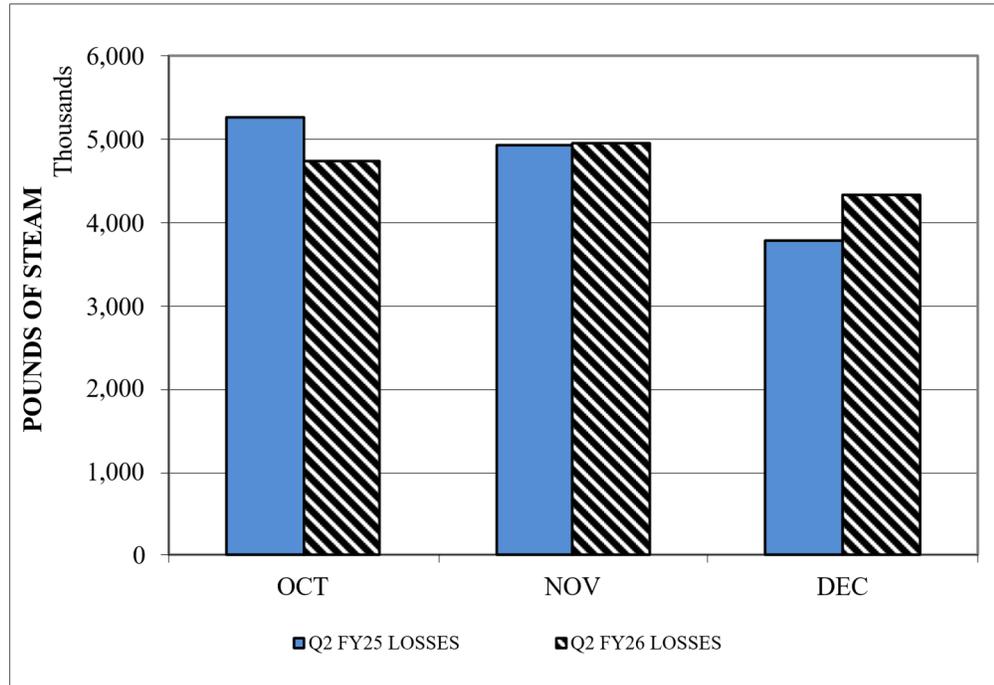
Figure 10. Steam System Losses

A comparison of the total steam mass losses in the EDS for the Second Quarter is shown in Figure 10. The mass loss is caused by the heat loss in the EDS between the EGF and the customer meters, resulting in a mass loss at steam traps. Faulty traps, steam leaks, or meter error could also be a contributing cause of these losses.

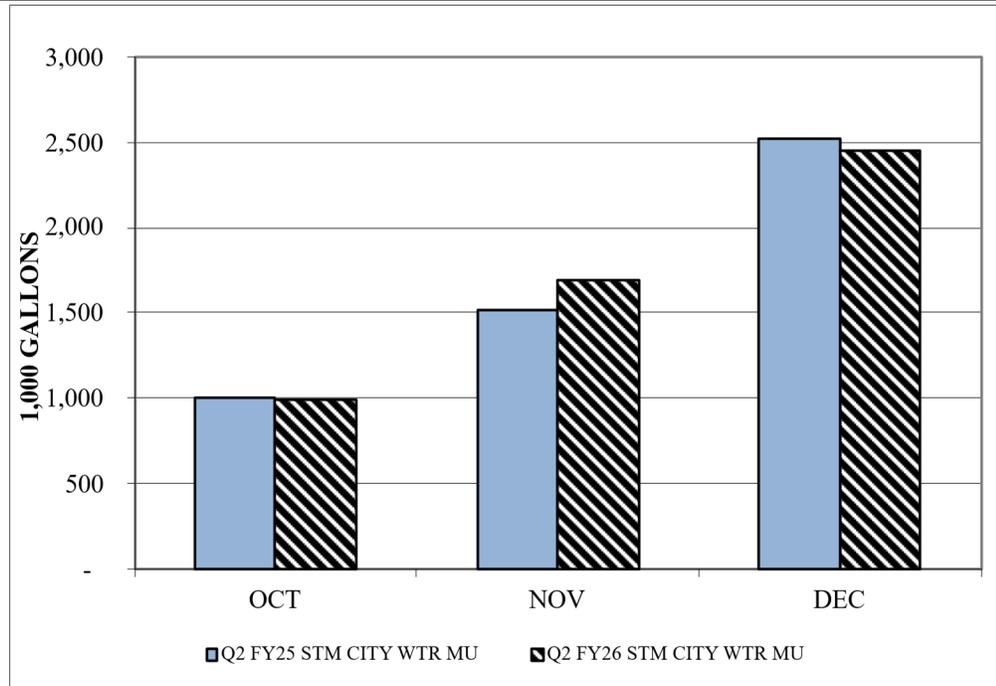
Figure 11. Steam System City Water Make-up Comparison

The amount of city water make-up (MU) to the steam system consists of the loss in mass between the EGF and the customers, in the condensate return from the customers to the EGF and losses at the EGF. The amount of make-up to the steam system increased 1.8% over the Second Quarter FY25. The relative amount of condensate return increased 1.6% over the previous Second Quarter. With an increase in the amount of make-up water, the relative amount of condensate return may be expected to decrease. However, an additional leak on Third Avenue North was discovered during the quarter and repaired in December. During the period between the discovery of the leak and the restoration of service, the condensate return from the customers in this area was drained at their buildings and not returned to the plant. The corresponding data for steam system make-up is shown in the comparison of Second Quarter data in Figure 11.

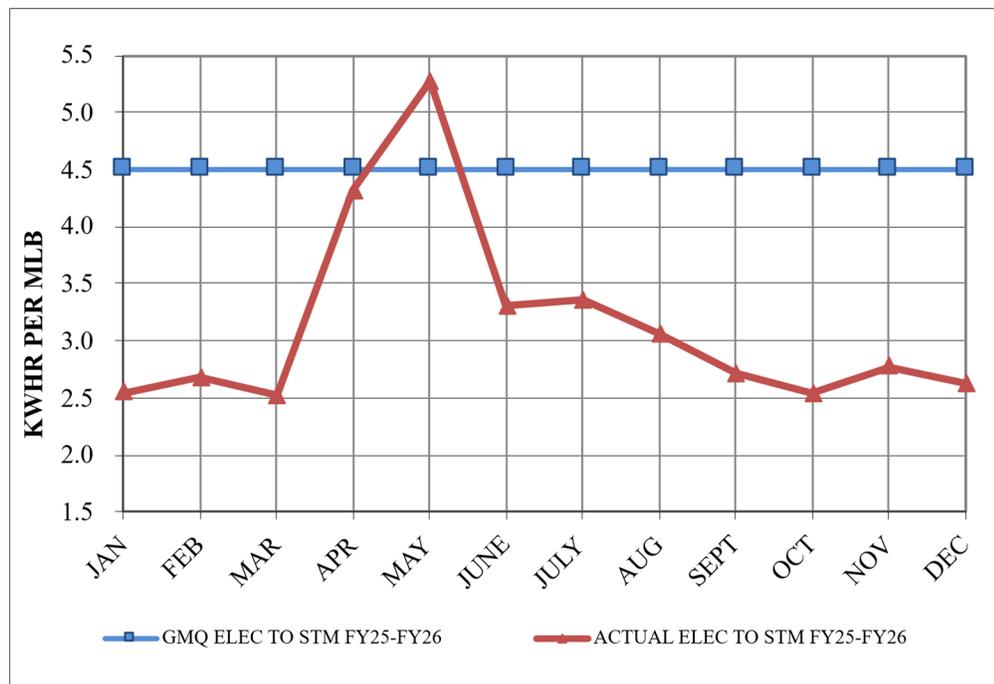
Figure 12. Steam Plant Electric Performance Guarantee for the Previous Twelve Months

The monthly steam-electric conversion factors, along with the guaranteed values, for the previous twelve months are shown in Figure 12.

The performance of the steam system of the EGF is presented in the following three charts, Figures 12, 13, and 14. The steam electric conversion factor was met for each month of the quarter. The steam plant electric consumption for the current quarter was 7.5% higher in the Second Quarter FY26 than in the previous Second Quarter. The steam-electric metric decreased 6.3% over the previous Second Quarter.

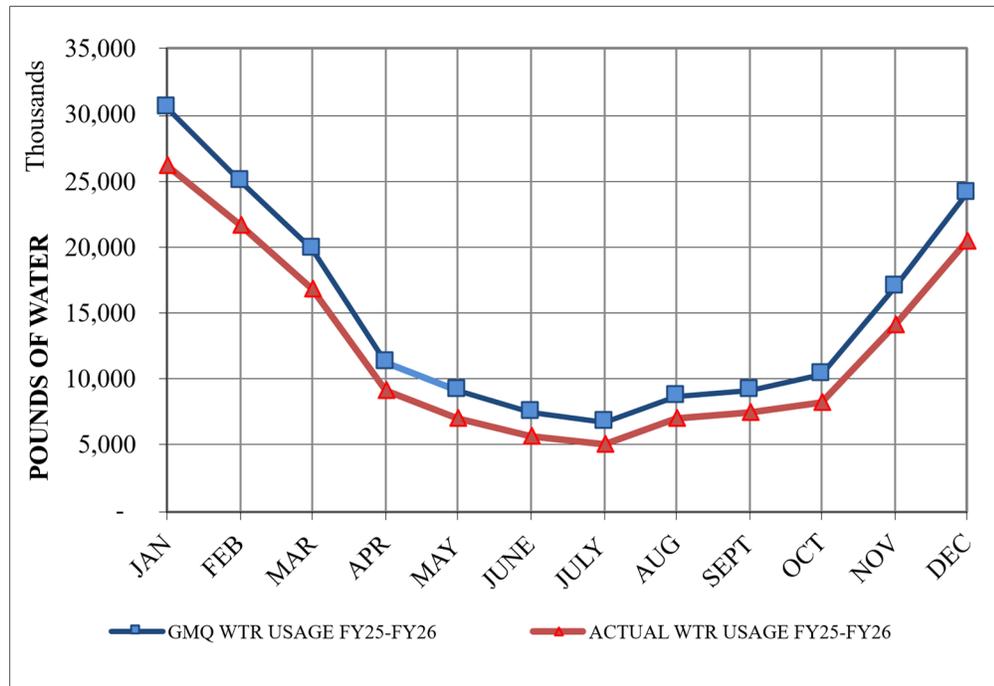
Figure 13. Steam Plant Water Performance Guarantee for the Previous Twelve Months Using a Mass Comparison

For the Second Quarter, the boiler plant water usage increased 1.8%. The metric performance was met each month during the quarter. Figure 13 shows the steam-water metric using new methodology addressed in Amendment 3.

The steam-fuel metric did not change in Amendment 3; however, the relative amount of condensate return is reported using the mass flow determined by the density corrected values used in the steam-water metric (see Figure 13). The actual steam-fuel metric was met in October but not in November or December. The fuel consumption per unit of steam sendout decreased marginally over the previous Second Quarter indicating an increase in efficiency.

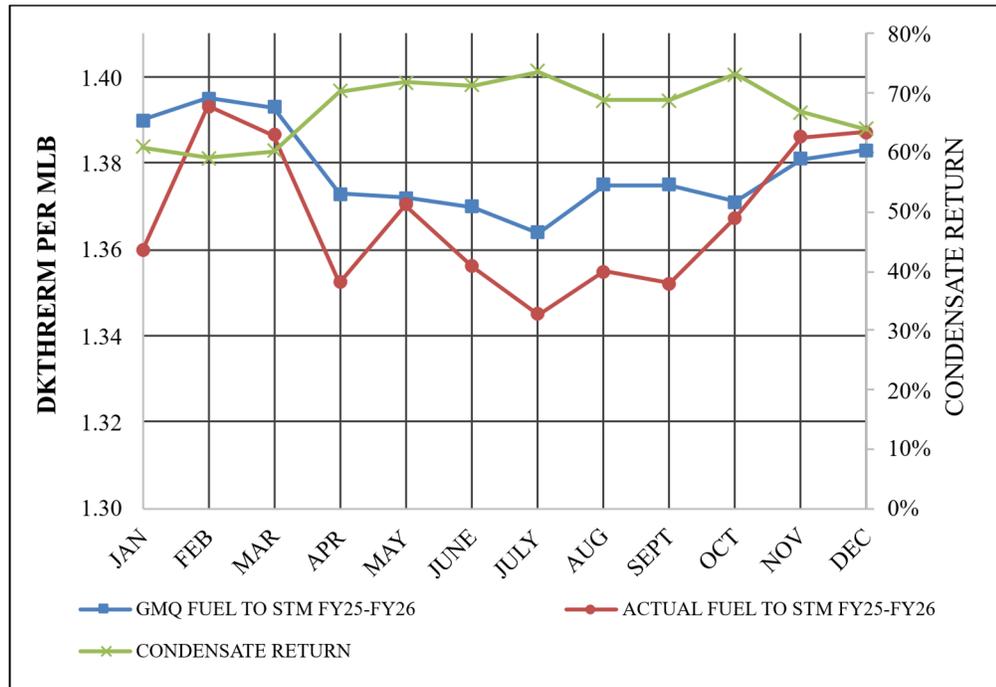
Figure 14. Steam Plant Fuel Performance Guarantee for the Previous Twelve Months

Figure 14 shows the performance of the conversion factors for the previous twelve months. The relative amount of condensate return is shown on this graph to reflect the influence the condensate return has on the plant efficiency.

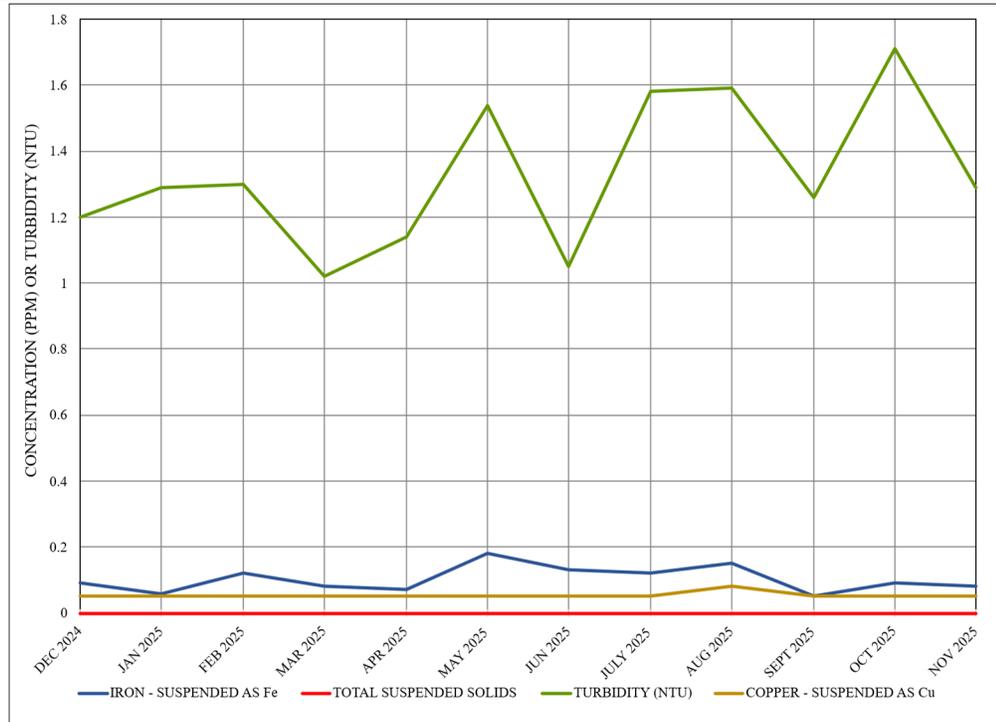
Figure 15. Chilled Water Composition Downstream of Side Stream Filter

- Figure 15 shows the results of several measured metrics within the chilled water system which may be affected through the use of the side stream filter. Values shown at or near zero may be at or below the detectable limit and are represented by "zero" on the graph. Data for December 2025 was not available at the time of publishing this report.

- The side stream filter has significantly reduced the amount of suspended solids in the chilled water and improved the turbidity of the system since it became operational in 2023. However, the turbidity shows an increasing trend through the First and Second Quarters of FY26. The water treatment vendor has stated they believe the increase in turbidity may be due to one or more of the following: 1) the presence of the dye in the system used to detect leaks within the EDS, 2) degradation of the filter media, and 3) the presence of particulates entering the system from customer buildings. Additional samples and testing are anticipated in the Third Quarter to help determine the cause and potentially adjust the water treatment.
