Operations Monitoring Report

Third Quarter FY26

**Thermal Engineering Group, Inc.
105 Hazel Path Court, Ste 2
Hendersonville, TN 37075**

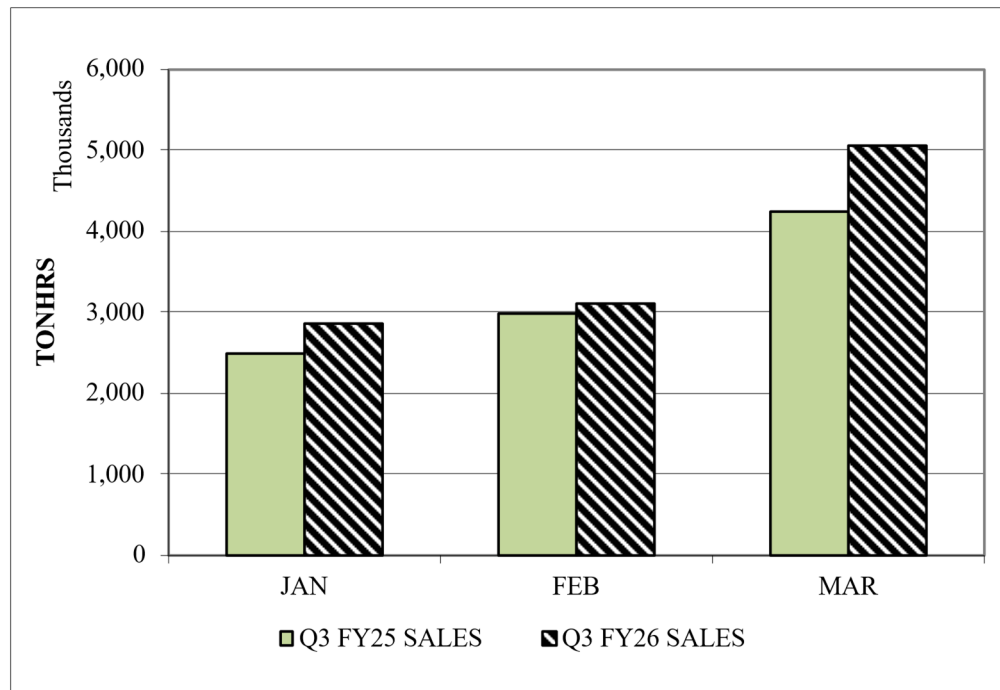
Figure 1. Chilled Water Sales Comparison

A comparison for the Third Quarter chilled water sales is shown in Figure 1. This data reflects a 13.9% increase in sales for the current quarter over the same quarter of the previous fiscal year with a significant increase (196%) in the number of cooling degree days due to an unseasonably warm March. Many of the issues related to the customer meter panels were resolved during the quarter and issues remain at only a few customer buildings. DEAO and TEG continue to address these problems so that customer sales values do not have to be estimated and remote access to the panels and the data they record can be maintained. DEAO and TEG continue to direct the customers to resolve those issues under their control.

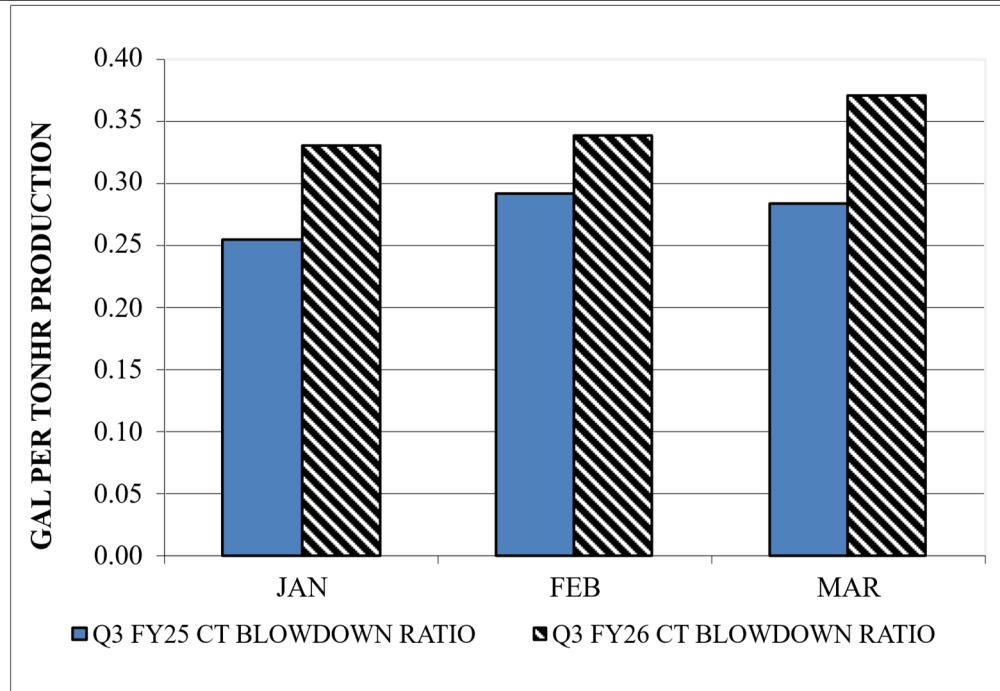
Figure 5. Cooling Tower Blowdown Ratio Comparison

The cooling tower blowdown is monitored and controlled to maintain the conductivity of the condensing water within a range of 1,000 to 1,150 micromhos. The relationship between the cooling tower blowdown and the chilled water production should be consistent and tracking this relationship has proven helpful in reducing the chiller plant make-up water usage. DEAO has made operational changes with respect to the ratio of the cooling tower blowdown to the chilled water production over the past several years with the expectation of reducing the water usage and improving their performance relative to the chilled water-water guarantee. A comparison of the Third Quarter values between FY25 and FY26 are shown in Figure 5.

When a comparison is made between the Third Quarter FY25 and FY26, the average cooling tower blowdown ratio increased 25.8%. The chilled water-water performance guarantee was met each month during the Third Quarter FY26. However, the metric averaged 0.35 gallons per tonhr in FY26 and 0.28 in FY25. Previous analysis of the cooling tower blowdown indicated values between 0.27 and 0.30 appeared to result in more favorable operation and water usage. Although the chilled water-water metric was met each month during the quarter, the average value increased 11.5%. Additional factors may have impacted the performance during the Third Quarter FY26. The cooling tower blowdown ratio metric will continue to be tracked and monitored to verify the operational changes made by DEAO at the EGF continue to result in a decrease in chiller plant water usage.

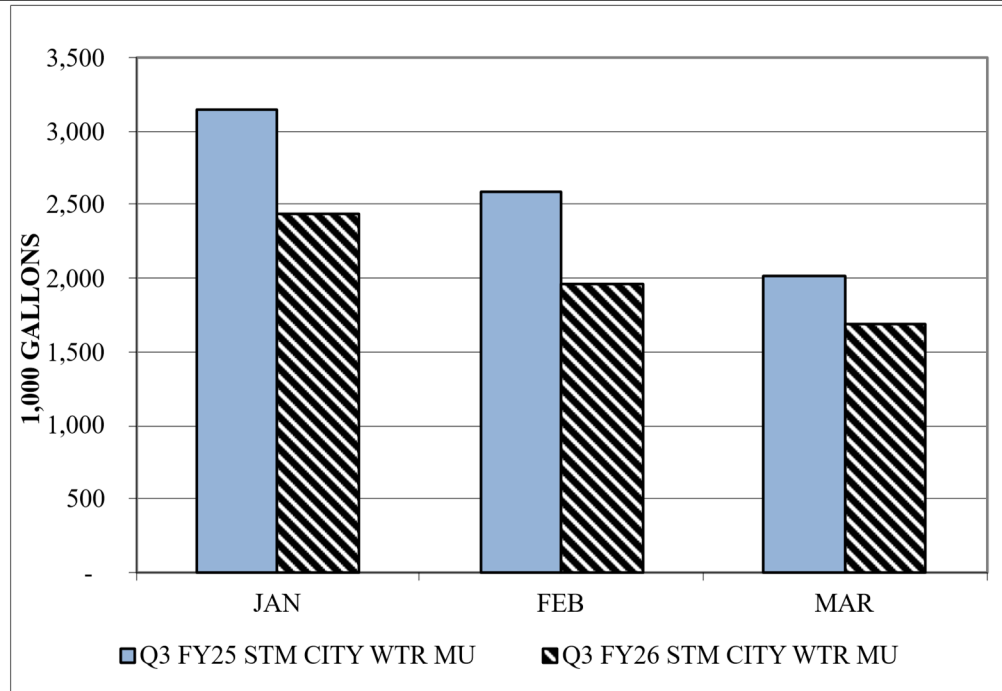
Figure 11. Steam System City Water Make-up Comparison

The amount of city water make-up (MU) to the steam system consists of the loss in mass between the EGF and the customers, in the condensate return from the customers to the EGF and losses at the EGF. The amount of make-up to the steam system decreased 21.3% over the Third Quarter FY25. The relative amount of condensate return increased 11.1% over the previous Third Quarter. The decrease in make-up and increase in condensate return are due to recent condensate repairs to the EDS. Additional leaks may be present in the condensate piping in Third Ave N, which will be addressed in the Fourth Quarter FY26. The corresponding data for steam system make-up is shown in the comparison of Third Quarter data in Figure 11.

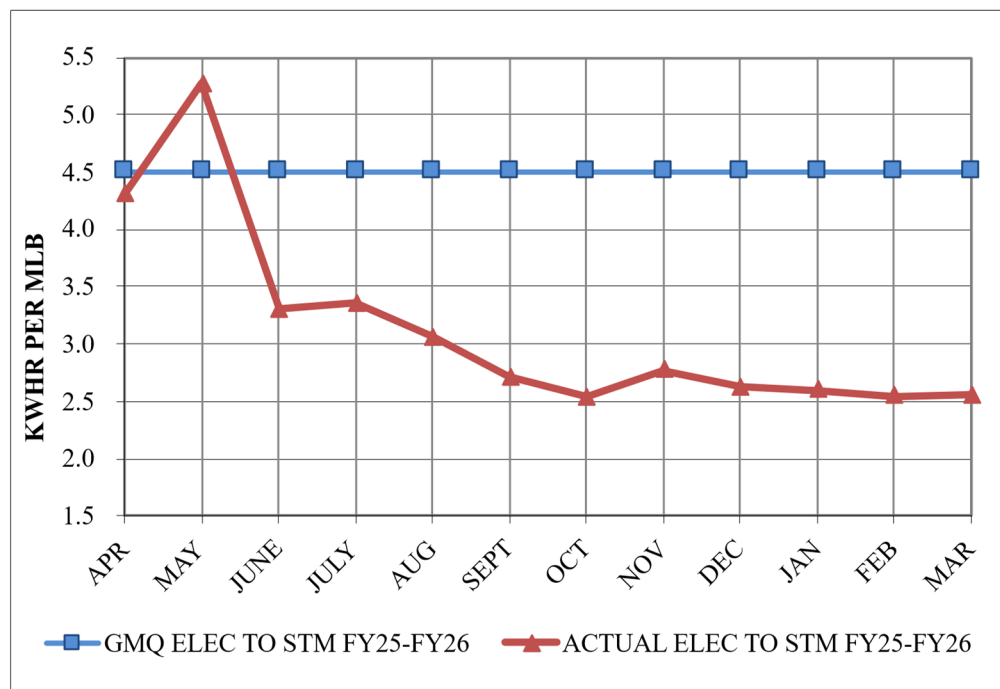
Figure 12. Steam Plant Electric Performance Guarantee for the Previous Twelve Months

The monthly steam-electric conversion factors, along with the guaranteed values, for the previous twelve months are shown in Figure 12.

The performance of the steam system of the EGF is presented in the following three charts, Figures 12, 13, and 14. The steam electric conversion factor was met for each month of the quarter. The steam plant electric consumption for the current quarter was 3.0% lower in the Third Quarter FY26 than in the previous Third Quarter. The steam-electric metric decreased marginally over the previous Third Quarter.
