**STAFF RECOMMENDATION**  
**126 Second Avenue South**  
**August 21, 2019**

**Application:** Demolition  
**District:** Second Avenue Historic Preservation Zoning Overlay  
**Council District:** 19  
**Base Zoning:** DTC  
**Map and Parcel Number:** 09306208000  
**Applicant:** Larry Papel, owner  
**Project Lead:** Robin Zeigler, [robin.zeigler@nashville.gov](mailto:robin.zeigler@nashville.gov)

**RE: 126 Second Avenue South  
EMC Project No. 19666**

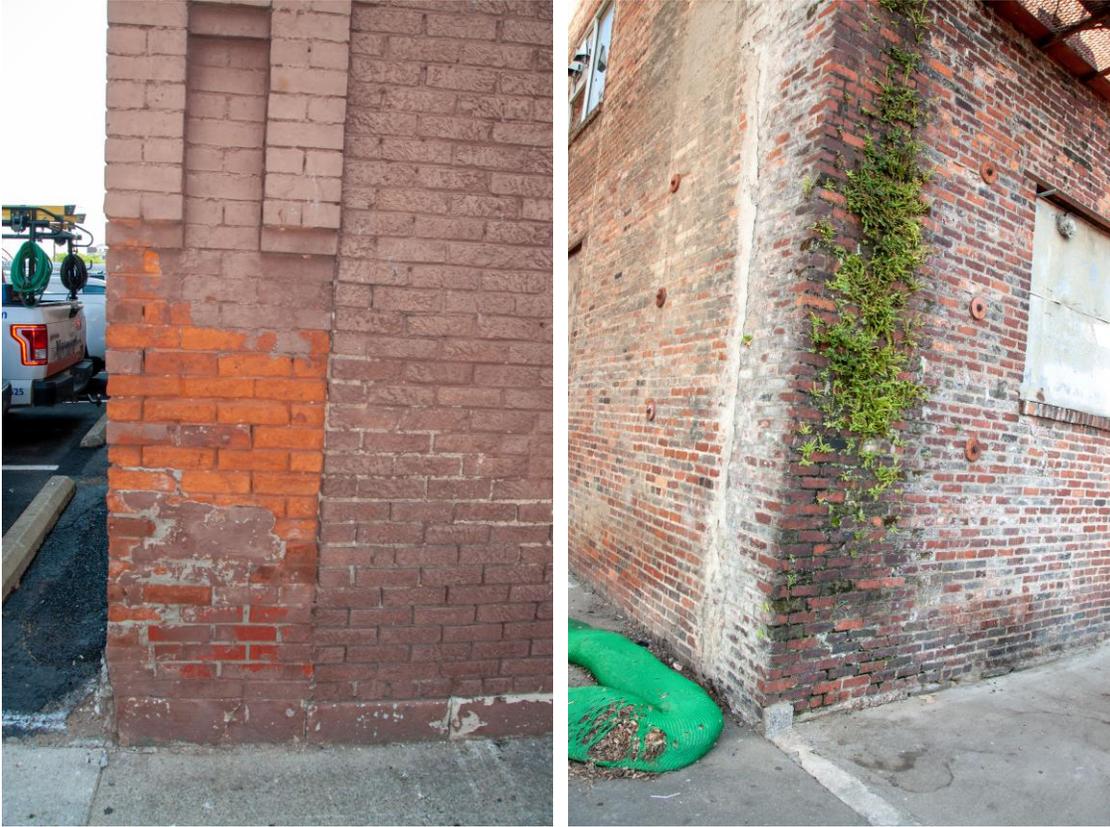
Front-left corner and rear-right corner of building exterior.

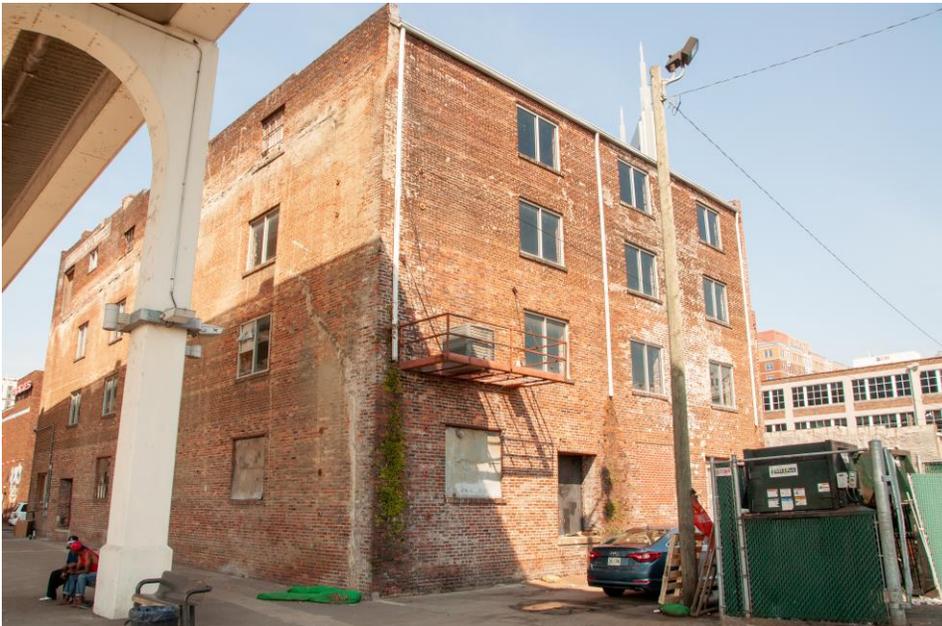
Rear right corner of exterior of building.

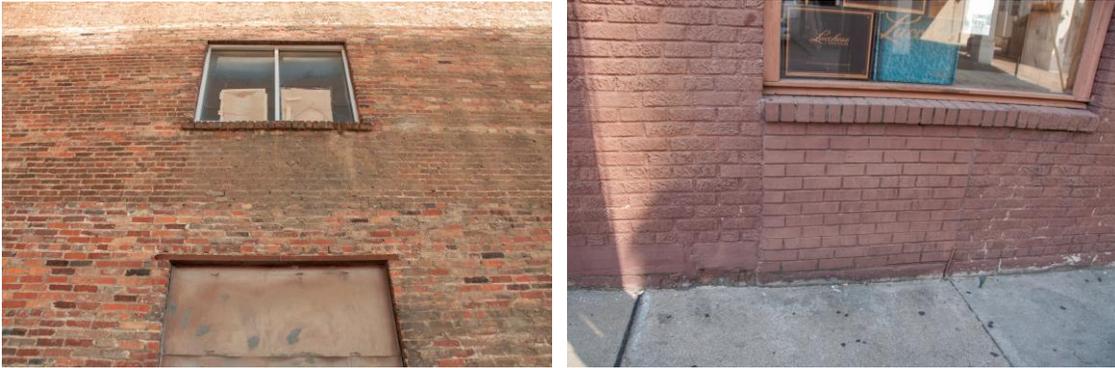
Two close ups views of walls showing the variety of brick. Left image is the right side of the building and the right image is the front-right of the building.

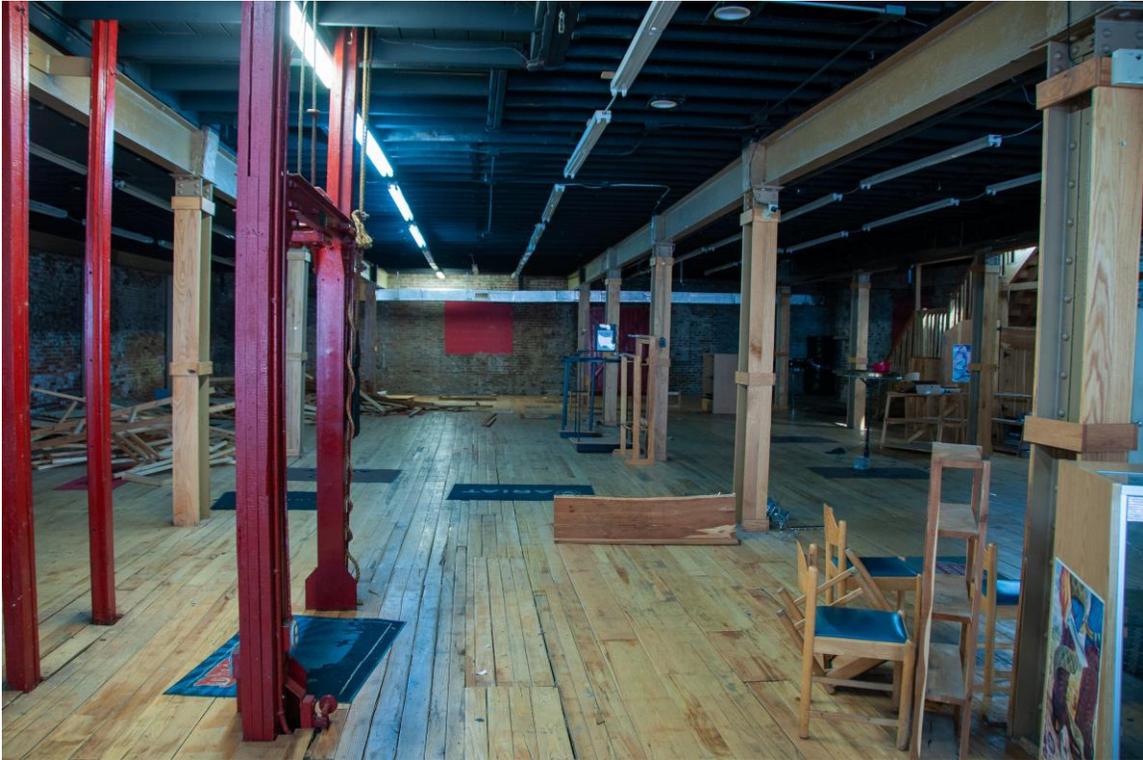
First level interior, with remains of the elevator shaft on the left.

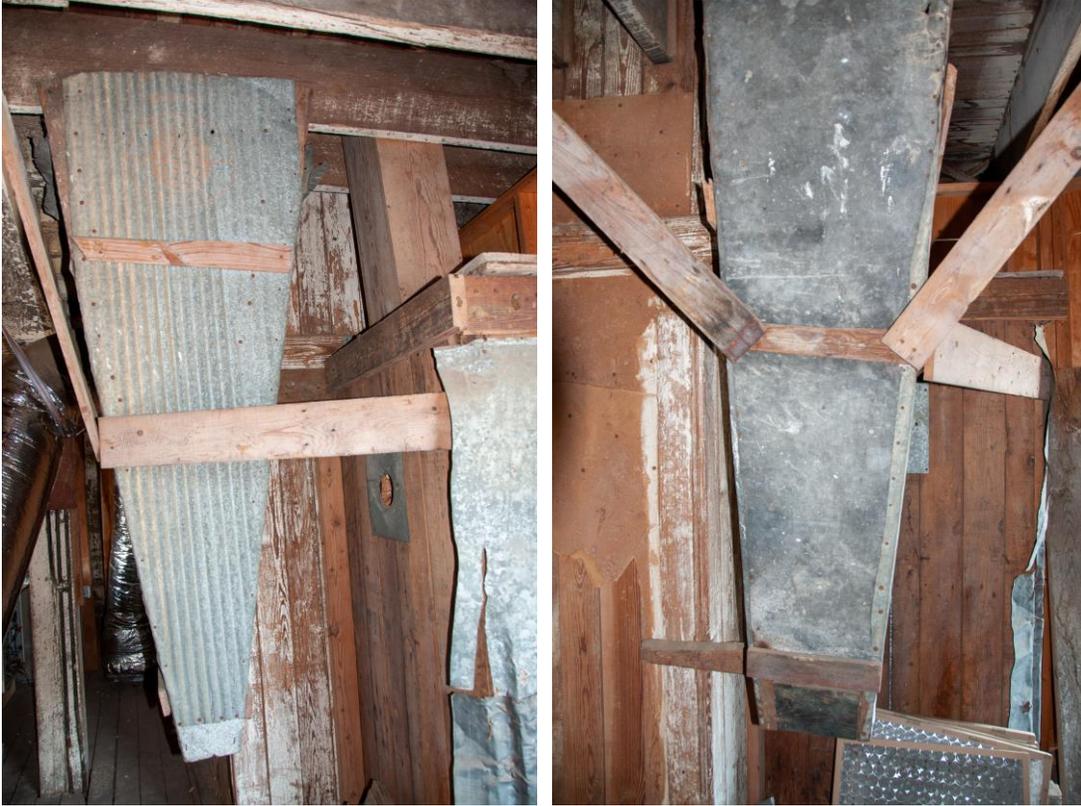
This chute on the 2<sup>nd</sup> level may be left over from the American Steam Feed's occupation of the building.

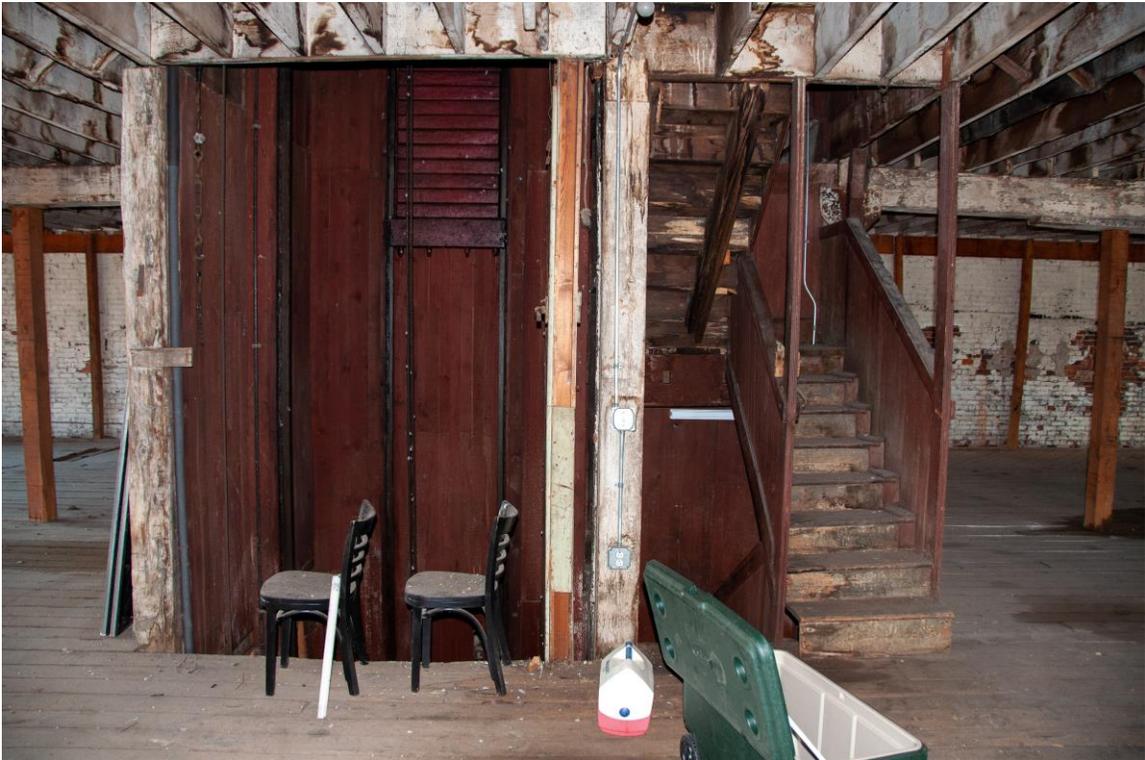
Elevator shaft remains on upper levels.

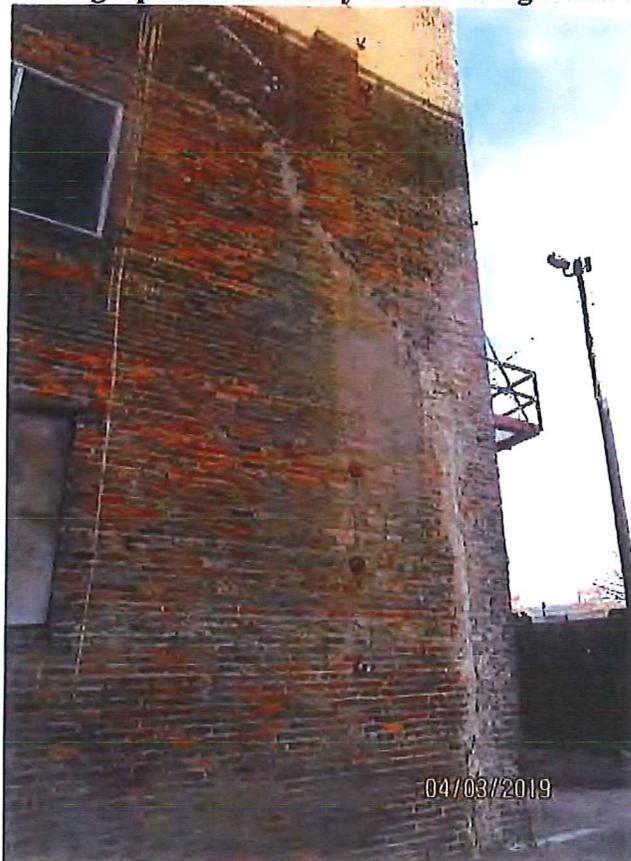
**Photograph 31: Rear wall elevation.**

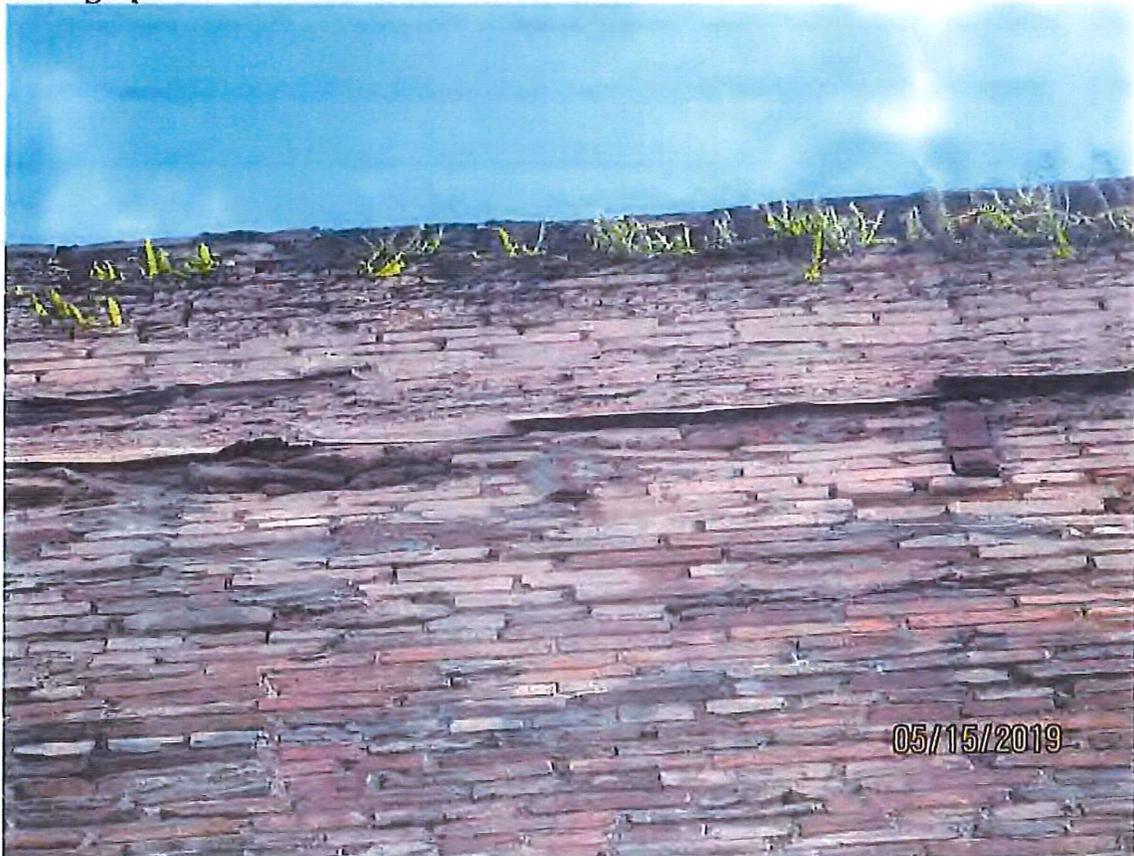
As seen in photograph 44, the north wall (left wall when facing the front of the building) had once been an interior wall. This is obvious by the flashing that is left in place and the brick pockets that have been infilled. It is also obvious that the original roofline for this building was at the approximately third-floor line, which is evidenced by the original brick pocket in the wall (photograph 51).

**Photograph 44: View of first offset at left wall.**

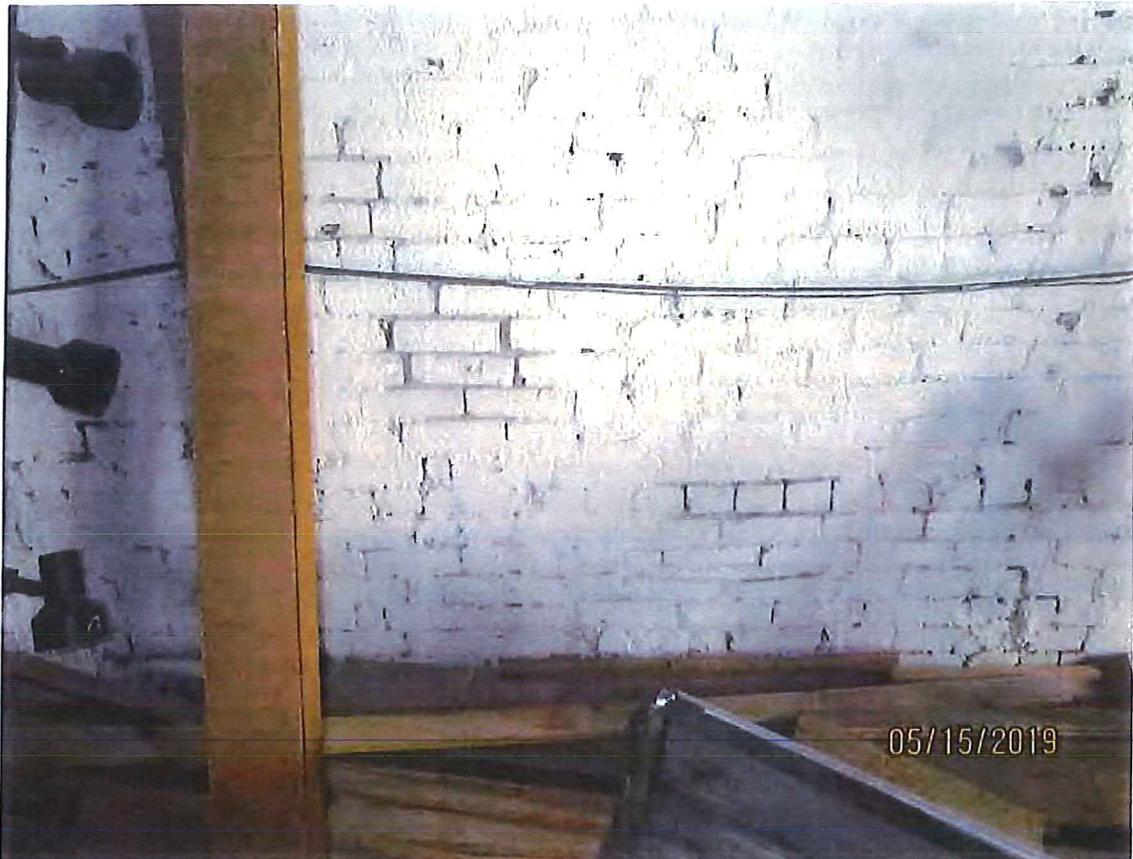
**Photograph 49: Floor movement / brick deterioration at left wall on second floor.**

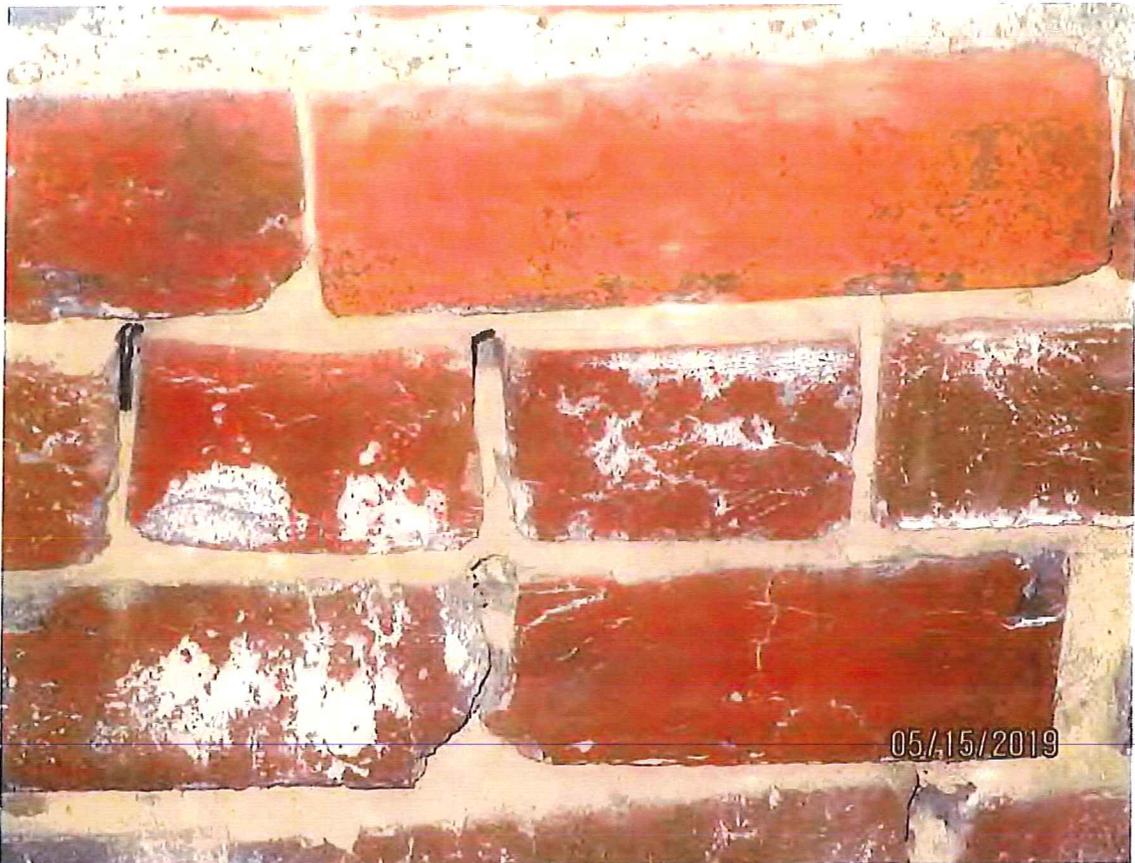
**Photograph 67: Deterioration of bricks / mortar at left wall on fourth floor.**

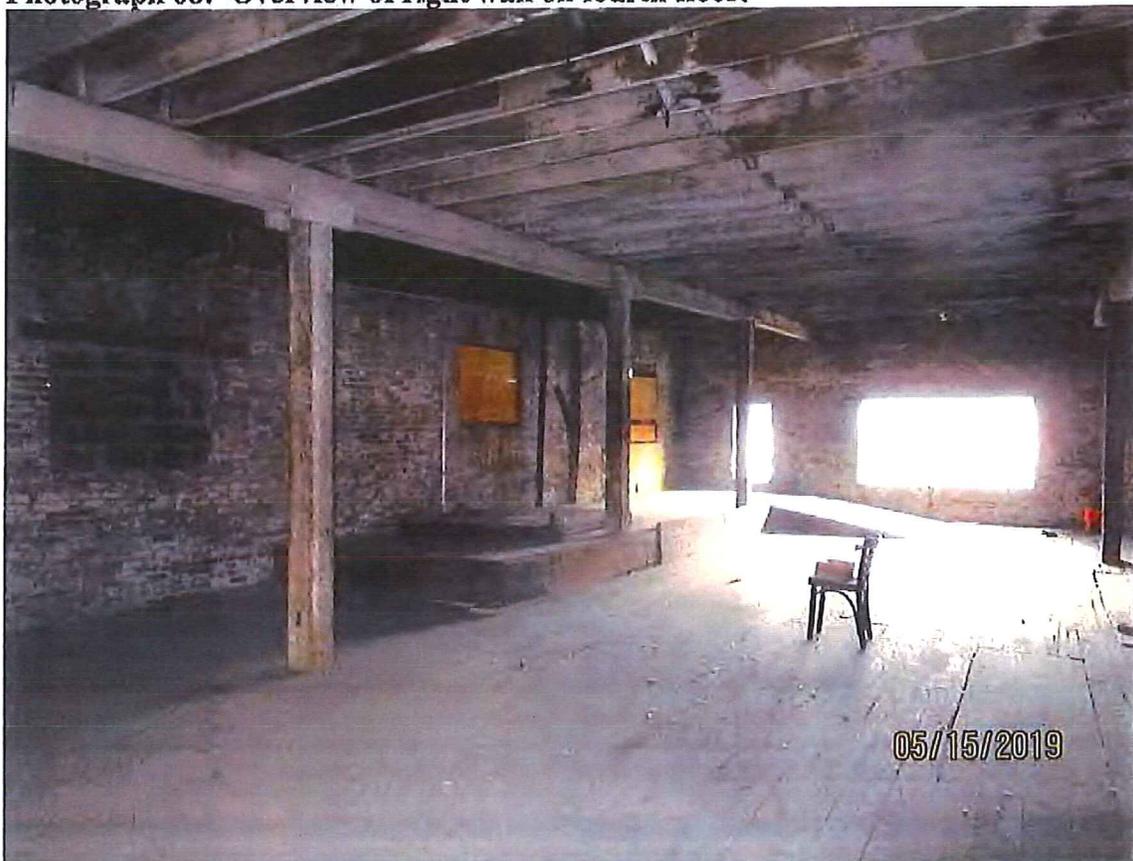
**Photograph 69: Overview of right wall on fourth floor.**
